# CASE STUDIES OF HMA CONSTRUCTION PROJECTS

R. BROWN  
Engineer Research and Development Center (ERDC)  
US Army Corps of Engineers  
Vicksburg, MS. 39180  
[brownel@eng.auburn.edu](mailto:brownel@eng.auburn.edu)

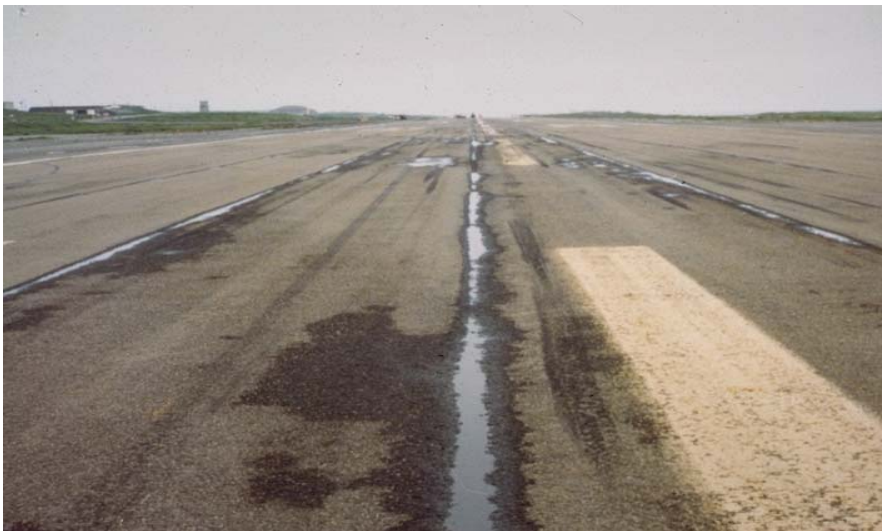
The long lasting pavement was constructed in Shemya, Alaska in 1976. The old pavement was originally completely reconstructed in 1967. Then in 1976 a new overlay had to be placed over the existing surface primarily due to cracking and raveling at the longitudinal joints (Figure 1).

**Figure 1. Cracking and Raveling of Longitudinal Joint.**

The repair specified that some high spots be removed with a heater planer and that some low spots be patched with a leveling course of HMA. After the planing and the leveling course was placed, the entire surface was overlaid with a two inch layer of hot mix asphalt (Figure 2).

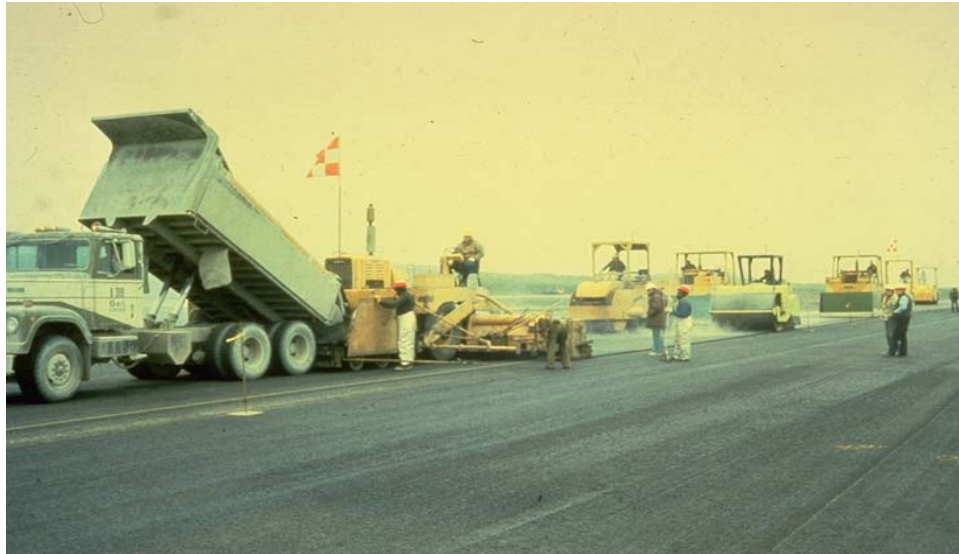
**Figure 2. Placement and Compaction of 2-inch overlay.**

It can be seen from Figure 2 that a significant amount of compactive effort was provided to the hot mix asphalt. The primary reason for this high effort was that this was the first airfield pavement project that had a reduction in pay clause for density not meeting the specification requirements. The density of the mixture was measured in the mat and in the joint and the results were evaluated separately. When the density was slightly below the specification requirements a reduction in pay was applied based on the density but the material was accepted at this reduced cost. When the material was significantly below the specifications then the material would have to be removed and replaced. Of course this type of specification encouraged the contractor to apply additional compactive effort to ensure that adequate density was obtained.

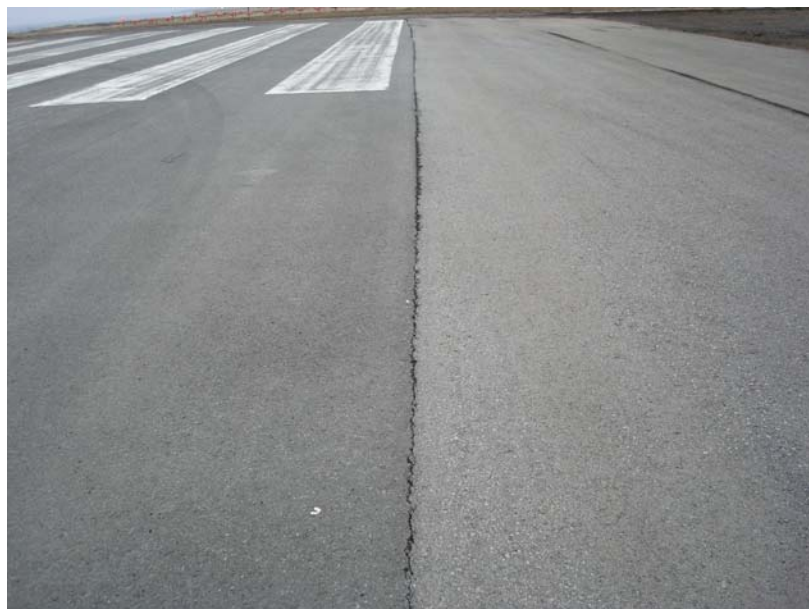
**Figure 3. Longitudinal joints that have cracked and been sealed**

Figure 3 shows that much of the pavement surface is still in good condition even though some sealing of the longitudinal joint has been required. Figure 4 shows that an old patch has deteriorated to the point that it will have to be patched again in the near future. In general, most of the pavement is still in very good condition especially considering that it is over 30 years old. The conclusion from this project is that good control of materials and good compaction will help ensure a long pavement life.

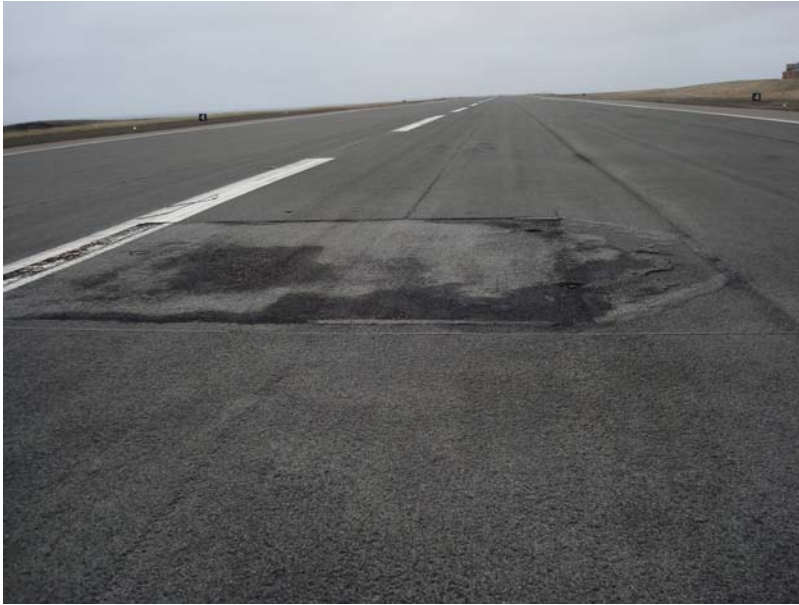
**Figure 4. Patching that exists on the 31 year old pavement.**

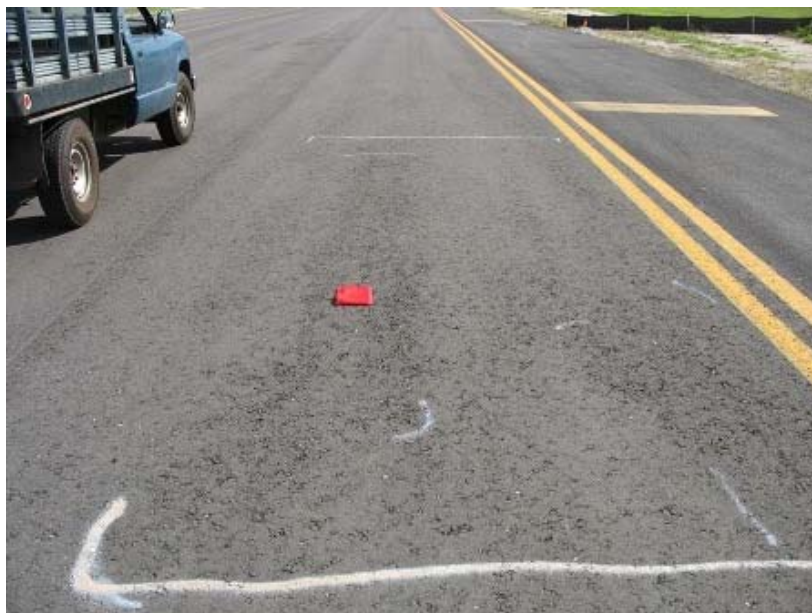
A typical project that has significant segregation is shown in Figures 5 and 6. The areas shown in Figure 6 will most likely ravel with time resulting in FOD

**Figure 5. Surface of Pavement showing Segregation.**

Segregation of the aggregate in hot mix asphalt has been a problem on many projects. While segregation is sometimes a difficult problem to solve, it can almost always be minimized so that it is not a significant issue. Steps to minimize segregation include controlling the stockpiles, proper loading of the storage silo, proper loading of the trucks from the silo, using a material transfer vehicle, proper operation of the paver, and minimizing handwork.

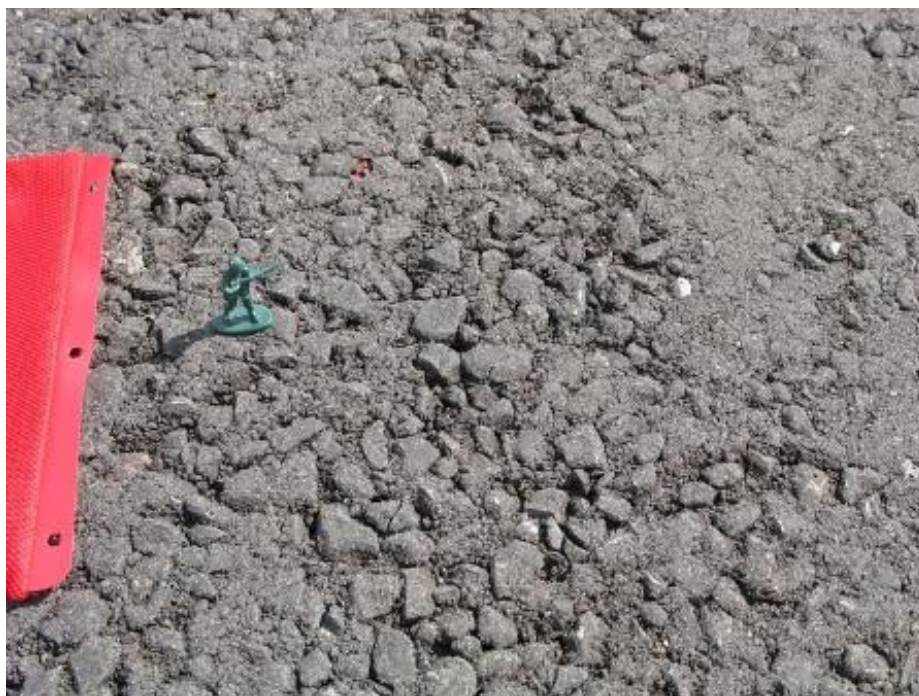
issues and the need to patch the area. Segregation happens on too many projects and in most cases this can be prevented. The problem must first be identified and then steps made to correct the problem. Without correcting segregation issues, the pavement life will be significantly reduced.

**Figure 6 - Close-up of Segregated area showing porous surface.**

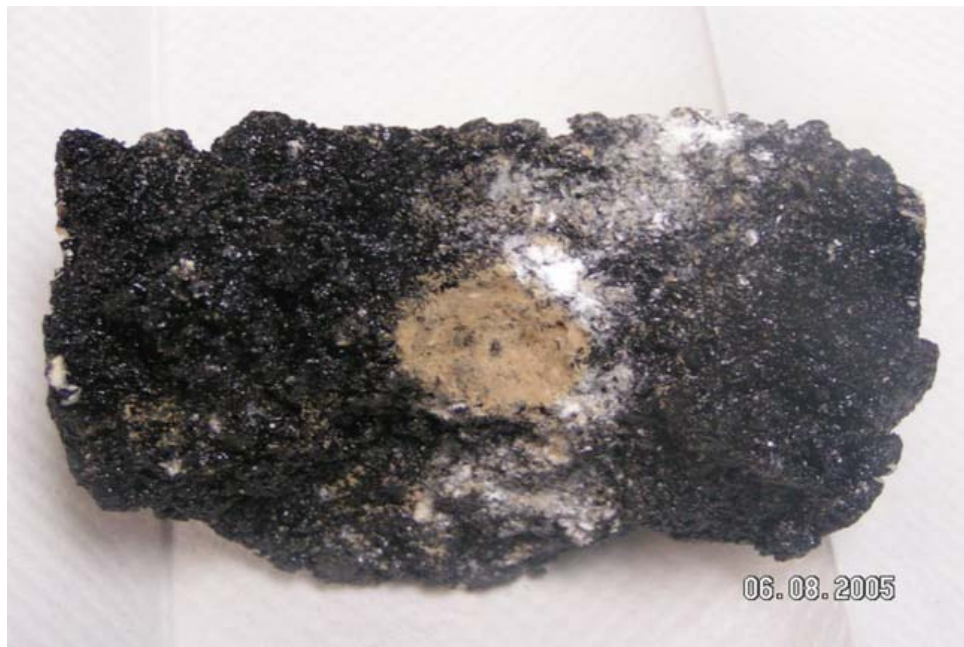
Clayballs can be found in many natural sand stockpiles and are sometimes found in seams in a quarry that may end up in the crushed material. Also, there has been at least one instance where the clayballs were found in the settling pond where the fines were wasted. A front end loader was used to clean out the settling pond and then used to load the crushed aggregate into the cold feeders. The clayballs were inadvertently transported from the settling pond into the stockpiles with the loader and thus resulted in contamination that caused the clayball problems. A picture of one of the clayballs is shown in Figure 7. Close inspection should be made during construction to ensure that clayballs are not used in HMA. If clayballs do exist some popouts and likely some FOD problems may occur.

**Figure 7. Removed sample of HMA showing clayball.**

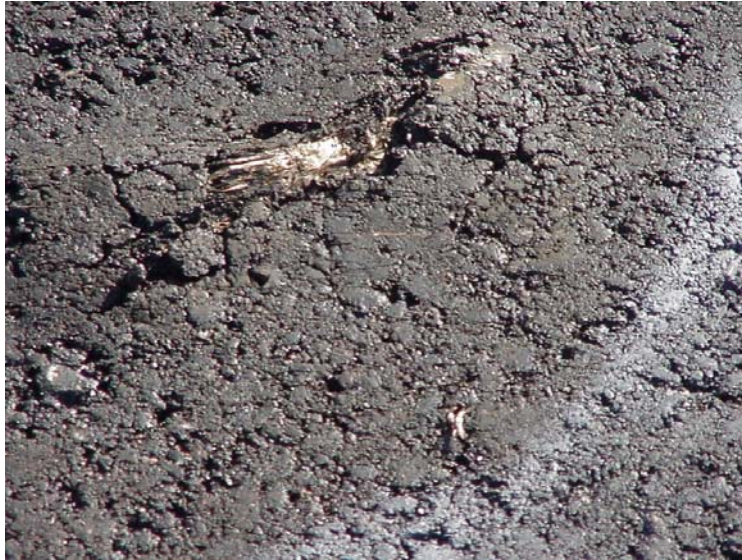
There have been a number of problems where contamination with wood chips has occurred. One project was constructed where wood chips were observed in the pavement surface (Figure 8) shortly after construction was completed. Generally the wood chips will not cause a significant problem if they are not excessive or if they are not too large. The wood chips are likely to swell and cause FOD problems if not controlled. The wood chips normally come from natural sand stockpiles.

**Figure 8 - Contamination of HMA with wood chips.**

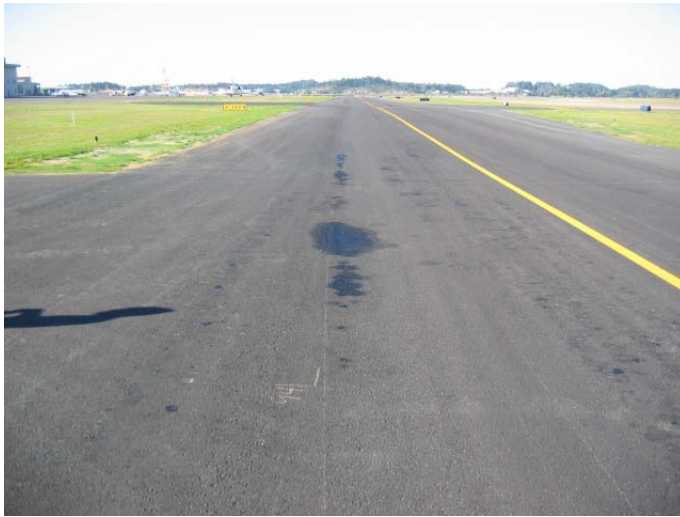
A typical example of the water draining out the surface of a pavement is shown in Figure 9. Typically this does not result in long term performance issues but it does have the potential to be a problem. Often the water gets underneath the pavement surface due to rainfall during construction. For this type of problem the water underneath the pavement may evaporate with time and not continue to be a problem. Sometimes water gets into the pavement from underneath. In this case it is more likely to result in performance issues since the moisture will continue to be a problem during the life of the pavement.

**Figure 9. Water flowing out the surface of a pavement.**

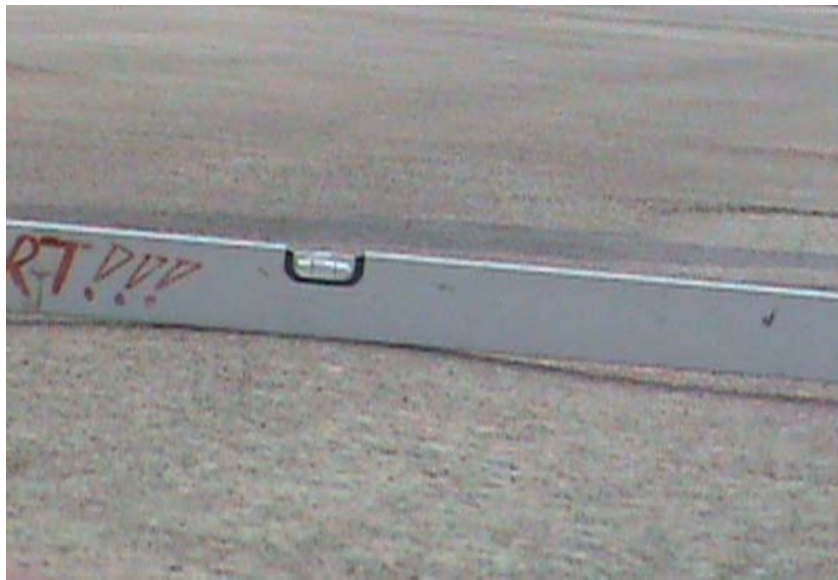
When the moisture is trapped underneath the pavement due to the surface mixture not being permeable blisters may occur (Figure 10). These blisters are caused by the water vapor. It is important that these blisters be punctured so that the water vapor can escape and the HMA can rebond to the underlying layer. If the water is not allowed to drain out of the blister, debonding around the blister may occur eventually possibly in a pothole.

**Figure 10. Blister caused by Water Vapor underneath the Pavement Surface.**
