ROAD ADMINISTRATOR'S RESPONSE TO THE 2004 NIIGATA-KEN CHUETSU EARTHQUAKE

Y. KAJIWARA

Road Bureau, Ministry of Land, Infrastructure and Transport, Japan

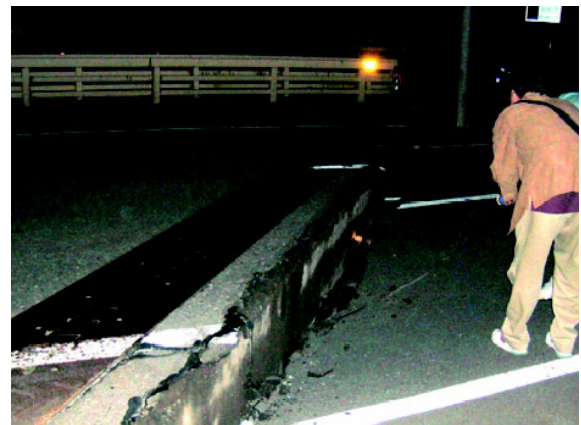
This highway was damaged at 8 locations. At Kamishinden in Mitsuke City, the embankment behind an abutment of the Mitsuke Bridge (L=148m) subsided, and caused a level difference (approximately 40cm) on the vehicle lanes (Photo 1). The bridge bearings were also damaged.

Photo 1 Road level difference at the Mitsuke Bridge, national highway Route 8 [1]

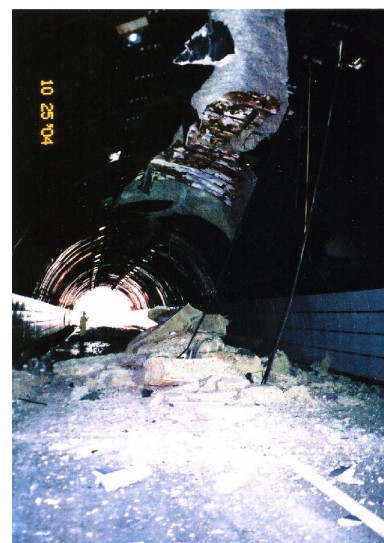
Damage occurred at 31 locations. At the Wanazu Tunnel (L=300m) in Kawaguchi-cho, the crown of covering concrete (length about 20m, width about 2m, volume about 20m³, and weight about 50t) separated, pushing part of the side wall into the tunnel (Photo 2). Bearings of the Wanazu Bridge (L=300m) were also damaged. At Maejima, the road surface subsided about 40cm. At

Photo 2 Damage inside the Wanazu Tunnel, national highway Route 17

At the Wanazu Tunnel on the national highway Route 17 (L=300m, Wanazu, Kawaguchi Town), the earthquake caused covering concrete to peel from the inside of the tunnel for approximately 120m from the Nagaoka side portal, and this forced the temporary closure of the tunnel to all traffic. The Wanazu Tunnel is a key transportation point used by 17,000 vehicles/day, and because there are no alternative routes usable as detours in the district, it had to be restored as quickly as possible. The emergency measures taken were steel H-shaped timbering work and concrete spraying work, which enabled alternating traffic on a single lane on November 2. And to protect passing vehicles from falling objects, before it was opened to traffic, protectors were installed to prevent damage to vehicles. The Wanazu Tunnel intersects a tunnel on the JR Joetsu Line located directly below it, so the restoration work was done with great care.

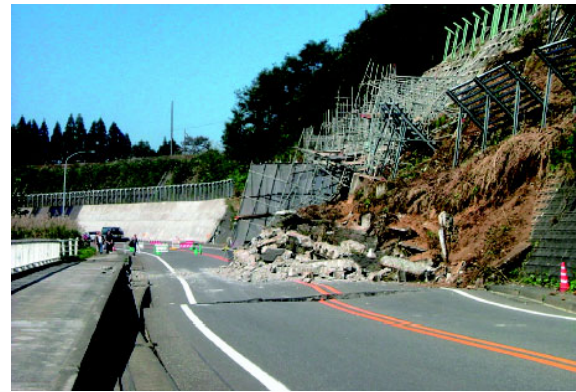
Ushigashima, concrete block retaining walls fell for a length of about 24m, and on the slope behind the walls, surface landslide (width about 30m, length about 50m) occurred, reaching the road (Photo 3). At Tenno, in a section close to the JR Joetsu Line, the road collapsed, enclosing the line (L=56m, H=40m) (Photo 4). An optical fiber communication cable buried under the road was also broken.

Photo 3 Slope collapsed at Ushigashima, national highway Route 17 [1]

Large-scale collapse of cuts and slopes occurred on the national highway Route 17 in Horinouchi Town and at Ushigashima in Kawaguchi Town. At Ushigashima, the slope collapsed and the road surface settled in a 200m section including an approximately 90m long cut section. The first step in its restoration was to remove the collapsed soil. Then, in the sheathing section, the soldier piles and lagging method was adopted to prevent soil from flowing into the road lane,

and in the cut section, cracks on the slope were partially cut to ensure safety.

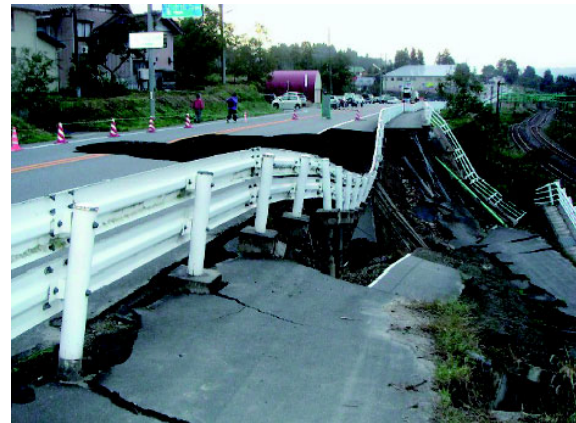
Photo 4 Collapsed road at Tenno, national highway Route 17 [1]

At Tenno in Kawaguchi Town on the national highway Route 17, a large-scale slope collapse including part of the road and the JR Joetsu line forced the temporary closure of the road to all traffic. Because it would take a long time to restore the damage, an emergency single lane was immediately constructed on the shoulder of the highway on October 25 (for emergency vehicles and local traffic). With the cooperation of landowners, a detour was constructed on the mountain-side of the highway on October 31 (Photo 9). Efforts to ensure traffic continued and restoration of the main highway was completed on December 29.

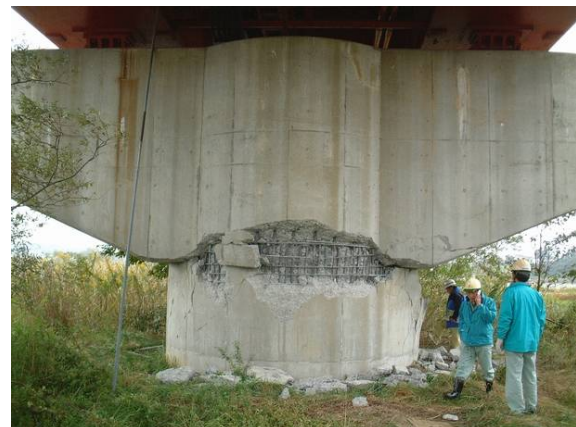
At Hiu in Ojiya City, the road surface subsided about 55cm, bearings and main girders of the Ojiya Bridge (L=300m), which spans the Shinano River, were deformed, and the cover concrete of bridge piers were separated, exposing the reinforcing bars (Photo 5). In Tokamachi in Nagaoka City, a level difference (approx. 30cm) appeared on a traffic lane on the Tokamachi Viaduct (L=534.8m).

Photo 5 Damaged bridge pier of the Ojiya Bridge, national highway Route 17 [3]

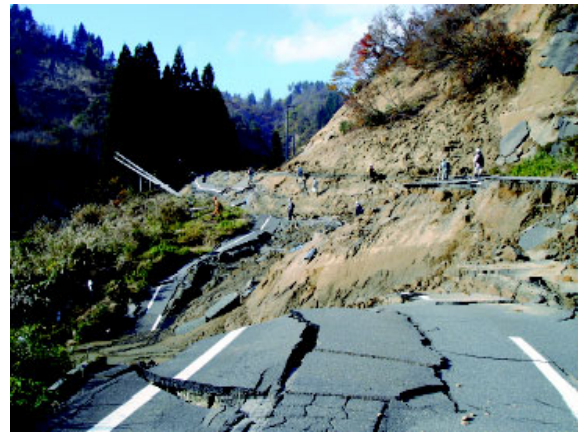
The national highway Route 291 is a 240km long national highway managed by prefectures that starts in Maebashi City in Gunma Prefecture and ends in Kashiwazaki City in Niigata Prefecture. The Niigata-ken Chuetsu Earthquake caused particularly severe damage on an approximately 10km stretch of the national highway Route 291 from Takezawa in Nagaoka City (formerly Yamakoshi Village) to Oguriyama in Ojiya City, and at some places on the road, damage was so severe that the original shape of the road disappeared (Photo 6). The damaged locations in this road section included the collapse of the road at 15 locations, slope failure at 9 locations, and bridge damage at 3 locations.

Photo 6 Collapsed road at Higashi-Takezawa, national highway Route 291 [1]

Niigata Prefecture is a heavy snowfall region where the maximum snow cover reaches a depth of 5.8m, so the emergency restoration work had to be completed before the snow started falling to prevent the spring thaw from causing any secondary disasters. Therefore, the work was executed day and night, and on December 14 before snow began falling in earnest, the road was able to be used by emergency vehicles and construction vehicles. The restoration plan was enacted by establishing the National Highway Route 291 Damage Restoration Technical Committee, whose members were scholars and other experts, to study restoration policies. At locations where collapsed soil and other damage was particularly severe, restoration was carried out on a separate route.

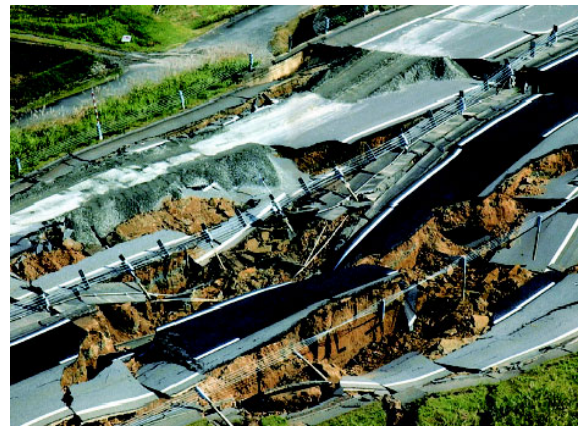
The Kan-etsu Expressway is a major traffic artery that, along with the Joetsu Shinkansen, links Tokyo with Niigata. The Kan-etsu Expressway was damaged between the Koide Interchange, which is close to the earthquake epicenter, and the Nagaoka Junction. The typical forms of damage were subsidence of road surface at bridge approaches and box culverts crossing the expressway, settlement of embankments, accompanying settlement and cracking of road surfaces, and damage of retaining walls. The section where the damage was particularly severe was the section between the Horinouchi Interchange and the Echigokawaguchi Interchange that passes through the earthquake fault region (Photo 7). In this section, large-scale embankment collapses occurred, causing damage that completely destroyed traffic lanes. At bridges, the earthquake caused bearing damage, expansion damage, and damage to the ends of bridge girders. Concrete block retaining walls and reinforced earth retaining walls were also damaged.

Photo 7 Damage to Kan-etsu Expressway (between Horinouchi IC and Echigo-Kawaguchi IC) [1]

On the Kanetsu Expressway, as described in 2.2, after the road closure was ended on October 26 except certain sections. Single lane traffic for both directions was released on October 27 so that the emergency vehicles could travel quickly and smoothly. Special measures were taken, such as exempting expressway toll for vehicles transporting emergency support materials. Later, at locations with large level differences, crushed stone was laid, road surfaces were restored with emergency paving, and bridges were restored, then on November 5, one lane was opened in each direction for ordinary vehicles and the closure was cancelled on the entire route. Then all four lanes were opened on November 26.

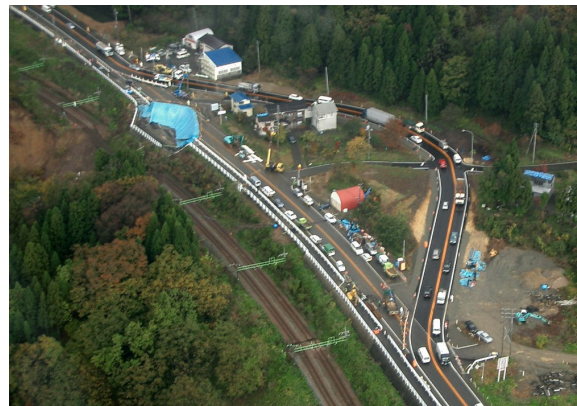
Photo 9 Detour at Tenno, national highway Route 17 [3]
