Road Administrator's Response to the 2004 Niigata-ken Chuetsu Earthquake

Keiichi Tamura

- National Institute for Land and Infrastructure Management
- Research Coordinator for Earthquake Disaster Prevention
- tamura-k92ta@nilim.go.jp

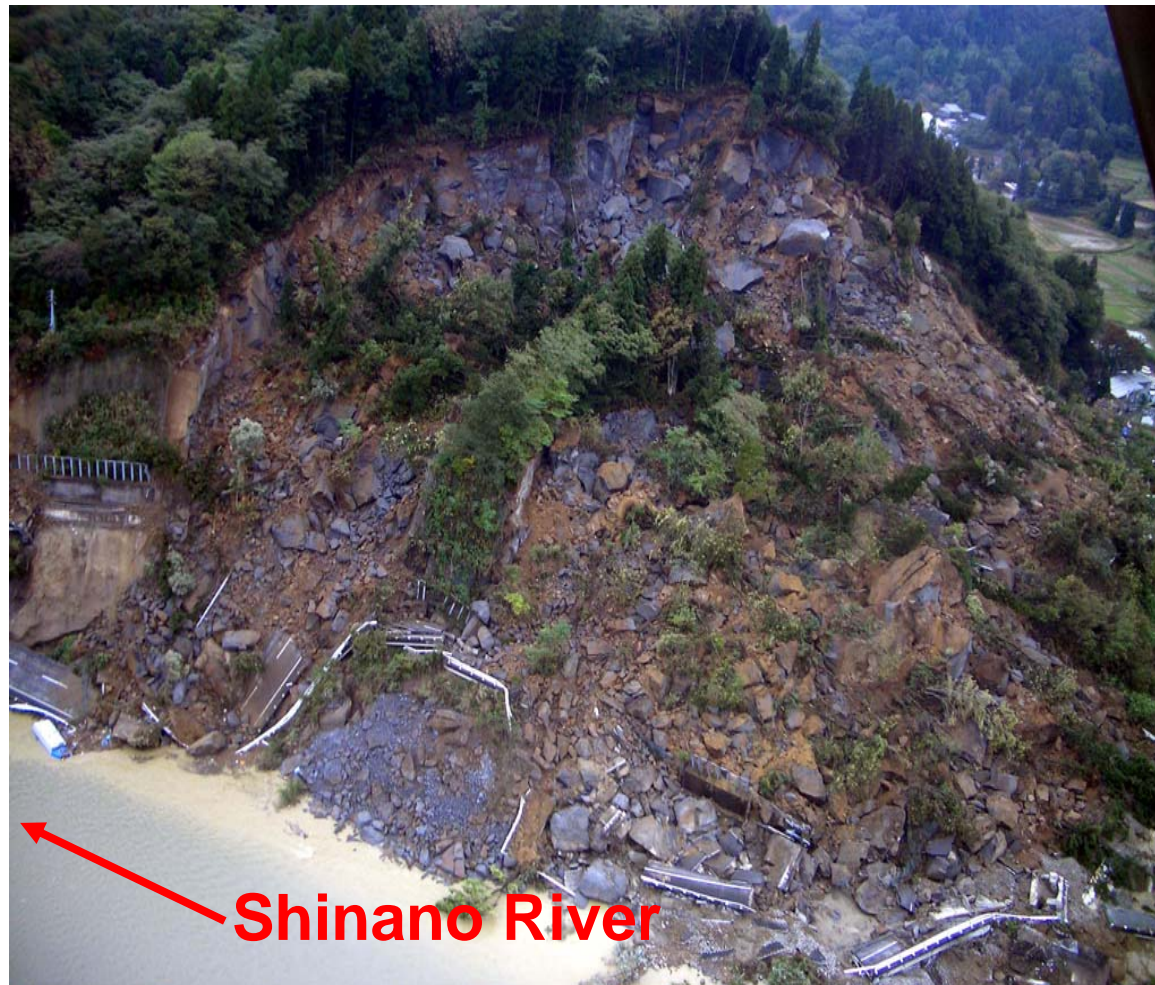
Landslide (W=250m, L=150m) at Myoken, Nagaoka City

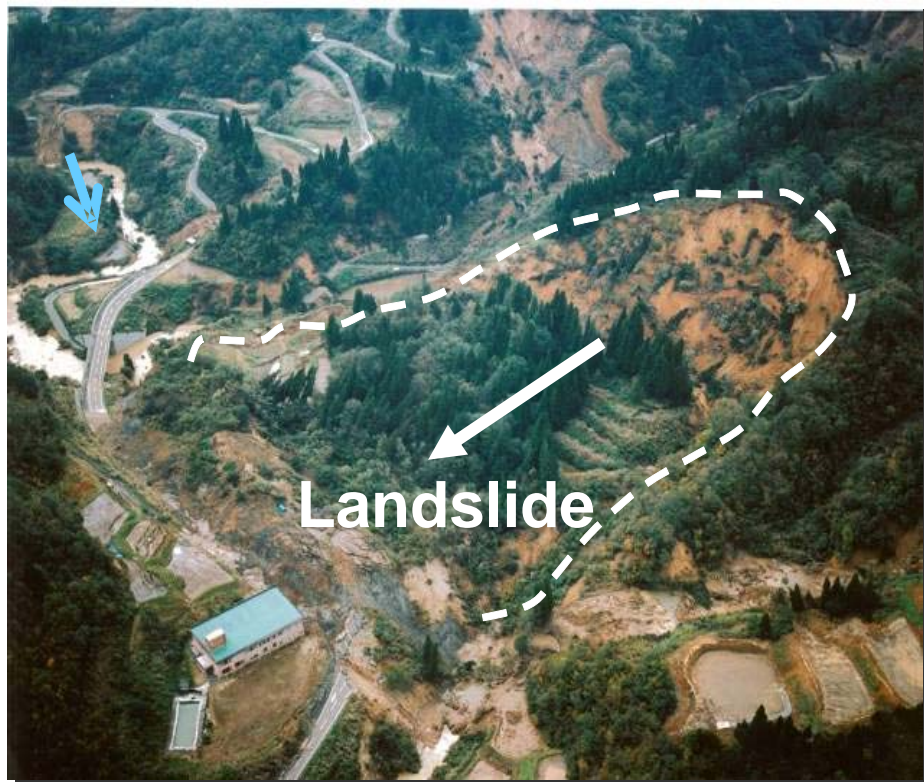
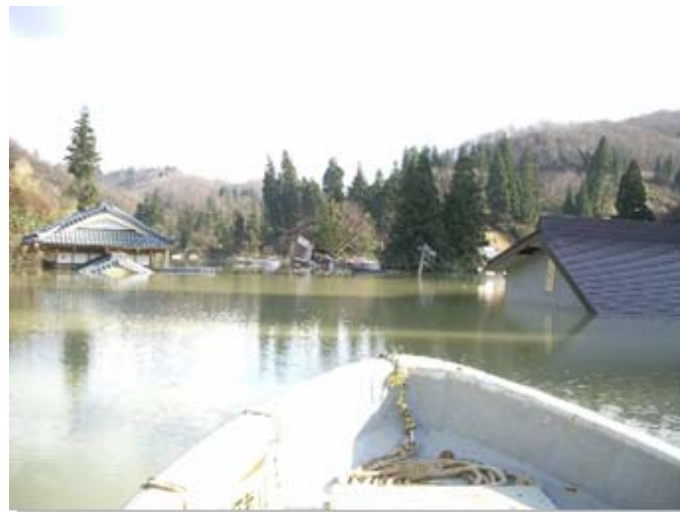
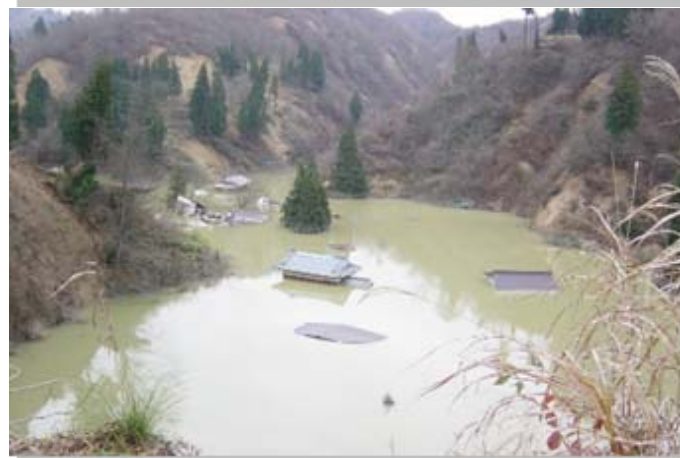
Landslide Blocked River Course in Higashi-Takezawa, Former Yamakoshi Village

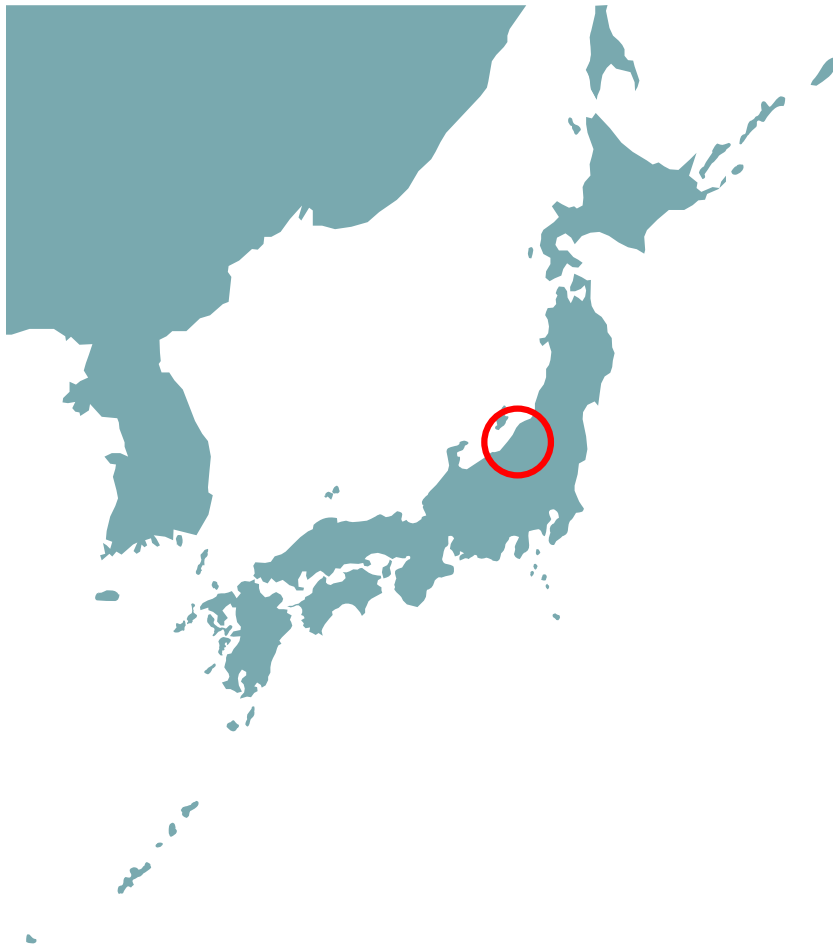
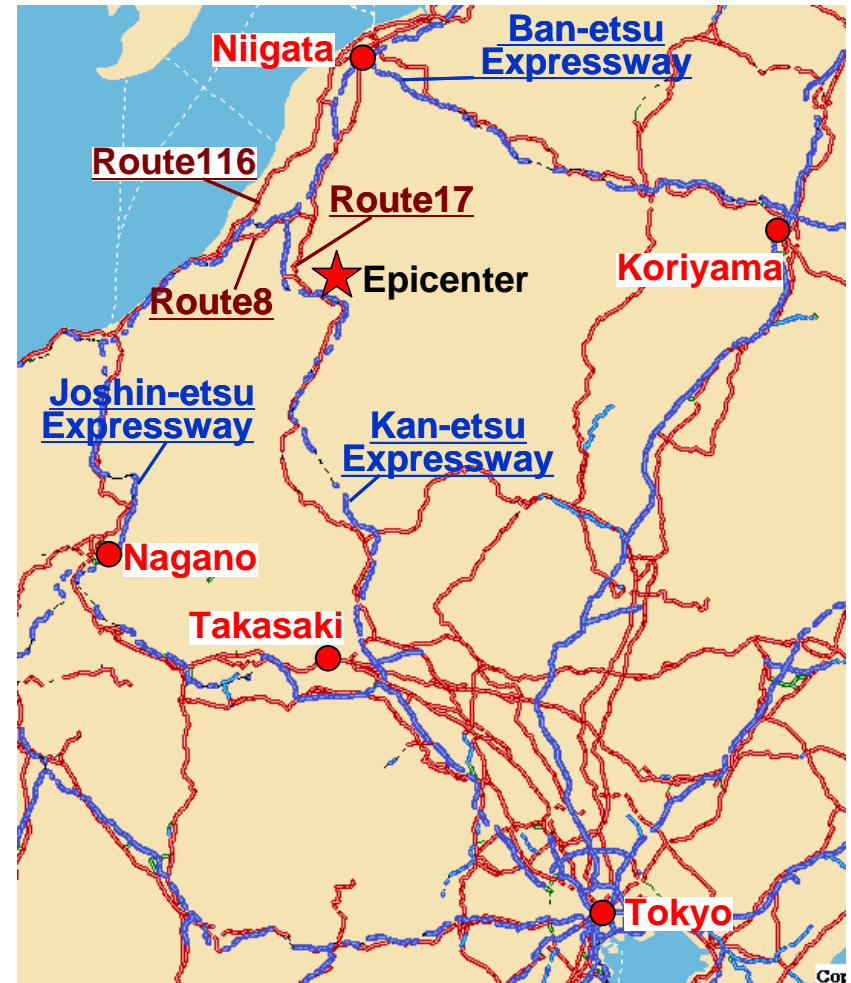
Earthquake-affected Region and Major Roads

Number of Locations Completely Closed to Traffic and Damaged

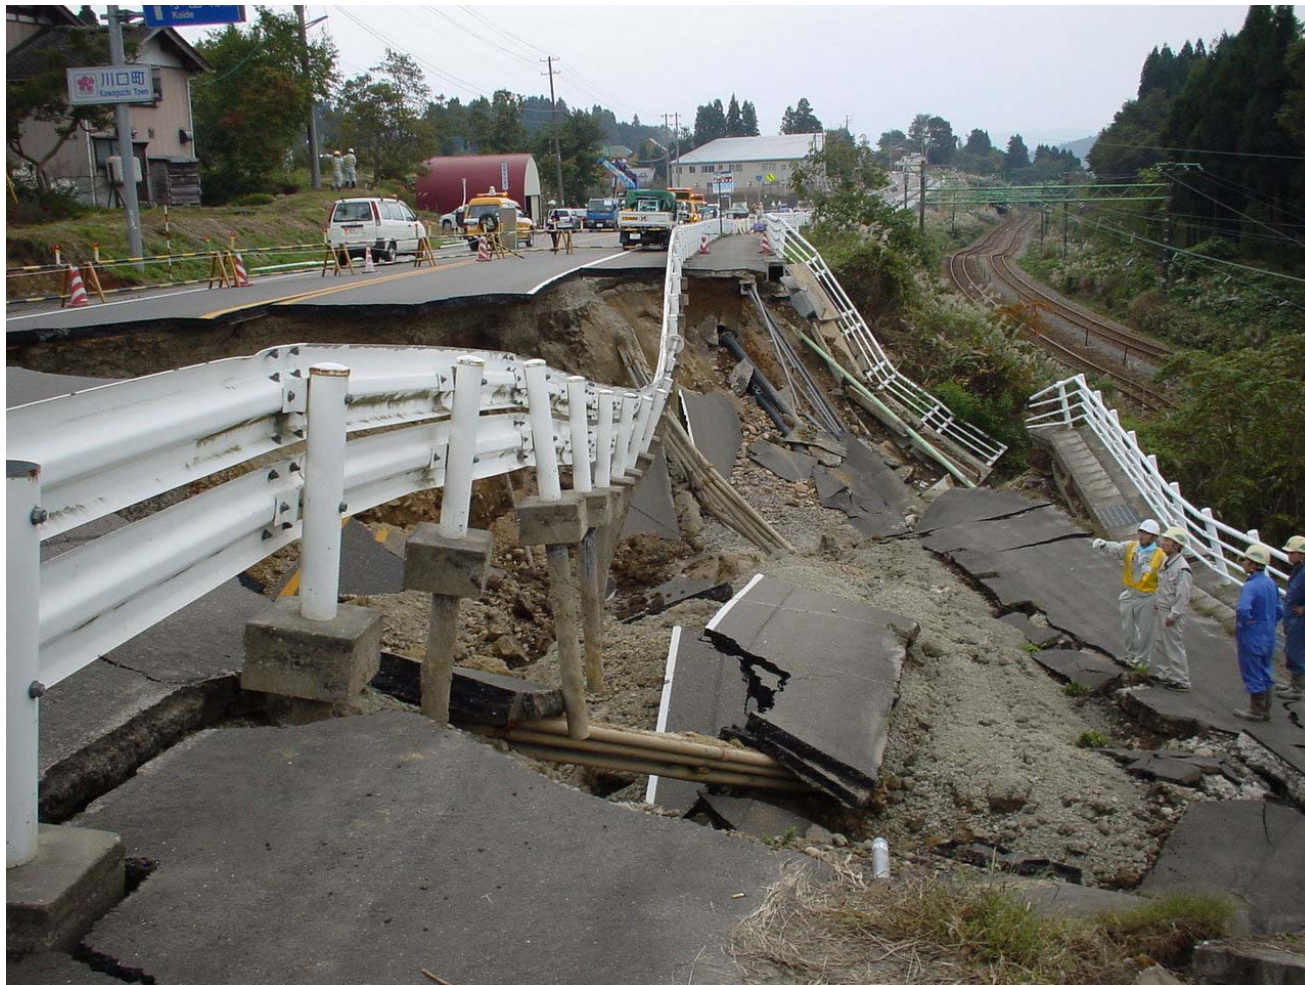
Failure of Road Embankment at Tenno, National Highway Route 17

Two-lane detour was constructed on the mountain-side of Route 17 at Tenno.

- December 29 (67 days after)
Restoration of highway was completed at Tenno.

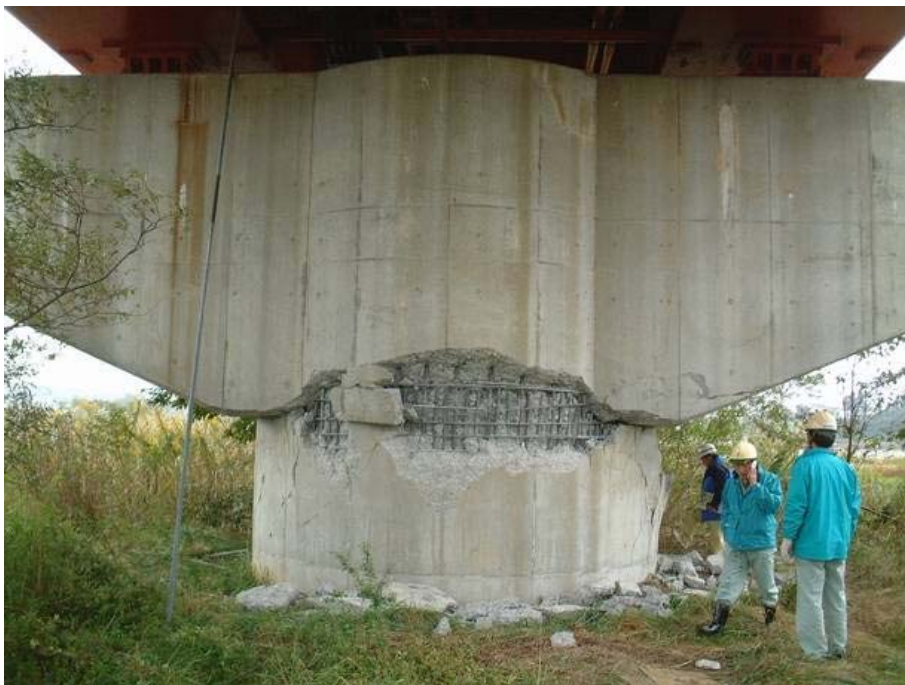
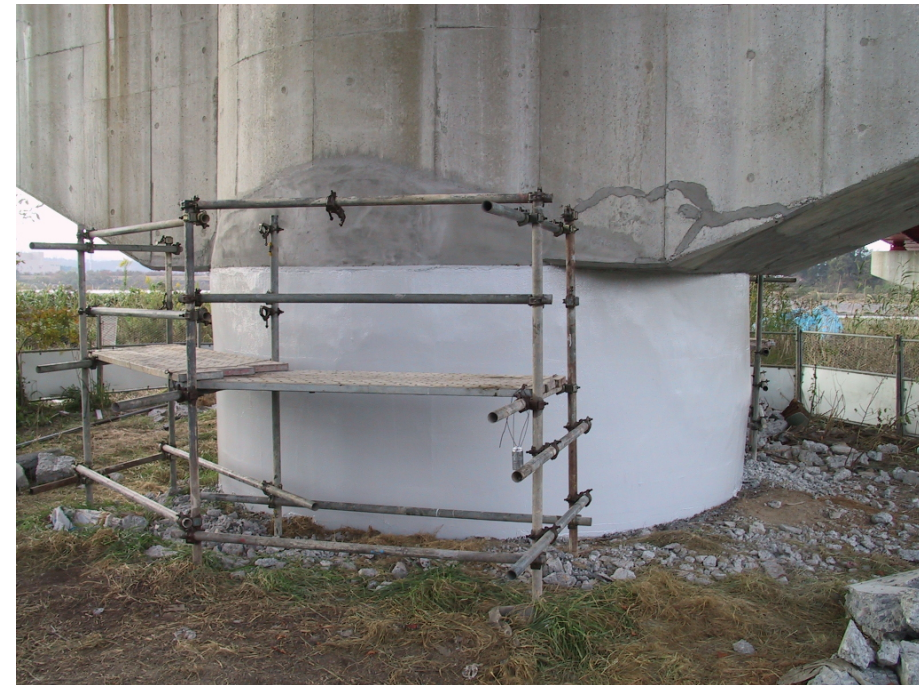
Damaged Pier of Ojiya Bridge, National Highway Route 17

Emergency Repair by Carbon
Fiber Jacketing

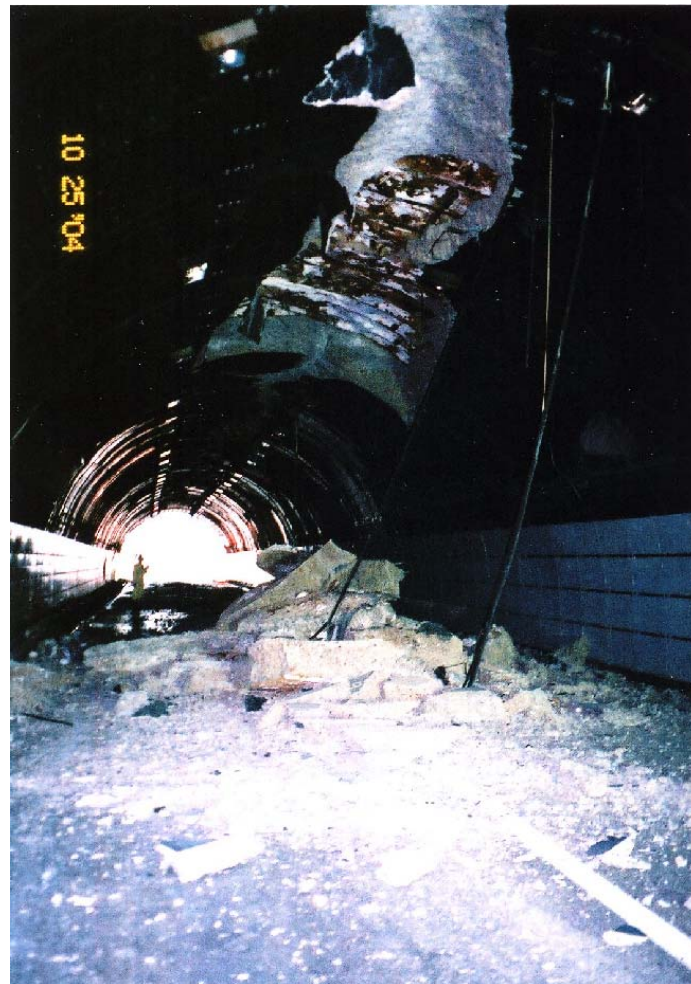
Spalling-off of Concrete Lining in Wanazu Tunnel, National Highway Route 17

- November 2 (10 days after)
Enabled alternating traffic on a single lane at the Wanazu Tunnel. Entire Route 17 was opened to traffic.

- December 26 (64 days after)
Two lanes were opened at the Wanazu Tunnel.

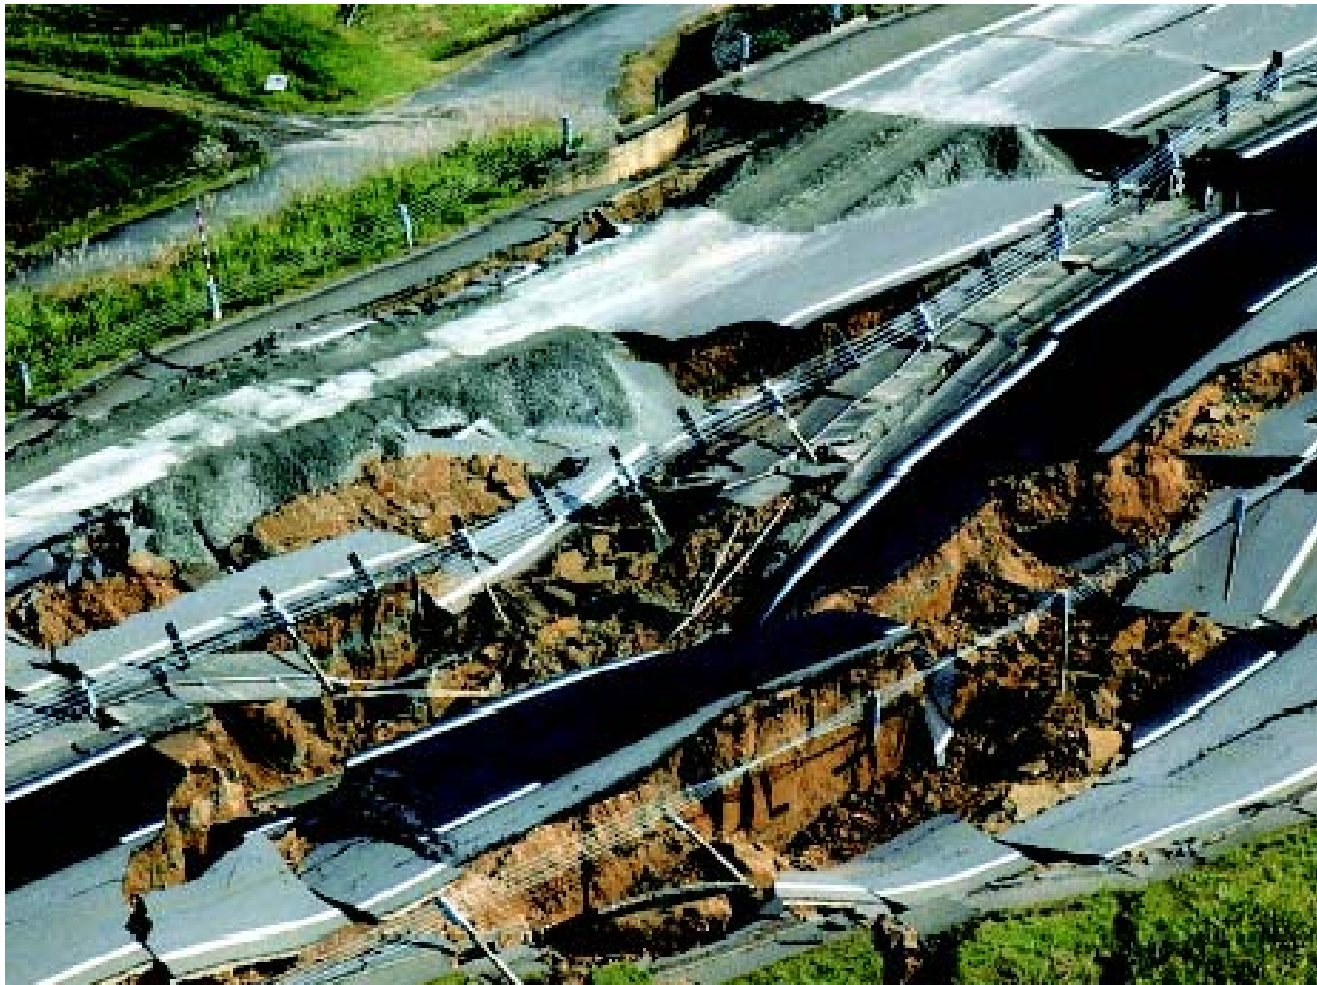
Damaged Kan-etsu Expressway between Horinouchi IC and Echigo-Kawaguchi IC

One lane was opened in each direction for ordinary vehicles and the closure was cancelled on the entire Kan-etsu Expressway.

All four lanes were opened.

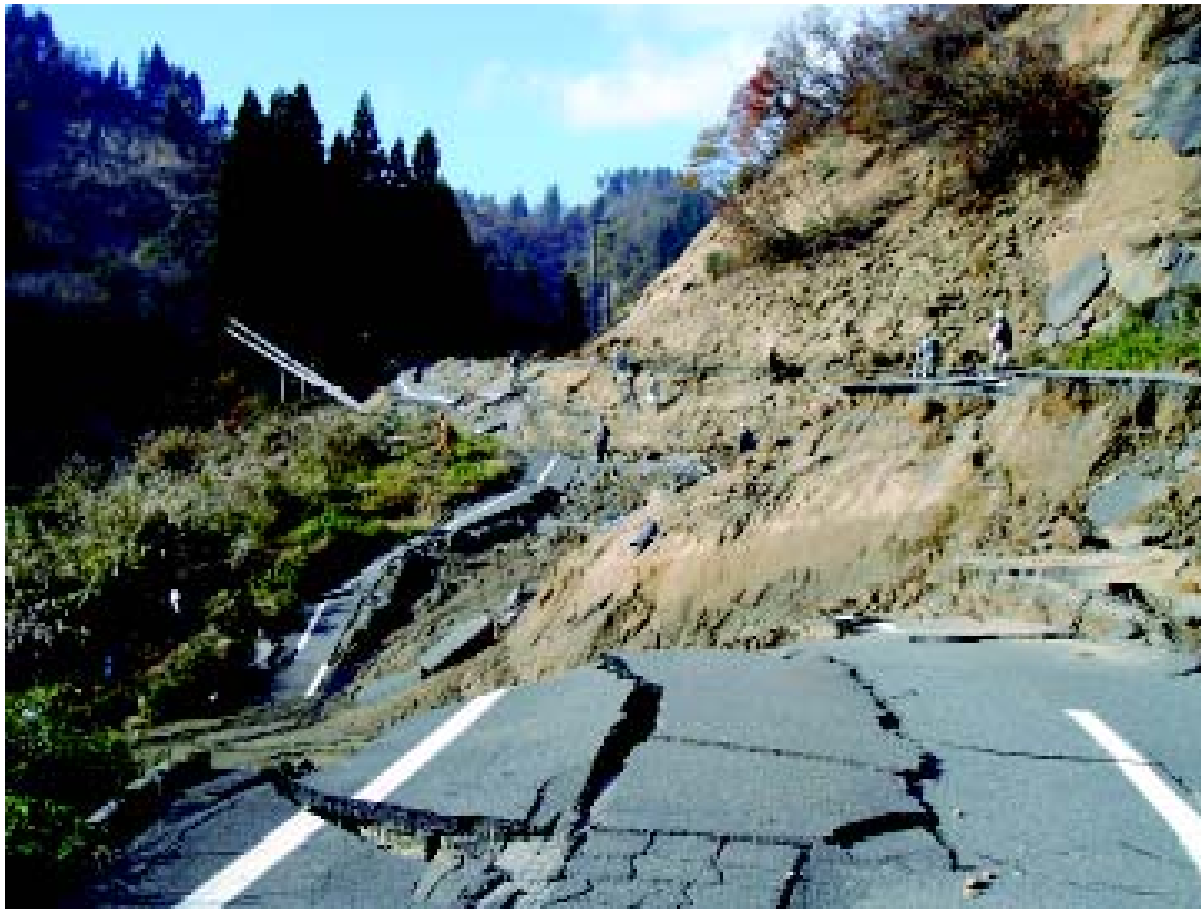
Collapsed Road in Higashi-Takezawa, National Highway Route 291

Designated as MLIT proxy exercise of authority road section.

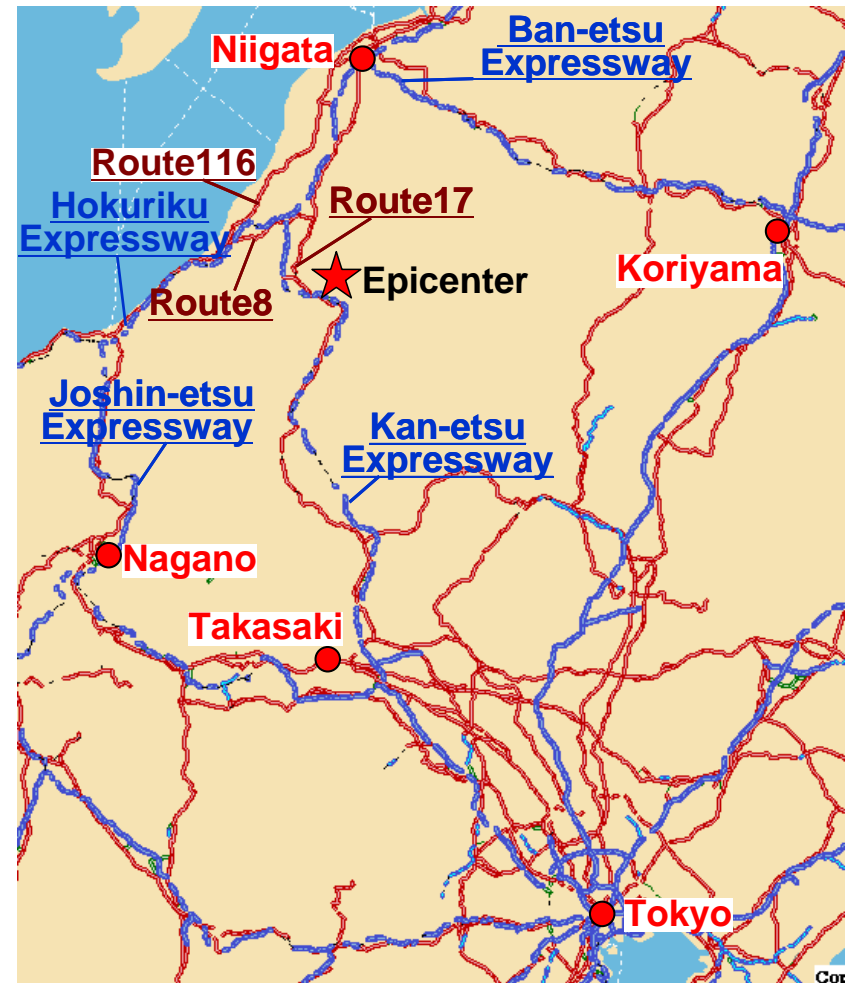
Disruption of Wide Area Transportation Infrastructure

- After the earthquake, traffic was stopped on the Kan-etsu and Hokuriku Expressways. On national highways, traffic was stopped or forced to travel alternately in one direction at 55 locations.
- The derailling of a train on the Joetsu Shinkansen further disrupted transportation between Tokyo and Niigata.
