SPECIAL DESIGN PROBLEMS AT USAF AIRFIELDS

R. ROLLINGS & M. ROLLINGS,
Rollings Consulting, LLC, USA, rollingseng@earthlink.net
J. GREENE & C. RUTLAND,
Air Force Civil Engineer Support Agency, USA,
James.Greene@tyndall.af.mil, Craig.rutland@tyndall.af.mil

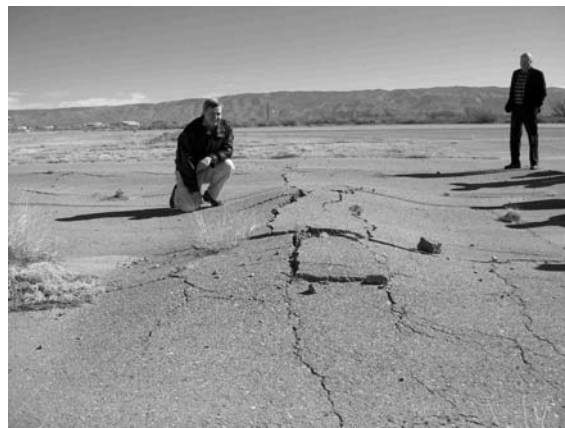
Figure 2 - Swelling caused by sulfate attack on cement-stabilized taxiway base course at Holloman AFB, NM.

Figure 2 shows an example of sulfate attack on a cement-stabilized base course at Holloman AFB, New Mexico. Type V cement was used for the stabilization of the local fine-grained soil, but sulfate resistant cements are ineffective under these conditions. In the high pH environment typical of stabilization, alumina in the soil's clay minerals is highly soluble and is released into the pore water. This provides the necessary alumina for ettringite formation, and the low-alumina content Type V cement provides no protection. An identical chemical process occurs with lime-stabilized materials, and a USAF runway with a lime-stabilized base in Texas had to be reconstructed because of sulfate attack. At present, there is no reliable military guidance on allowable sulfate exposure levels or conditions for lime or portland-cement stabilized materials or on adequate protective measures [6].

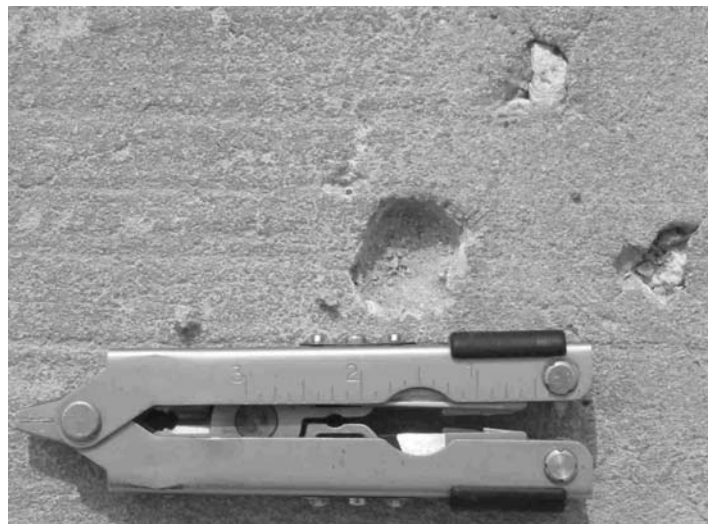
Figure 3 – Popouts from unsound aggregate

However, shortly after placement major popouts began appearing (Figure 3). The aircraft models slated to use the ramp in upcoming operations were those that are the most susceptible to foreign object damage (FOD) from ground debris such as these popouts. These aggregate popouts posed a safety risk and operations from the ramp were severely affected.

An examination of the aggregate used in this construction found it to be totally unsuitable for use in concrete. The rapid appearance of the popouts was foreordained by the use of a substandard local aggregate. It had been deemed more convenient to use the local aggregate and avoid the delay of shipping in appropriate quality aggregate to the locale. After all, this was a rush expedient military construction job. However, the headaches these popouts caused the USAF proved to be far greater than any savings in time or money that had been realized.
