STATE-OF-THE-PRACTICE: RUBBLIZATION OF AIRFIELD PAVEMENTS

INTRODUCTION

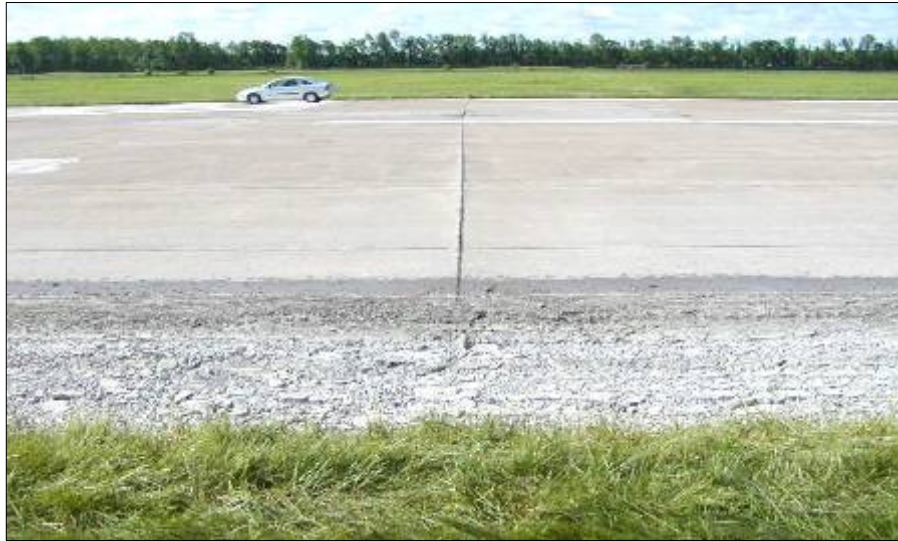
Rubblization of airfield pavements using a RPB must start at a free or unfractured edge and continue with successive passes until it has moved transversely across the width of the pavement (Figure 2). This makes the process self-regulating. Any attempt by the operator to move too far into the pavement transversely, and away from the free edge, results in less and less fracturing of the pavement, until finally the machine can no longer fracture the pavement. When this happens, breaking energy is no longer absorbed by the pavement, but is reflected back into the machine itself, producing a noticeable “hammer and anvil” effect where the hammer merely bounces off the pavement surface and very little breaking is accomplished.

Figure 2. Starting from Free Edge

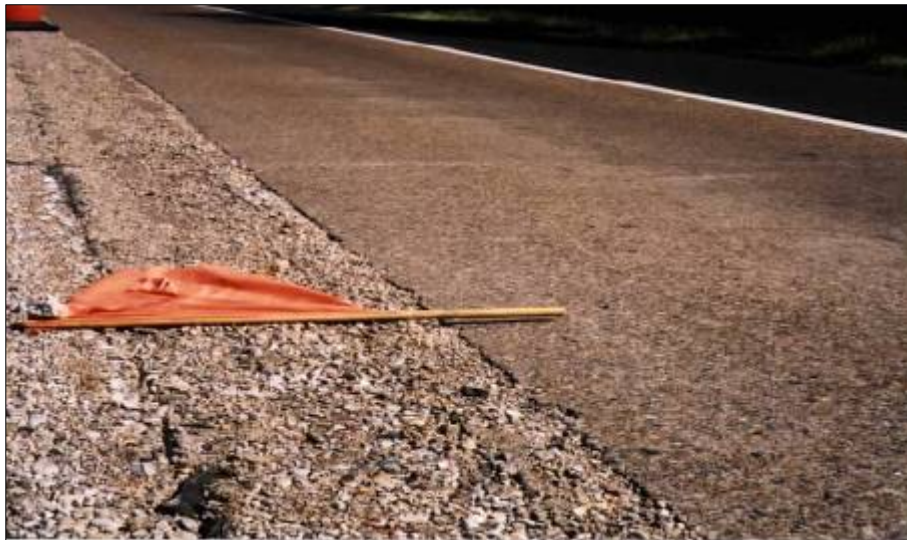
Relief Trenches: As RPBs work along the unfractured edge of an existing PCC pavement, a small amount of horizontal and vertical expansion takes place (Figure 3). Early airfield rubblization projects required relief joints (Figure 4) to be cut full-depth through the pavement, at fixed intervals, to take up the horizon expansion which accumulates as large areas are rubblized. Recent advancements in RPB design and technology, including significant horsepower increases, have all but eliminated the need for cutting relief trenches in the pavement prior to rubblization. However, certain combinations of older and smaller breakers, and thicker pavement sections, can result in situations where relief trenches are still necessary. The need for relief trenches will show up in the form of the “hammer and anvil” effect as described above and reduced breaking effectiveness.

Figure 3. Vertical Displacement Prior to Rolling

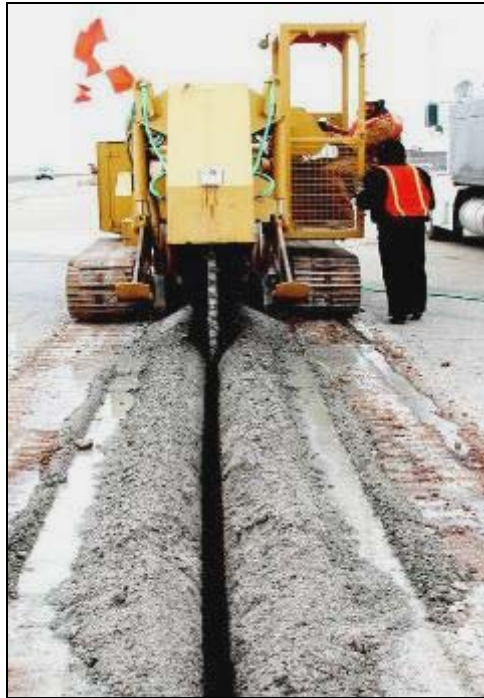
Figure 4. Relief Trench Cut with a Wheel Saw

Adjacent pavements, that are not to be rubblized, must be isolated from the rubblized pavements. This is best accomplished by cutting a relief trench with a wheel saw (Figure 4), or by utilizing two parallel full-depth diamond blade saw cuts spaced approximately six inches apart. Either method allows the rubblizing equipment to work up to the project limits without damaging the structural integrity of the pavement that is to remain in place.

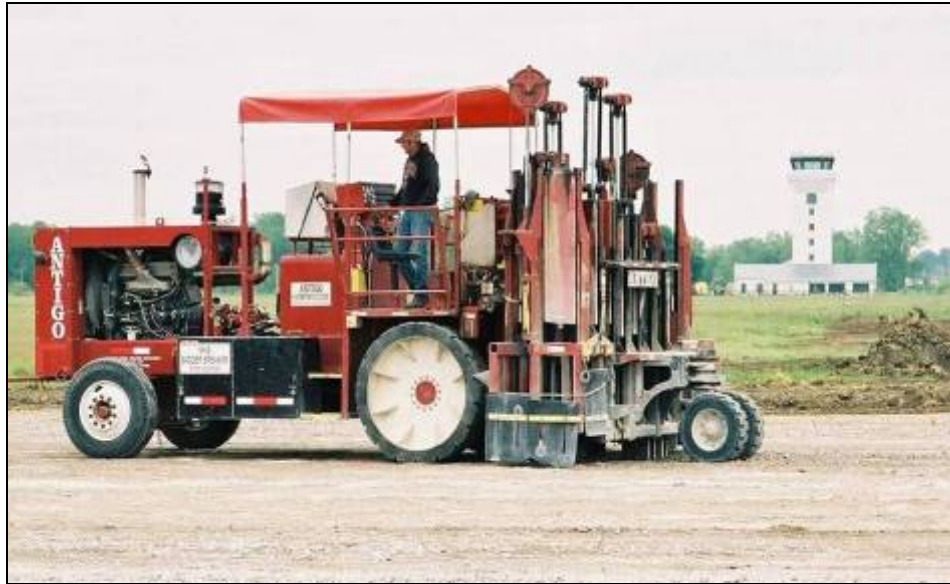
The MHB is a rubber-tired, self-contained, self-propelled unit (Figure 5). It consists of six pairs of 544 kg (1,200 lbs.), 20 cm (8 in) wide hammers mounted laterally in pairs, with half the hammers in a forward row and the remainder diagonally offset in a rear row, so that there is continuous breakage from side to side. Wing units, carrying two 680 kg (1,500 lb) hammers, can be added to each side for a total breaking width of up to 4.0 m (13 ft). In the 16-hammer configuration, the MHB weighs 25,855 kg (57,000 lb). Each pair of hammers is attached to a separate hydraulic lift cylinder, with an adjustable drop height from 0-1.5 m (0-60 in). Each pair operates as an independent unit, and develops between 1,355 to 10,800 joules (1,000 to 8,000 foot-pounds) of energy depending upon the drop height selected, and cycles at a rate of 30 to 35 impacts per minute.

Figure 5. Multiple Head Breaker

By controlling the individual lift cylinder for each pair of hammers, the MHB can rubblize in 0.6 to 4 m (2 to 13 ft) widths at a production rate of approximately 418-1,254 m² (500-1,500 yd²) per hour. This allows the multiple-head breaker to rubblize a 3.8 m (12.5 ft) wide lane, while traveling at a speed ranging from 0.11 and 0.32 km per hour (0.07 to 0.20 miles per hour). Production rates are comparable to the RPB, and depend upon the strength and thickness of the slab and the underlying subgrade.

Rubblization using a MHB requires a single pass over the area to be rubblized. The tractor or power unit travels on the unbroken slab as it moves forward and tows the breaking unit behind. Because it is a single pass technique, there is no need for the MHB to travel on the rubblized surface. Fracturing of the slab is controlled by a set combination of the drop height, the frequency of the impacts, and the forward speed of the machine, as determined by doing a test strip/pit.

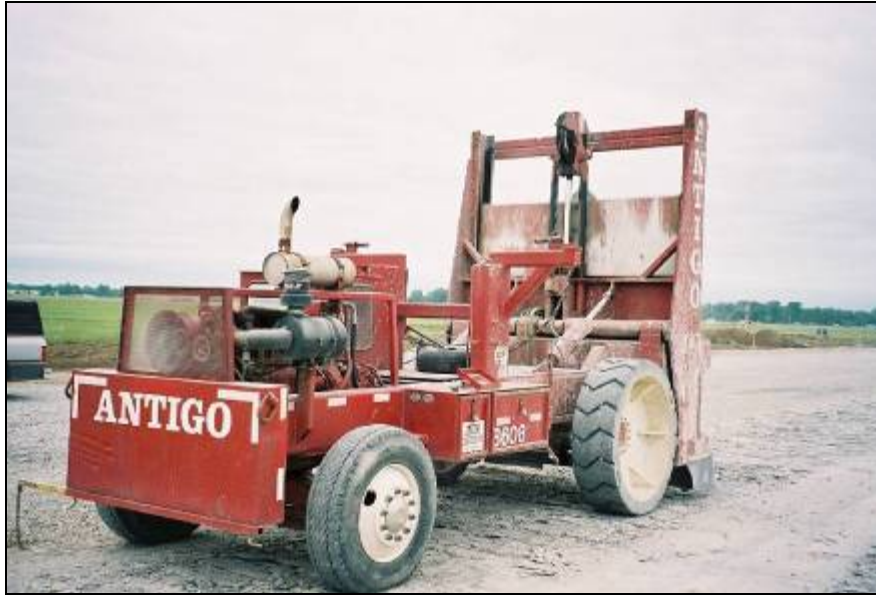
Guillotine Pavement Breaker: For heavy-duty airfield pavements (i.e., greater than 14 in thick), it may be necessary to utilize a guillotine pavement breaker, prior to a MHB, to expedite the rubblization process. This type of breaker (Figure 6) has rubber tires, is self-propelled, and generally weighs about 5,440 kg (12,000 lb). The drop height of the hammer is adjustable up to nine feet. The guillotine breaker makes the initial pass and pre-fractures the existing pavements, allowing the MHB to complete the rubblization. Another situation that may require the teaming of both a guillotine breaker and a MHB is if an interface exists within the PCCP, such as with an unbonded or partially-bonded rigid overlay. The interface between the two lifts creates a shear plane that absorbs some of the breaking force, requiring the PCCP to be pre-broken to ensure the bottom lift is adequately rubblized.

Figure 6. Guillotine Style Breaker

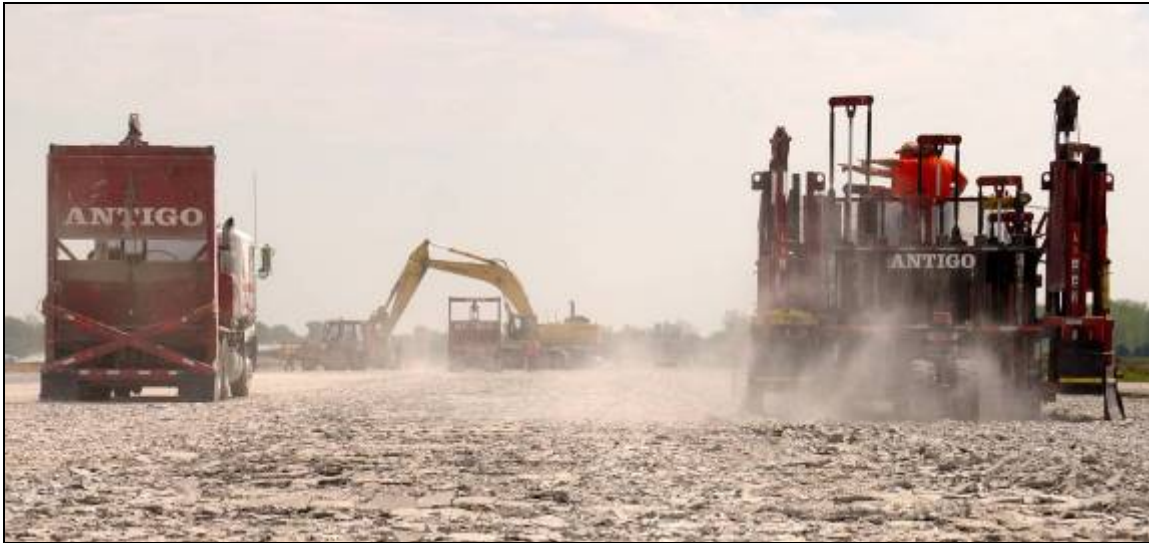
Generally, rubblization produces very little fugitive dust. The small amount (Figure 8) that is produced is usually not a problem on closed areas of an airfield. However, where traffic is maintained on nearby parallel runways, taxiways, or aprons, dust control may become an issue. Water as a dust palliative should be applied sparingly and only as needed to control fugitive dust.

Figure 8. Dust generated during Rubblization

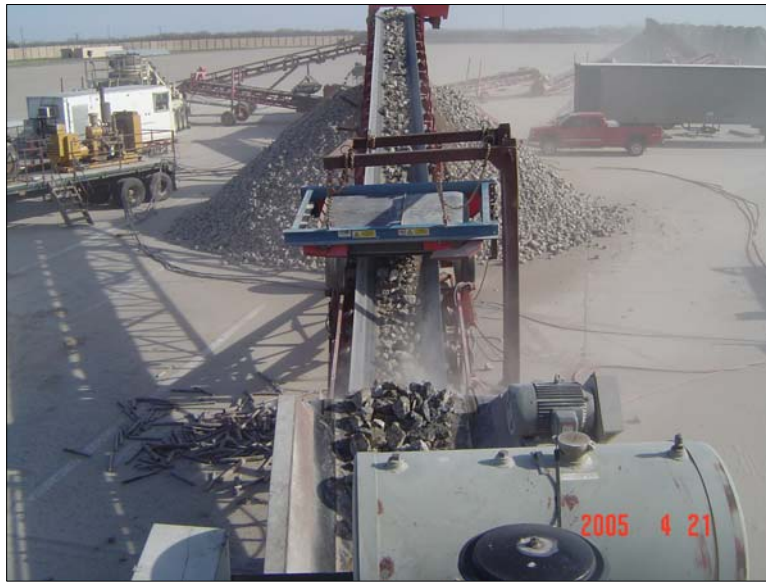
The PCC that was removed from both runway ends was run through a crusher (Figure 10) and re-used as a base course above the rubble surface to correct grade for a new offset crown.

Figure 10. PCC Crushing Operation

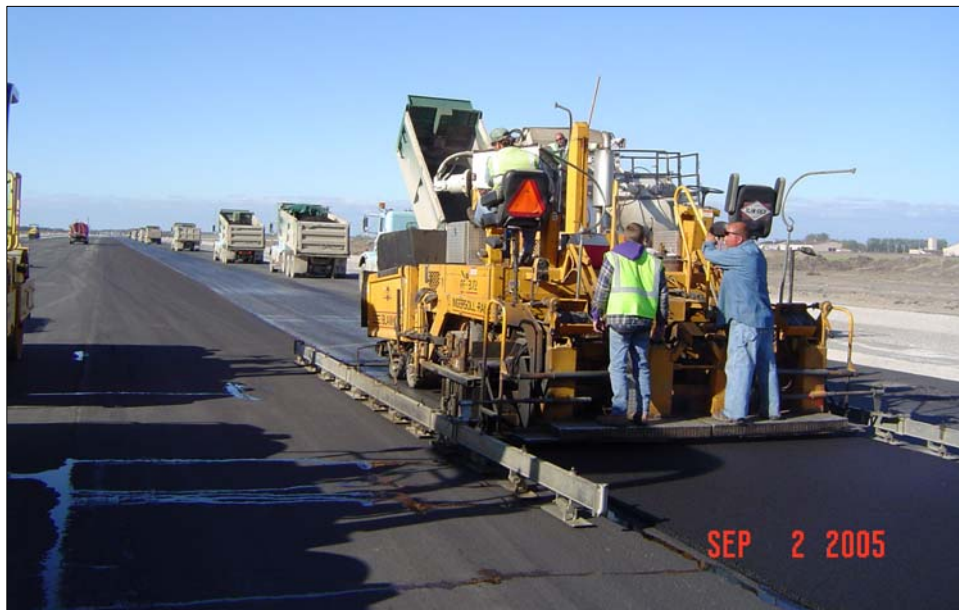
This runway had an offset crown. The crown was reestablished to the centerline of the runway, which required the placement of 4-13 inches of crushed aggregate. Nine inches of asphalt surface was placed on the runway (Figure 11). An aerial view of the completed runway is shown in Figure 12.

Figure 11. Placement of New Asphalt Surface

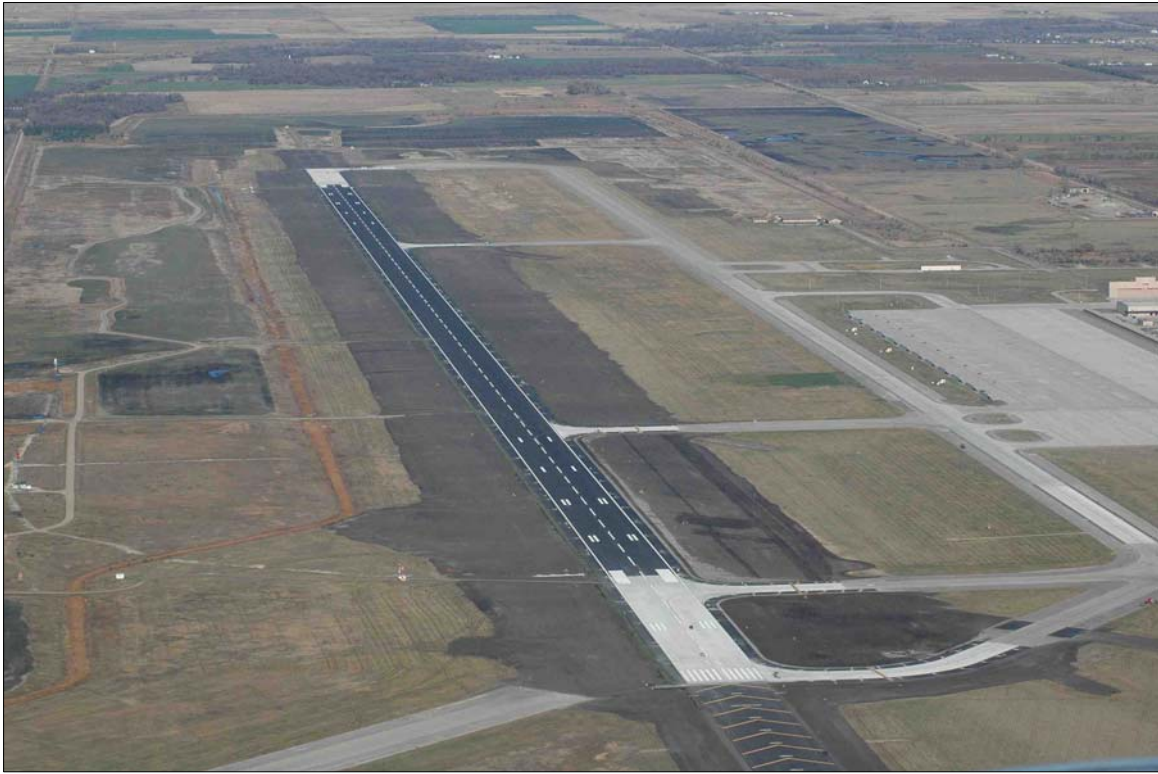
Figure 12. Aerial View of Completed Runway

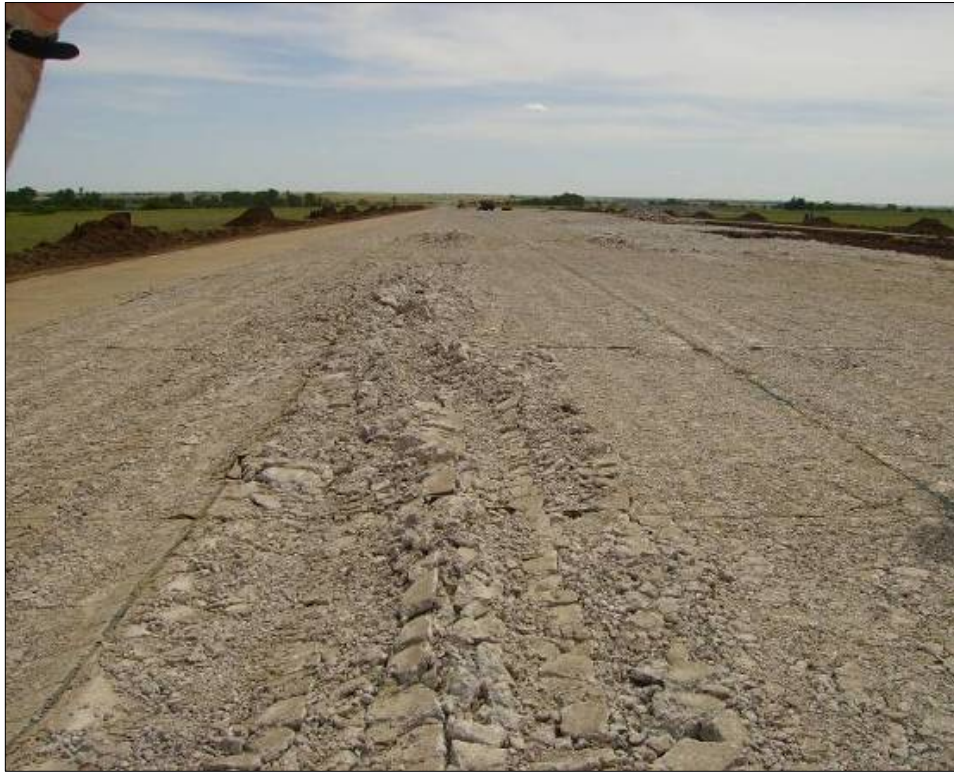
The specification called for using the RPB exclusively. Rubblization started in the Spring, under normal wet conditions. The RPB did not punch-thru, but rather excessive pumping and rutting occurred (Figure 13). High-float tires on the RPB were not used at the start, but were later on, which helped reduce rutting. By the end of the project, the percent of full-depth patching was about 30% of the rubblized area. This percentage grew as the process moved towards the centerline. In the unstable areas, the engineers decided to excavate 2 to 4 feet into the subgrade to ensure all the “mush” was removed (Figure 14). Crushed PCC and aggregate was used as patch material.

Figure 13. Rutting from RPB of Unstable Area at Kegelman that Requires Excavation

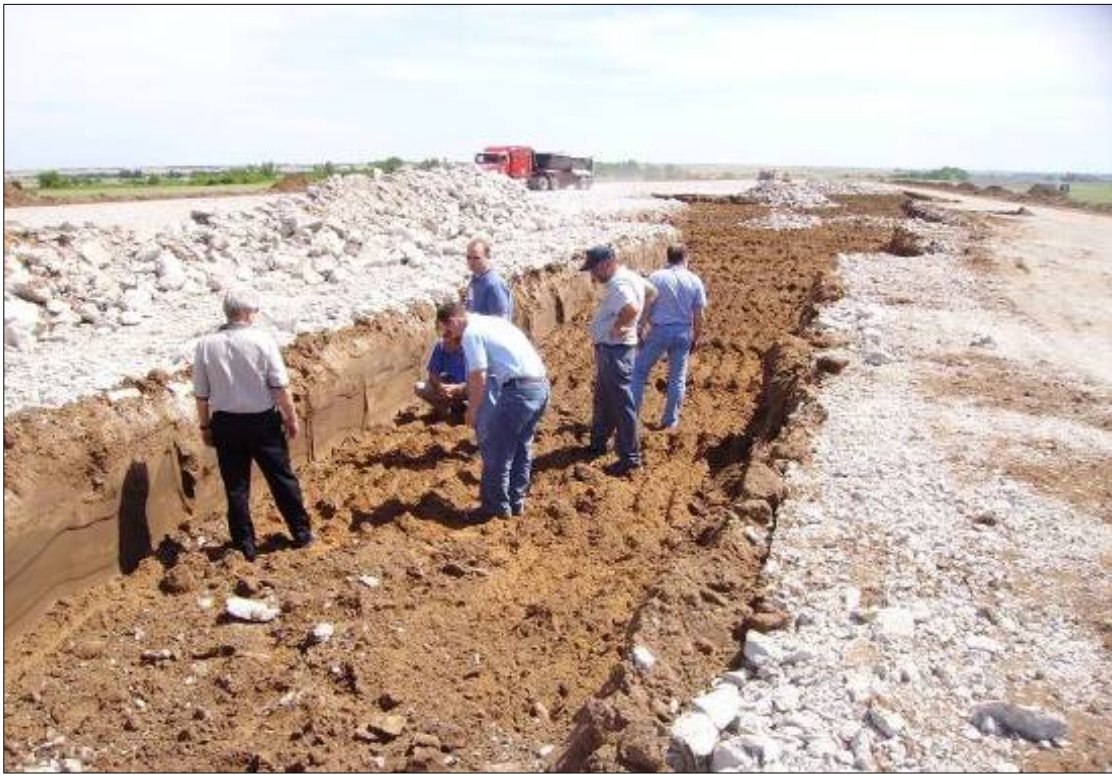
Figure 14. Full-depth Excavation Deep Into Subgrade of Patched Area at Kegelman
