RE-USING RECYCLED MATERIALS FOR THE CONSTRUCTION OF AIRPORT INFRASTRUCTURES

The article below retraces 5 years of use and progressive re-use of recycled materials in work carried out by SCREG Ile-de-France Normandie – Colas Ile-de-France Normandie and COSSON for Aéroports de Paris at the Roissy Charles de Gaulle, Orly and Le BOURGET platforms

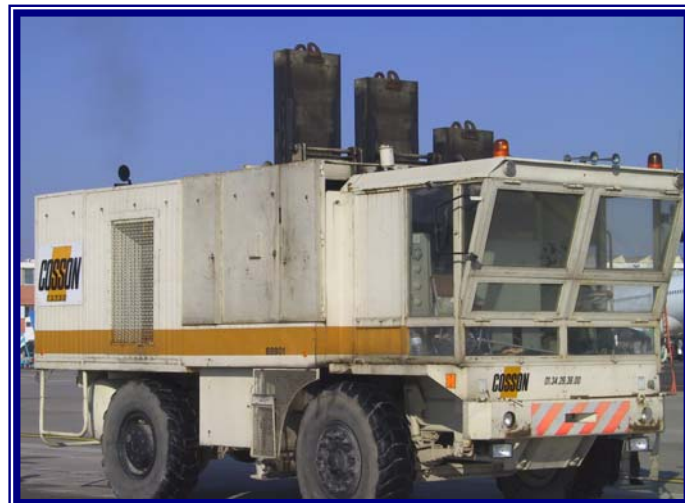
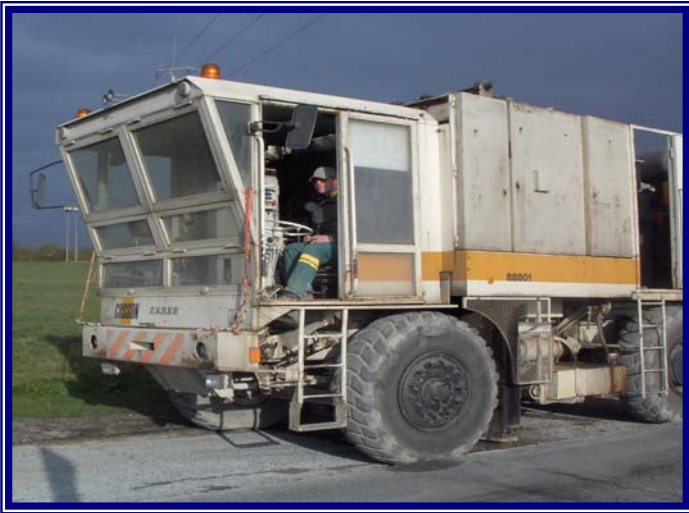
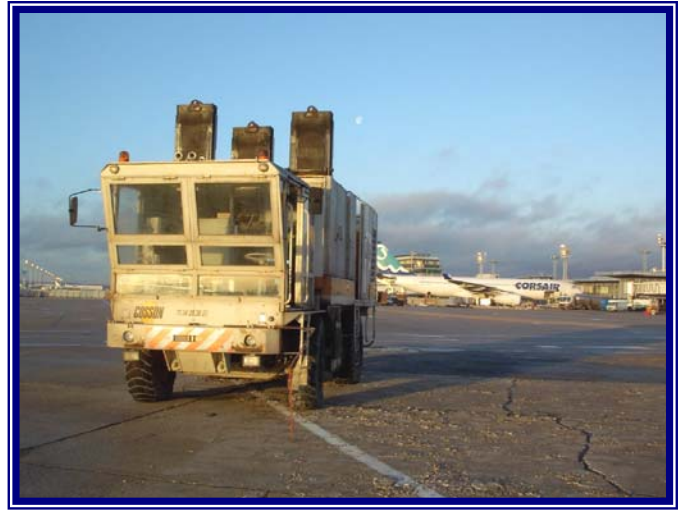
[figure 1: COSSON's crushing machine]

[figure 2: COSSON's crushing machine]

[figure 3: COSSON's crushing machine]

To speed up the job, the demolition was carried out using COSSON's slab crushing machine. This K3B type crushing machine consists of 3 drop hammers each weighing 3500 kg. The demolition operation for taxiways W 41, W 47 and 48 had an execution procedure aiming to provide a precise definition of the energy required to crush the slabs. The drop height of the hammers and the drop gap were determined on test beds. Once this "crushing" job was complete, hydraulic shovels removed the concrete fragments formed. *These concrete fragments* were then stacked on a specially prepared platform so as to avoid contaminating their quality. The work done by the crushing machine made it possible to reduce the size of the fragments and minimise re-crushing with a hydraulic rock breaker (HRB).

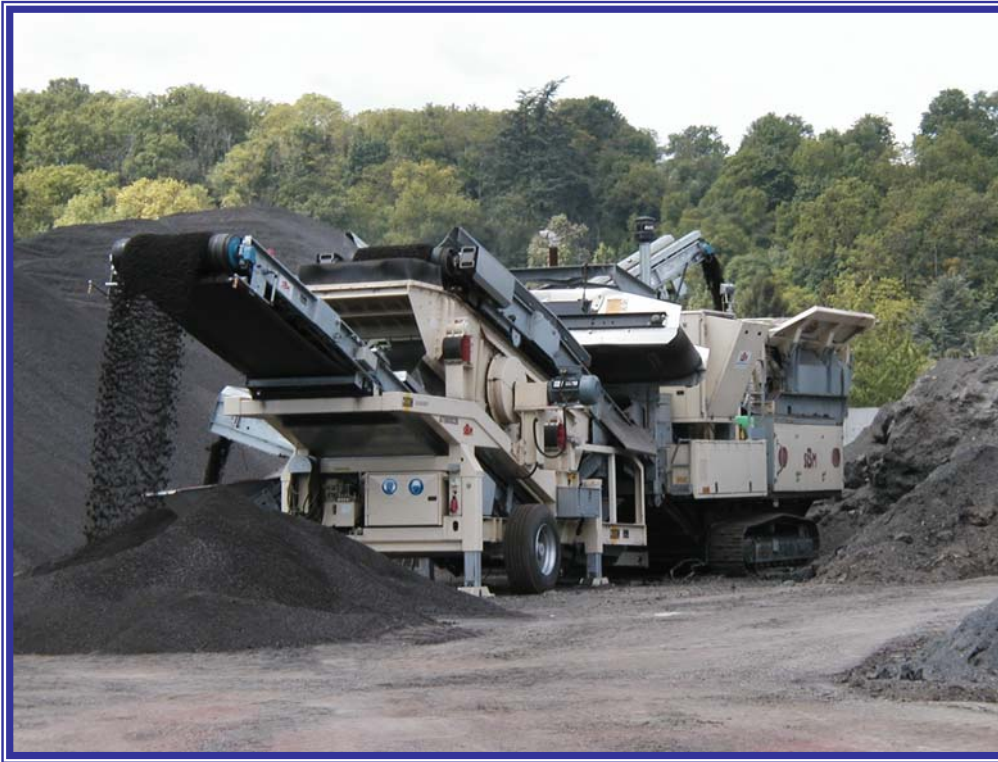
[figure 5: SBM crusher in action, crushing surfacing aggregates]

To lay this structure, the SCREG/COLAS partnership proposed adding 10 % surfacing aggregates to the reshaping BBSG 0/10. Production was carried out by two fixed units at Gennevilliers in Hauts-de-Seine, with a throughput capacity of at least 650 tonnes per hour. COSSON processed and stored the 0/8 cut surfacing aggregates on these sites using an SBM type COSSON crusher

Principle: before treatment, the aggregates were prepared to reduce them to a dimension compatible with the crushing equipment. The biggest fragments were reduced in a rock breaker, which eliminated the biggest impurities.

The materials prepared were then transferred by a wheel type loader, picked up by a hydraulic shovel and inserted into the crusher feed hopper.

They then passed onto the pre-screening scalper, which sent the fraction smaller than 8 mm directly onto the conveyor for pre-screened materials.

The fraction bigger than 8 mm was sent to the impact crusher, which fragmented the blocks before sending them onto the screener feed conveyor.

The materials were then put down on the screen, which calibrated the materials to 8 mm.

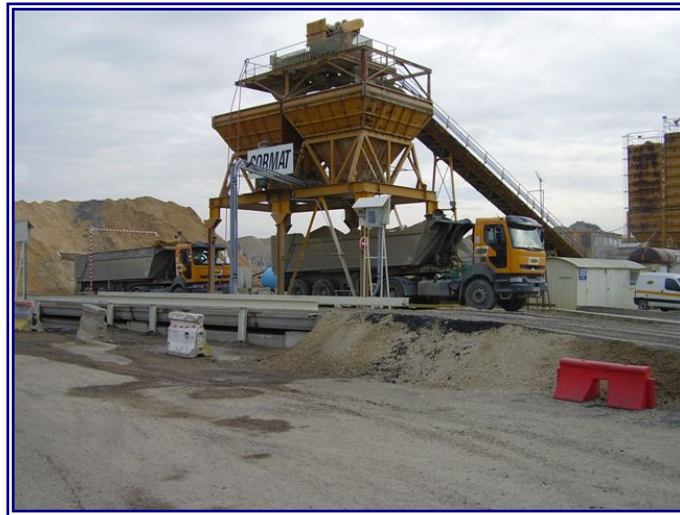
These 100,000 tonnes will be produced by COSSON via the Class 3 SAE type SORMAT plant, which has a production capacity of 600 t/h.

[figure 6: SORMAT manufacturing plant]

For this class 3 graded aggregate bound with cementitious binders as per standard NF EN 14 227-5 [8], the constituent level of crushed concrete is 45 %. This 0/20 grading concrete crushed at the COSSON platform mainly comes from concrete recycled from ROISSY Charles de Gaulle platform pavements.
