UNITED STATES AIR FORCE (USAF) EXPERIENCE STONE MATRIX ASPHALT (SMA) PAVEMENT

A. FRAGA, P.E.
HQ United States Air Force Europe
Engineering and Operations
Ramstein Air Base, Germany
Al.Fraga@ramstein.af.mil

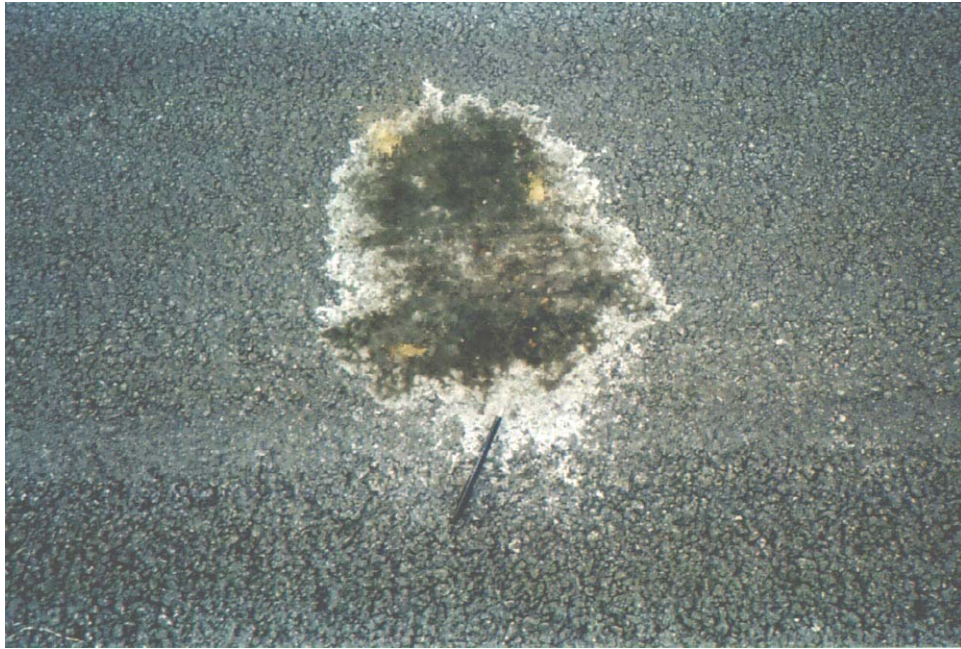
Figure 1 - Fat spot shown during inspection in 2000.

Grooving of the surface was not specified based on the history of these SMA mixes providing good friction characteristics in northern European countries. However, because of the asphalt rich mix, the new runway surface had lower friction coefficients until the asphalt film wore off under traffic and exposure to the weather. But these lower friction numbers increased after a few months and has been very good since. Other minor problems experienced were the formation of a few very small (typically only about 1 foot in diameter) fat spots likely due to draindown during construction (Figure 1). The small fat spots appear to have disappeared with time probably due to being worn off under traffic or erosion caused by environmental effects and maintenance operations on the pavement. There were also spots on the pavement where water had seeped up through the pavement surface (Figure 2). This is likely a ground water issue and is not related to any deficiencies in the SMA mixture. While this water continues to drain through the surface in hot weather it has not resulted in any performance problem to date.

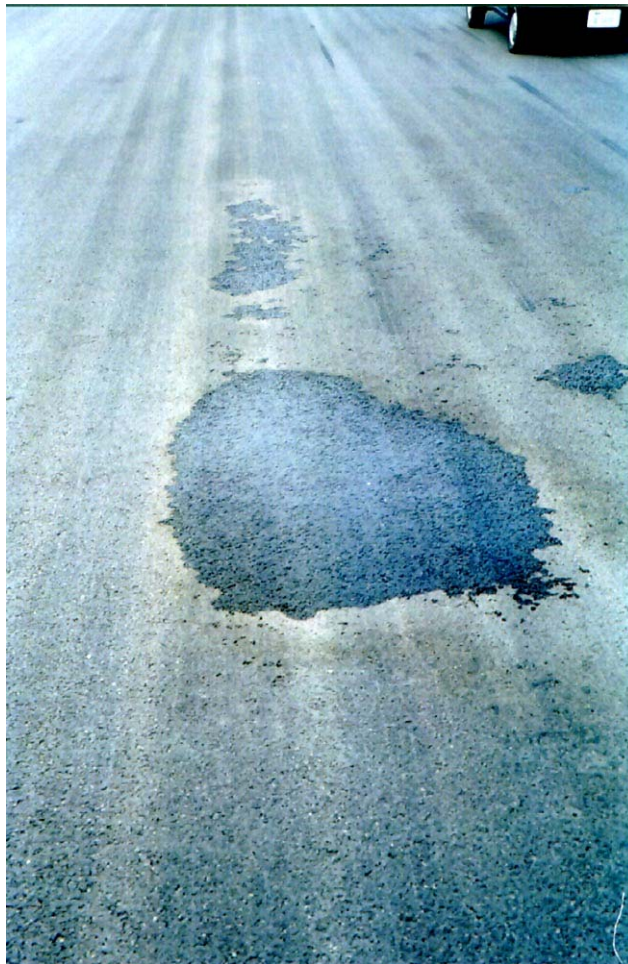
Figure 2 - Water draining up through pavement when inspected in 2000.

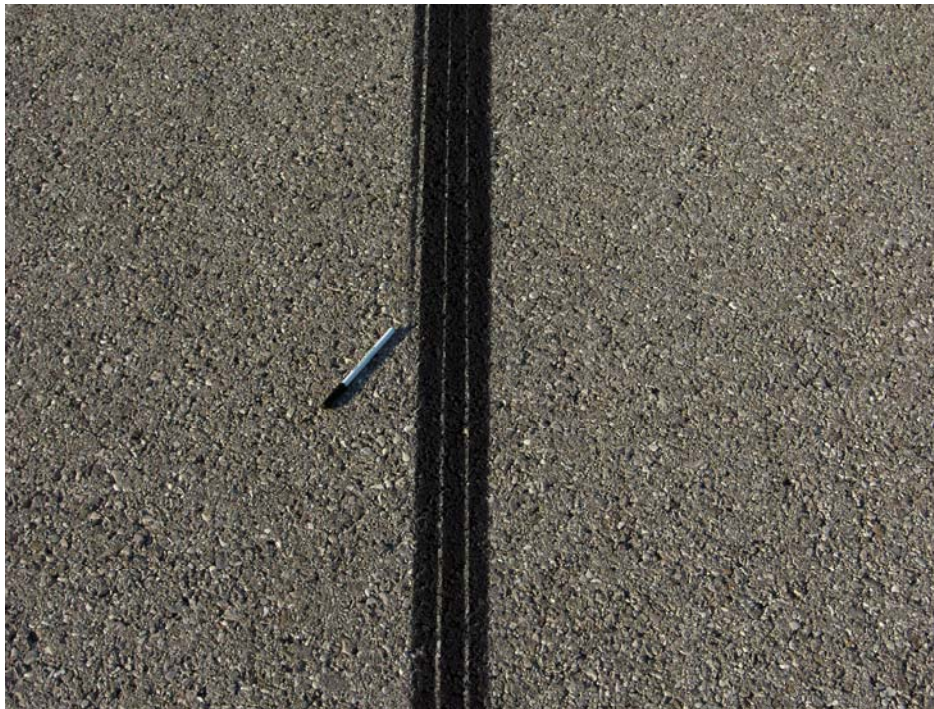
Figure 3 - Condition of SMA Surface with skid mark after 7 years.

This runway is providing excellent service to fighters and medium/heavy cargo aircraft (Figure 3). The last inspection, in September 2006, shows no permanent deformation or cracking, and its surface is still providing good friction characteristics.

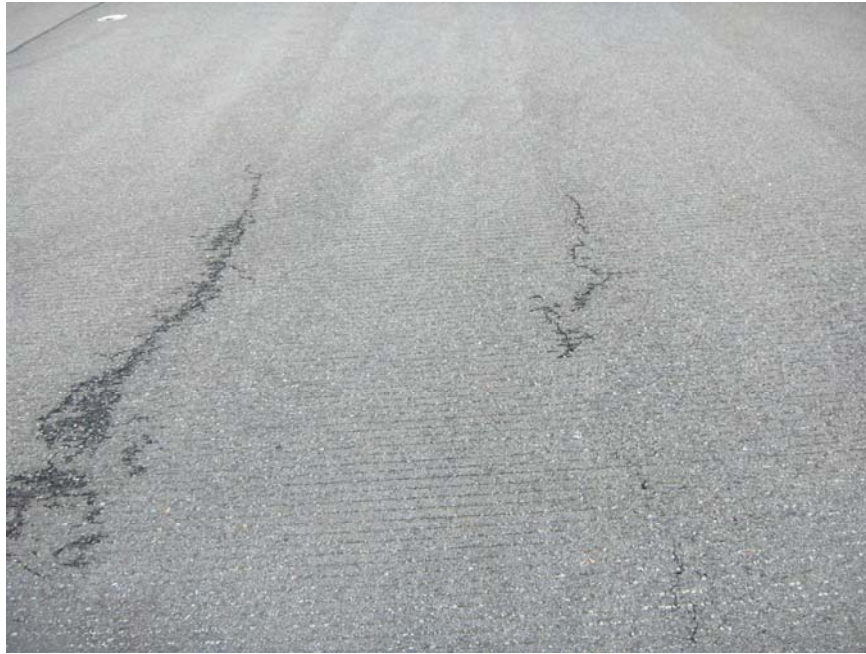
Figure 4 - Cracking with moisture migrating up through cracks.

Based on the success with the Aviano runway, HQ USAFE utilized SMA to resurface the runway at Spangdahlem AB, Germany in July 2007. Prior to milling and overlay, the existing hot mix asphalt surface had a significant amount of random cracking as well as cracking in and adjacent to longitudinal joints (Figure 4). During hot weather moisture could often be seen migrating up through the cracks. The scope of this project was to mill and remove the 5 cm (2 inches) wearing course and replace with the same thickness of SMA in a total area of 117,000 square meters.

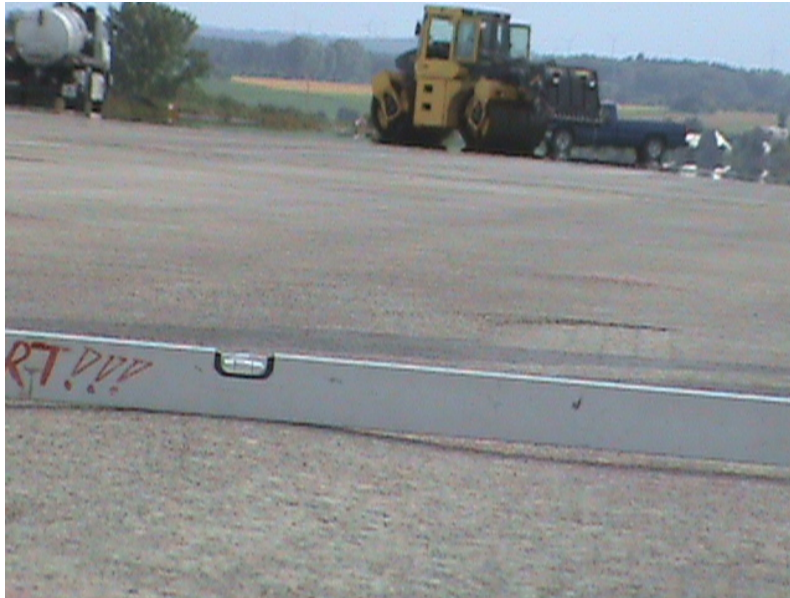
Figure 5 - Blister shown below straightedge.

Upon completion of milling and removal of the old wearing course, the area experienced heavy rains for over two weeks. The exposed surface that had been milled got completely saturated and even though precautions were taken to allow it to dry, some moisture remained trapped in this layer and is creating small diameter blisters on three small areas of the runway during periods of hot weather (Figure 5). If the surface is relatively porous then the moisture travels through the surface layer and appears on the pavement surface (Figure 6). The short term solution to the problem is to inspect the runway surface whenever ambient temperature reaches 25 degrees C., deflate blisters by drilling a small diameter hole and roll them to

ensure bonding. The problem appears to be localized in small areas and the trapped moisture is expected to dissipate with time.

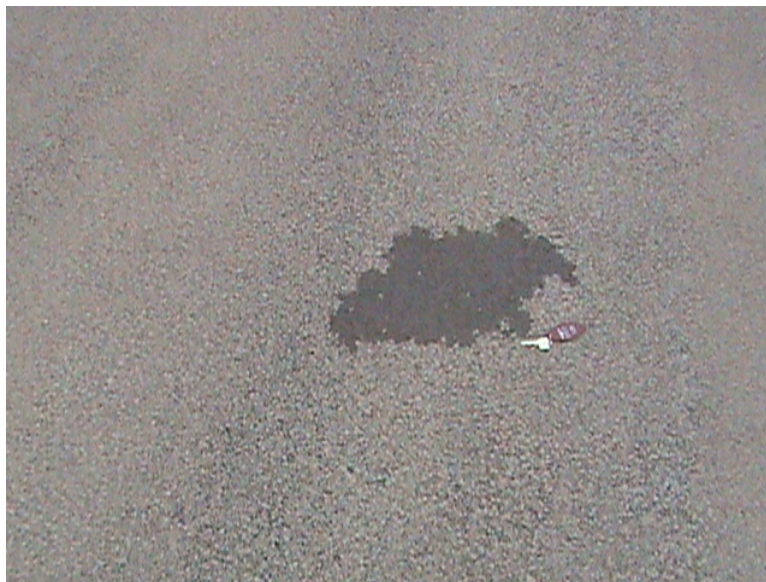
Figure 6 - Water from underlying layers moving through surface in hot weather.

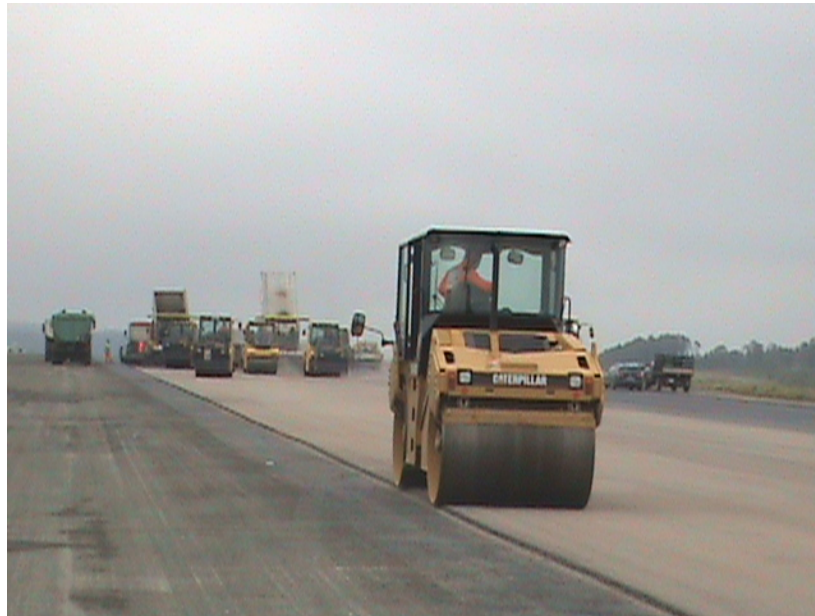
Figure 7 - Pavers and Rollers used on SMA Project.

The milling and SMA placement was done in 10 days and the total project in 45 days including weather delays. For the paving operation the contractor used two asphalt plants, two pavers, and up to 8 rollers (Figure 7). Due to this effort the project was quickly
