# TRAFFIC CALMING AT MOBILE ROADWORK ZONES: USE OF VEHICLE-MOUNTED RADAR TO EVALUATE THE EFFECT OF VARIABLE MESSAGE SIGNS

#### F. Friberg, M. Persson, J. Granlund & Å. Johansson Swedish Road Administration fredrik.friberg@vv.se; vagverket@vv.se

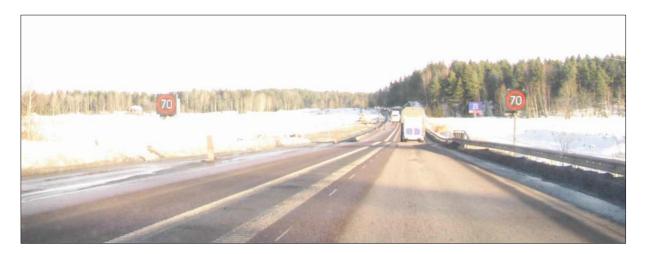
Figure 8 - LED sign in a sunny wintry landscape with the light from the side. In Sweden normal speed limit signs have been completely replaced by remotecontrolled digital signs at a few roadworks. Observe the red border on the sign, which shows that this is more than just a recommendation. No evaluation comparing digital and traditional signs has been conducted as regards driver comprehension and the impact on speed. Some are of the view that it can often be more difficult to see digital signs than normal signs. Works executed by Vägverket Produktion at Västerås-Köping, February 2007.

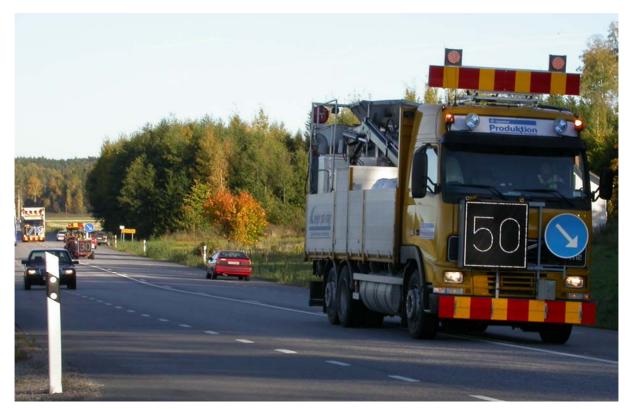
Figure 10 - LED (digital) signs mounted on trucks displaying the recommended speed during road marking operations. Enköping, 50 km northwest of Stockholm, 2005. Observe the white radar equipment (type SR3+) down to the right of the truck.

As a result of this study, Swedish legislation is being reviewed with the intention to legalise the use of this type of VMS on moving road work vehicles (Figure 9-10). Although there currently are legal impediments against the use of mobile prohibitory signs for speed limits, digital signs on moving vehicles displaying the recommended speed are included in a proposed amendment to the Swedish Road Sign Ordinance which is expected to gain legal force in June 2007, as a direct result of the findings in the project at hand.
