# **THE VIRGINIA DEPARTMENT OF TRANSPORTATION'S HISTORIC BRIDGE MANAGEMENT AND MAINTENANCE PLAN**

M. Kerley, P.E.

A. Miller

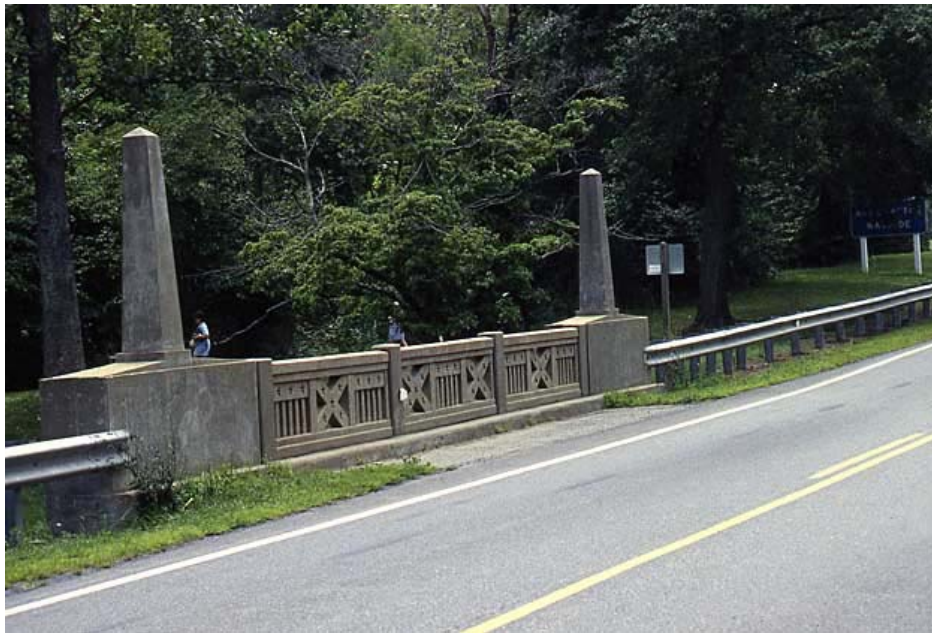
Figure 1 – Detail of concrete railing and obelisks, Appomattox County Structure No. 1002

Appomattox County Structure No. 1002 is a single-span reinforced concrete T-beam structure [104], built in 1930 with a 1971 widening, carrying Rt. 24 crossing the Appomattox River in Appomattox County, Virginia (Figure 1). The structure is approximately 33 feet (10.06

Condition issues were relatively minor for this bridge at the time that the Management Plan was formulated. There were some spalling and moisture seepage in the bottom deck. Cracks were present in the breast wall and in the T-beams. There was a small amount of spalling on the railposts. There was scour in the channel and under the footing. Additionally, there was scaling of the breast wall and delamination in the endwall. The wearing surface was delaminated. Vegetation was encroaching on the bridge.

Management Plan Recommended Treatment: Due to its concrete construction, location, and unique decorative design, moving the structure to another location or abandoning it were not considered options. Demolition was not recommended. The structure had already been widened; an upgrade to DOT standards was not necessary. The recommended management options for this structure were, in order of preference:

- 1) Repair and maintain for vehicular use, with subsequent preventive maintenance as needed. Immediate repair recommendations were to remove the asphalt overlay, evaluate and repair the deck, install a new concrete overlay, clean drains, remove vegetation, repair spalled and delaminated areas, and address the scour problem. Hydrologic and hydraulic analysis was recommended.
- 2) Transfer of ownership was not considered a feasible option under present conditions. However, it was noted that Rt. 24 to be realigned in the future, and in the event of interest in acquiring the bridge on the part of the National Park Service, this could be considered as a second option.

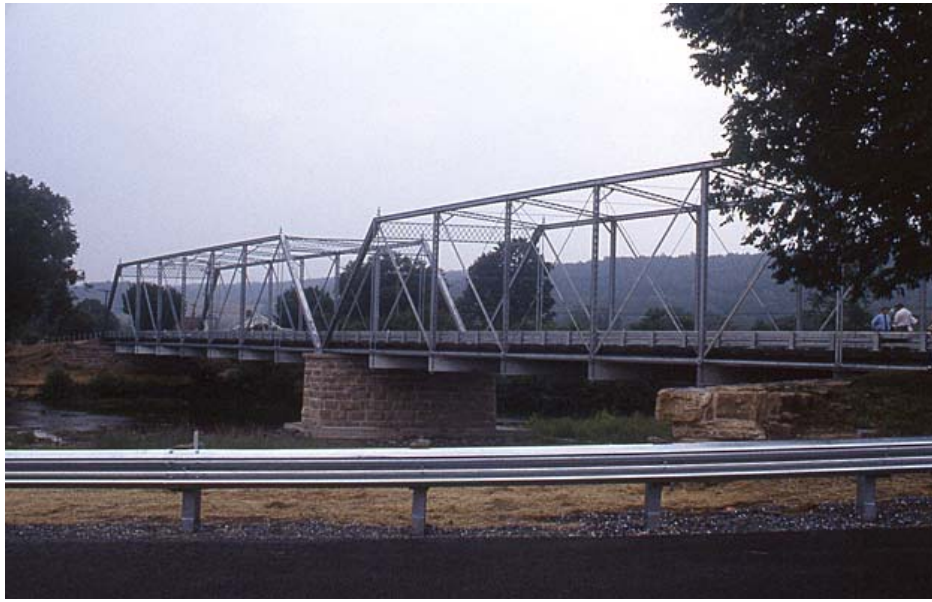
Figure 2 – The rehabilitated Goshen Bridge

Known familiarly as the Goshen Bridge, Rockbridge County Structure No. 6145 is a two-span steel Pratt through truss, built in 1890 by the Groton Bridge Co., carrying Rt. 746 crossing the Calfpasture River near Goshen, Virginia (Figure 2). This structure is approximately 261 feet (79.55 m.) long overall; the trusses are approximately 139 feet (42.37 m.) and 121 feet (36.88 m.) long. Originally designed and constructed for the planned industrial community of Goshen, this bridge has a number of points of historical significance: it is associated with an early planned industrial community; it is one of Virginia's earliest multi-span truss bridges; it is built on a skew; and it is an early multimodal bridge. As originally designed, the structure included a lane for vehicular traffic and a lane for streetcars, as well as a cantilevered sidewalk. Rockbridge County Structure No. 6145 was included in the initial metal truss survey report prepared by the VTRC (Deibler 1975) [4] and the more recent update (Miller and Clark 1997) [5]. It has also been recorded to Historic American Engineering Record Standards (HAER No. VA-102). The structure was placed on the Virginia Landmarks Register in 1977, and on the National Register of Historic Places in 1978.

By the end of the 1990s, this structure had numerous areas of corrosion and section loss to steel members. Piers were missing mortar and substructure stones in various locations. The roller bearing devices were frozen and some were displaced. In addition, debris was present on the bridge seats, connections and between stringers. Only one lane was open to vehicular traffic; the other lane, which was originally planned as a streetcar lane, had not had decking for at least 50 years; there was attendant corrosion of the exposed members. There was strong local and regional support for rehabilitating the structure rather than replacing it with a new bridge. VDOT's Staunton District Structure and Bridge office, after studying the situation, made the decision to undertake the design and construction project, and to do much of the work in-house in order to develop strong expertise in working with historic metal truss bridges.

In 2001-2002, a full rehabilitation of this structure was undertaken by VDOT through its Staunton District Structure and Bridge office. The stone piers were cleaned, repaired and repointed as needed, using a compatible mortar mix (i.e., with both lime and Portland cement components, instead of pure Portland cement content). The truss was disassembled, and the members were repaired or replaced in kind as needed. Radiographic and ultrasonic testing were required to ensure the suitability of the fracture-critical members designated for reuse.

Due to a large amount of severe deterioration in the truss members, a particularly large number of members (over 100) had to be replaced. Section loss, active corrosion, and pack rust necessitated the replacement of all end posts, hip verticals, upper chord members, counters, and pins. Nearly all elements were replaced in kind. The few exceptions included the loop-welded eye bars and counters: due to a tendency to fail, this technology has long been prohibited, and changes in these elements had to be made to comply with current American Association of State Highway and Transportation Officials (AASHTO) standards. Due to corrosion concerns, laminated elastomeric pads were used in the expansion bearings. Glued laminated timber deck panels replaced the original nail-laminated plank deck.

Following disassembly of the truss, original elements were taken off-site for removal of lead paint under controlled conditions. Subsequently, all of the structural steel, including the bolts and bearings, was galvanized. Following galvanization, the truss elements were then reassembled. The original members were connected with rivets; in the absence of modern professional riveting gangs, tension control bolts, placed with the round head on the visible face of the structure, were used in the reconstruction of the bridge.

The bridge was restored for two lanes of vehicular traffic, and included the capacity to carry emergency vehicles. It was reopened in July, 2002.

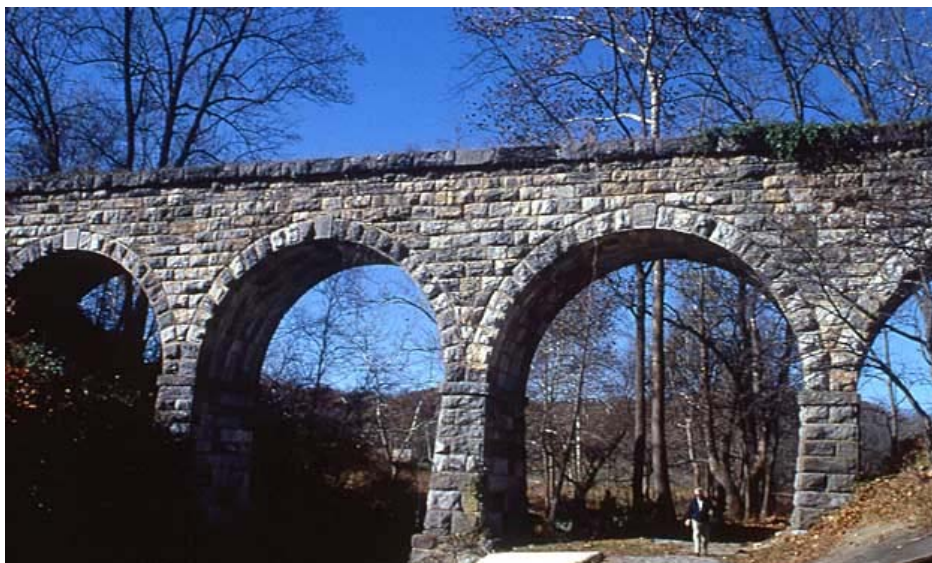
Figure 3 – The Valley Railroad Bridge

Known familiarly as the Valley Railroad Bridge, this structure is a four-span masonry arch bridge, crossing Folly Mills Creek just west of Interstate 81, south of the city of Staunton in Augusta County (Figure 3). The structure is approximately 147 feet (44.81 m.) long. Built in 1874 to carry rail traffic on the Valley Railroad, this large multi-span masonry arch bridge is one of the largest and most visible 19th century masonry railroad bridge structures in Virginia. The railroad line was discontinued in 1942, and the tracks were taken up. The bridge is now preserved as a landscape element adjacent to Interstate 81. The Valley Railroad Bridge was included in the initial arch bridge survey report prepared by the VTRC (Spero 1984) [6] and the more recent update (Miller and Clark 2000) [7]. The bridge was listed on the Virginia Landmarks Register and the National Register of Historic Places in 1974.

The Valley Railroad Bridge and its approaches carry no traffic of any kind; the structure is located within the right-of-way for Interstate 81; right-of-way ownership for this structure is not applicable. There are grass, weeds, vines, bushes and small trees growing on the old roadway and various other areas of the bridge. The bases of two piers along the creek have concrete aprons added as a stabilization measure. There are some areas of seepage through the arch, and corresponding loss of mortar; some repointing has been done with Portland cement.

Management Plan Recommended Treatment: Although unsuitable for use as a vehicular or pedestrian bridge due to its location in the Interstate 81 right-of-way, the Valley Railroad Bridge is one of the most visible, and popular, historic bridges in Virginia. Due to its location, material and appearance, it is a striking landscape feature, and it is seen and remarked upon by thousands of drivers every day. A condition assessment in the near future would be helpful to fully identify current and potential problems and needs. A structure number should be assigned and the structure should be placed on a regular inspection schedule. Once the structure is inventoried within HTRIS, VDOT can use state maintenance funds to work on a bridge asset, albeit out-of-active service. This attractive and highly visible historic bridge should be considered a candidate for a transportation enhancement grant. Due to its masonry construction and location, moving the structure to another location is not an option. Other usual options such as upgrade to DOT standards, transferring ownership, etc. are not applicable in the case of this structure, which will not carry either vehicular or foot traffic. The recommended management options for this structure are to repair and maintain for adaptive use (i.e., its continuing role as a landscape feature), with subsequent preventive maintenance as needed. Immediate maintenance recommendations are to remove the vegetation from the bridge. The grass on the roadbed is not a serious encroachment, but the vines, bushes and trees should be removed to prevent further damage to the structure. A structural assessment should be made of the cracks in the bridge, these should be repaired or monitored as necessary; an appropriate mortar mix [part-lime, not pure Portland cement] should be used for repointing. Monitoring and maintenance of the streambed should be continued. In order to minimize seepage through the structure, the roadway should be evaluated for the most effective sealing and drainage methods (possibly an impermeable clay liner and drainage pipe inserted into the roadway to promote runoff). Interpretive signage regarding the bridge
