MANAGEMENT OF THE ROAD CAVE-IN RISK AFTER A LARGE EARTHQUAKE USING SUBSURFACE CAVITY SURVEY TECHNOLOGY

T. ABE, M. SAIKA & T. KUSAKABE
Road Management Technology Center, Japan
saika-m@hozen.or.jp

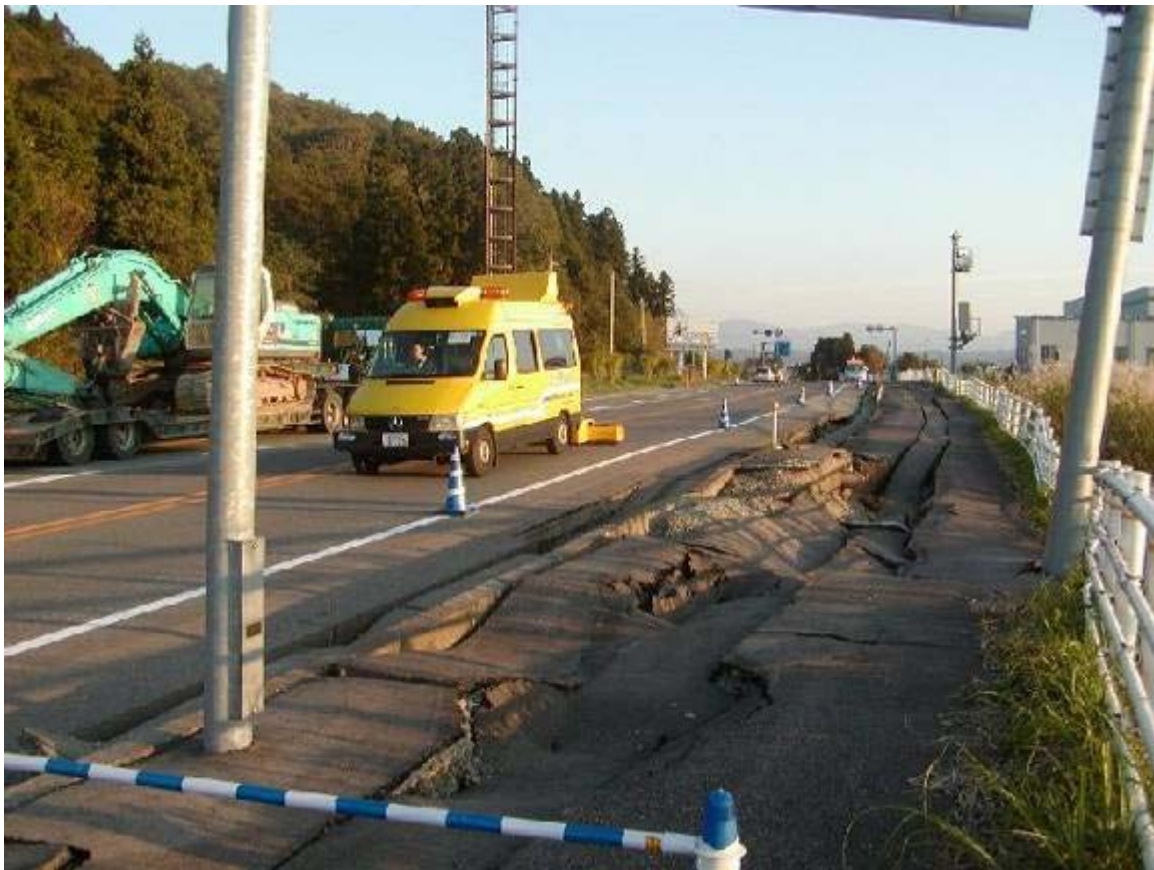
Photograph 1 – Primary Survey (Data Collection by Survey Vehicle)

The survey vehicle, which is designed to detect cavities up to 1.5m from the surface of the ground, is used for a primary survey. This vehicle equipping with seven channel ground penetrating radars runs at a maximum speed of 45km/hr and covers 2.45m wide in one run. (Photograph 1) Therefore, speedy survey is achievable and influence upon the restoration activities can be minimized.

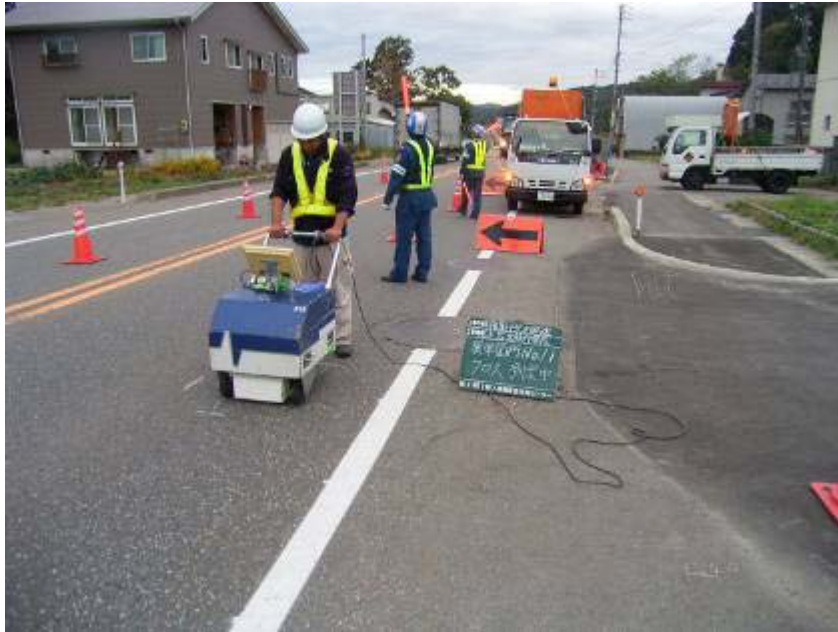
Data collection with a portable GPR

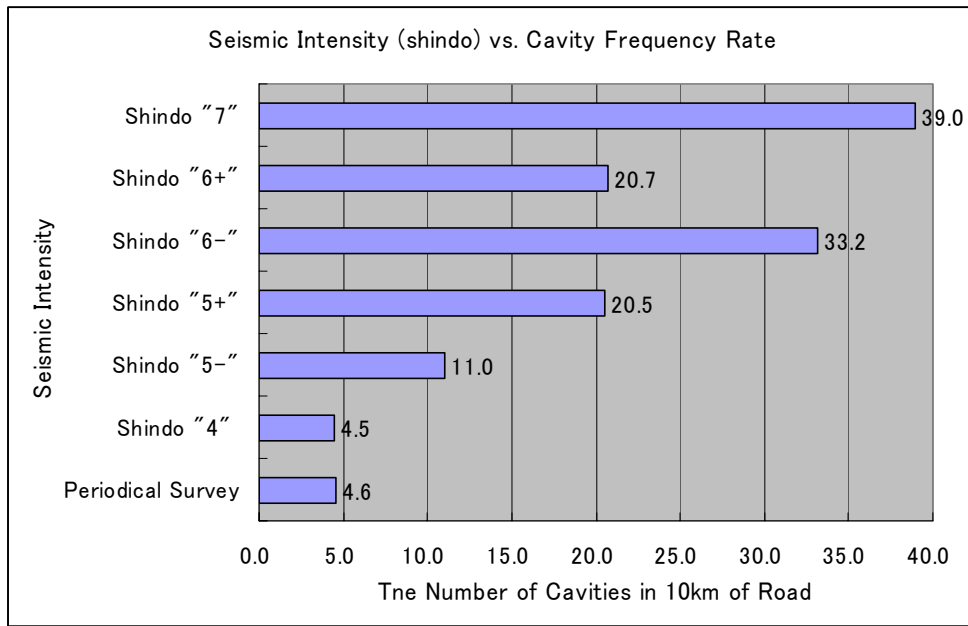
Table 8 - Seismic Intensity (shindo) vs. Cavity Frequency Rate

The 438 cavities (note 2) were detected in the emergency survey. As the surveyed road length is about 318km, the number of cavities per 10km is 13.8 on the average. According to the periodical survey results in this area from 1991 to 2003, it is 4.6. Therefore, the cavity frequency rate after the earthquake become threefold compared with the ordinary situation. As shown in the figure 8, the cavity frequency rate increases as the seismic intensity increases in general. It can be understood that the cavity frequency rate increases rapidly in the area where the seismic intensity recorded 5- or more.
