MONITORING AND MAINTENANCE OF SOIL ENGINEERING STRUCTURES ON THE A43 MOTORWAY

A. Bergère
Terrasol -, France
a.bergere@terrasol.com
P.L. Veyron
Setec, France
veyron@tpi.setec.fr

ABSTRACT

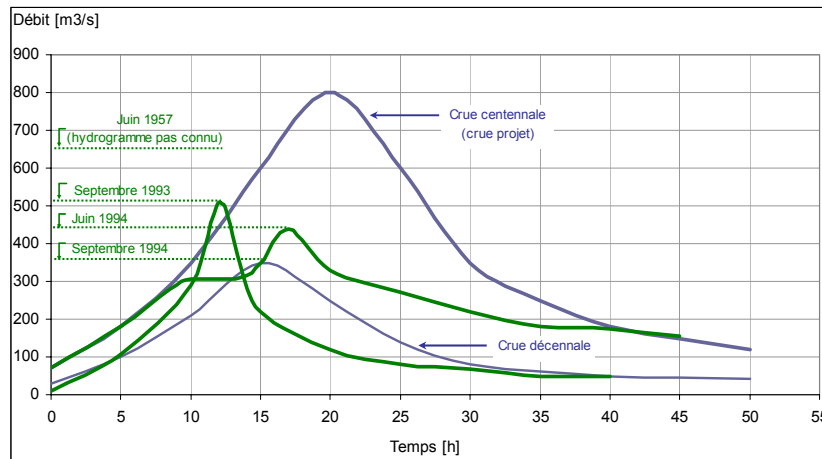
Figure 3 - Histogram of floods of the River Arc.

- Flow-rate (m³/s)
- June 1957
- (hydrogram unknown)
- September 1993
- June 1994
- September 1994

100-year record maximum flood
(design flood)

10-year record maximum flood

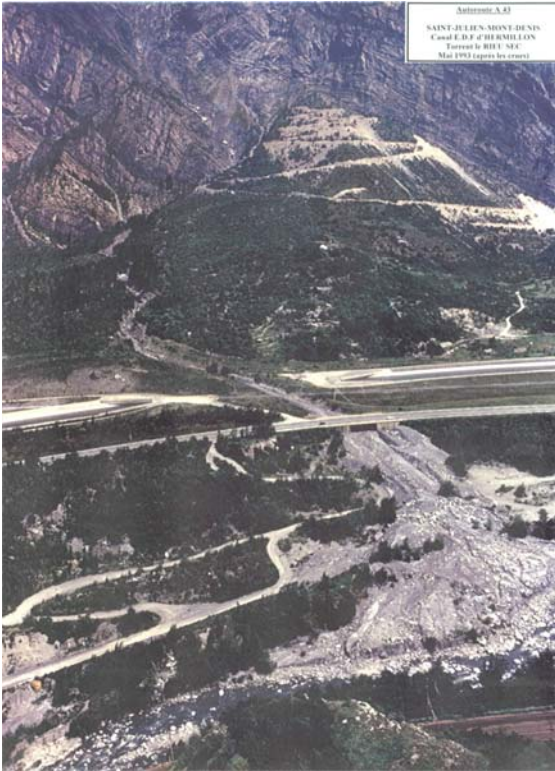
Figure 4 – Photograph of the A43 motorway after the 1993 flood.

In 1993, strong floods (with flow-rate of the River Arc reaching 500 m³/h) caused infill of the Rieu Sec's bed and the hydraulic structure, reduced the cross-section of the River Arc's bed and eroded the base of the railway on the south bank of the river. The 1993 photograph in [Figure 4](#) shows the site after the flood.

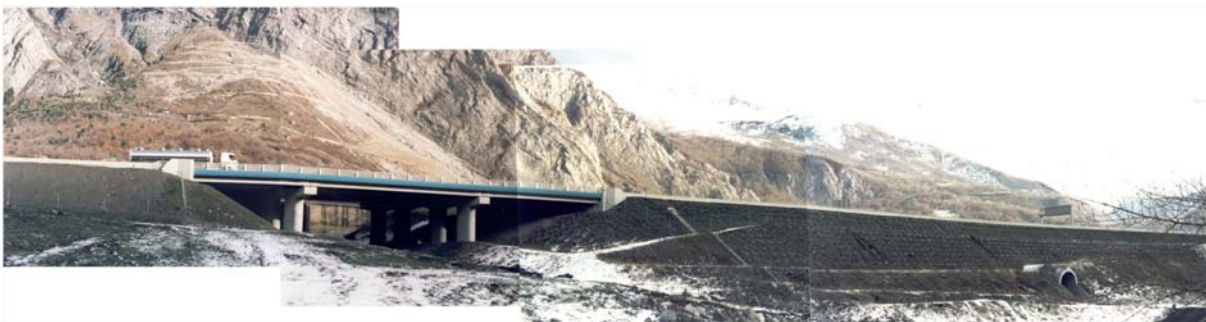
Figure 5: Structure OH90 in the Rieu Sec area (PI91 on the right).

The structures were therefore built on shallow strip foundations protected against any risk of scouring by large masses of rockfill in the bed of the Rieu Sec (see [Figure 5](#) ~~Figure 5~~).

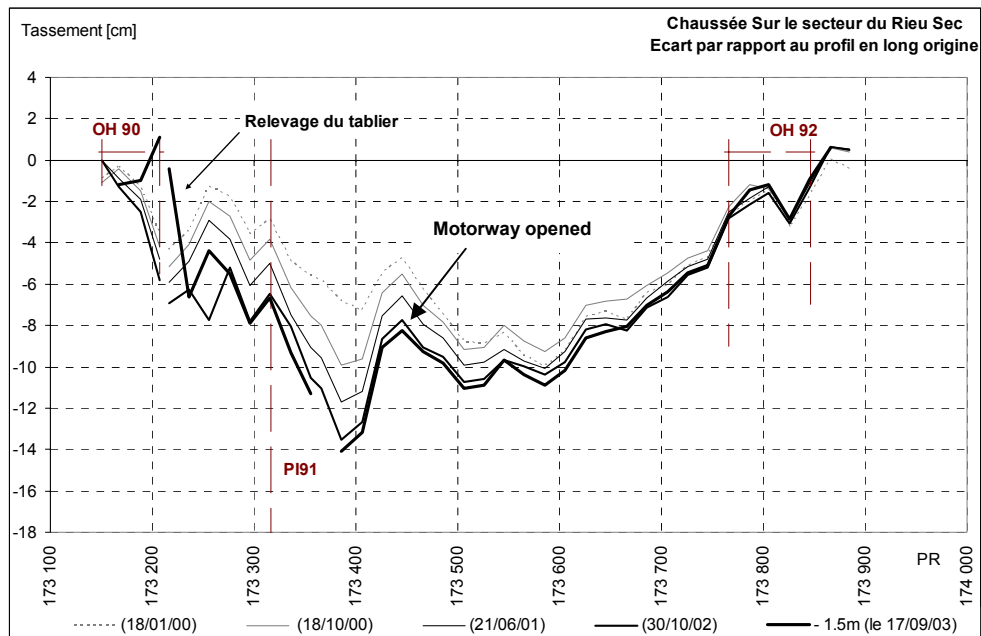
Figure 7 - Settlement measured on the carriageway in the Rieu Sec area until Sept. 2003.

- There was major settlement of the carriageway, of around 10 cm, but differential settlement remained acceptable (see [Figure 7](#)).
- OH no. 90 underwent major settlement, which slowed down over time (10+20 = 30 cm for C0, and 18+55 = 73 cm for C3). The deformations measured were not uniform, since abutment C3 was settling more than abutment C0 and, in addition, settlement was greater on the South side than on the North side of the structure. This differential settlement caused gradual deformation of the structure's deck, which tended to twist (see [Table 5](#)).
- PI91 underwent major settlement of 30 to 50 cm during construction and 150 cm before the motorway was opened. This settlement tended to slow down in an asymptotic manner, but had caused abutting of several arch elements and cracking of several prefabricated elements (see [Figure 9](#)).

Carriageway in the Rieu Sec area.
Deviation in relation to the original longitudinal section.

Raising of deck

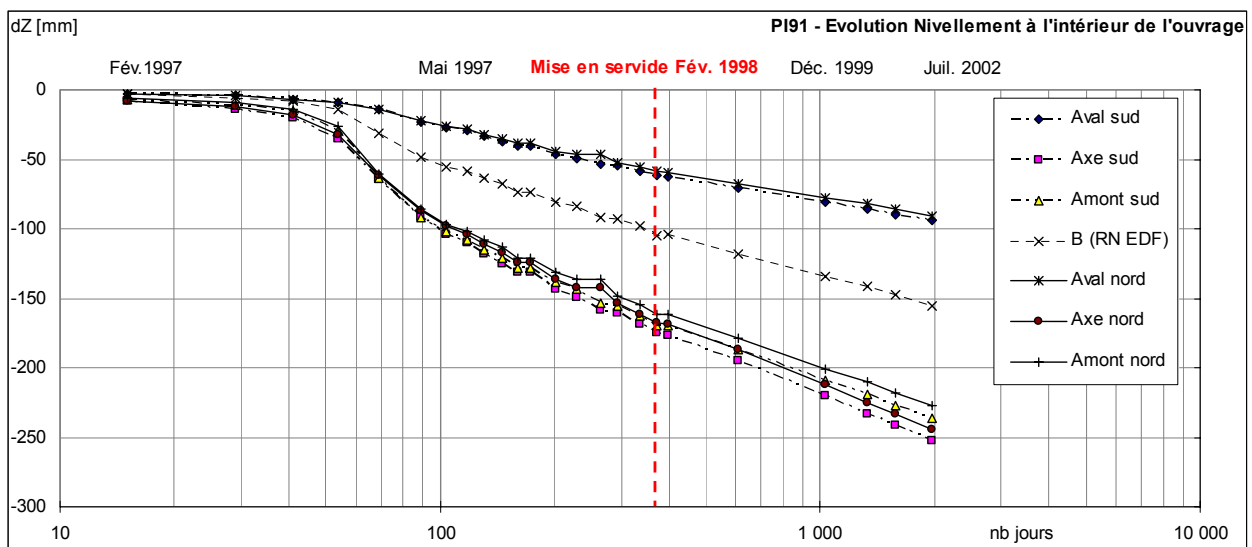
Figure 9 - PI91 Assessment of settlement inside the structure. Zero was redefined in February 1997, and it does not take into account settlement during the construction stage.

South downhill
 South centre-line
 South uphill
 B (RN EDF)
 North downhill
 North centre-line
 North uphill

As a result of the assessment of settlement inside the structures and the carriageway, annual monitoring was continued until 2004. No anomalies were found in the variations in settlement. The phenomenon is developing towards stabilisation in the long term, as forecast on opening to traffic in 2000. Monitoring is now reduced, but it still necessary.

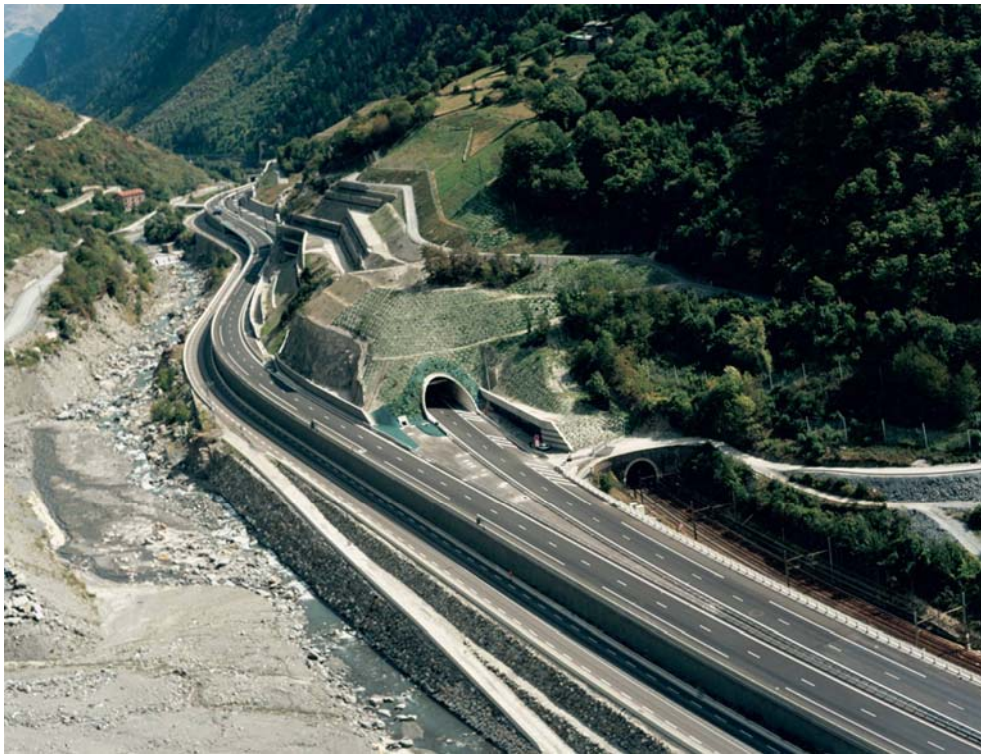
Figure 10: Present state of Les Sorderettes.

Figure 10 shows the complete present site in a narrow valley that is particularly constricted by the presence of the Arc, the Lyon - Turin railway line and the RN6.

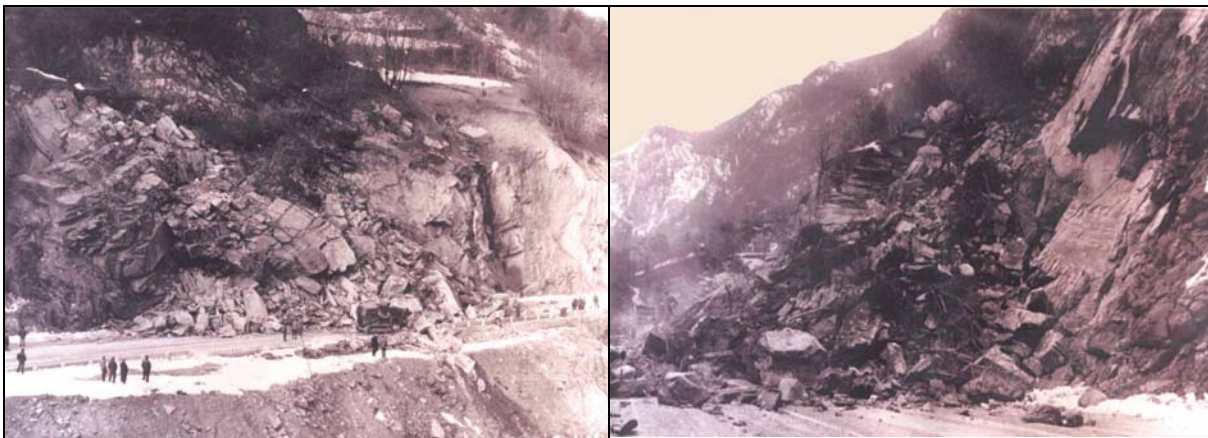
Figure 11– Rock landslide of Les Sorderettes spur in 1969.

The 1969 work site suffered several ruptures of the slope, a rock landslide in the East part of the spur (see [Figure 11](#)) and repeated landslides of loose ground during construction of a large masonry wall in the West part of the spur.

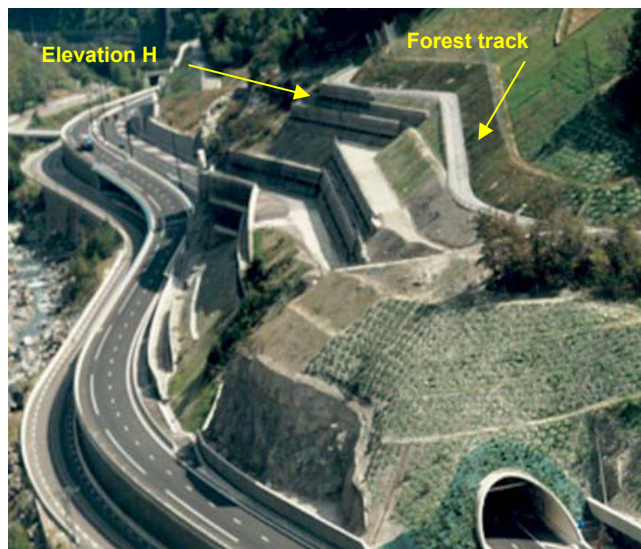
Figure 15– Locations of the measurement points on the retaining wall.

Monitoring of the site was continued after construction work was completed. The monitoring systems were reduced, taking into consideration the stabilisation of the reference parameters. The data is presented below as an example, at the level of the tie beam in elevation H and the forest track (see Figure 15).

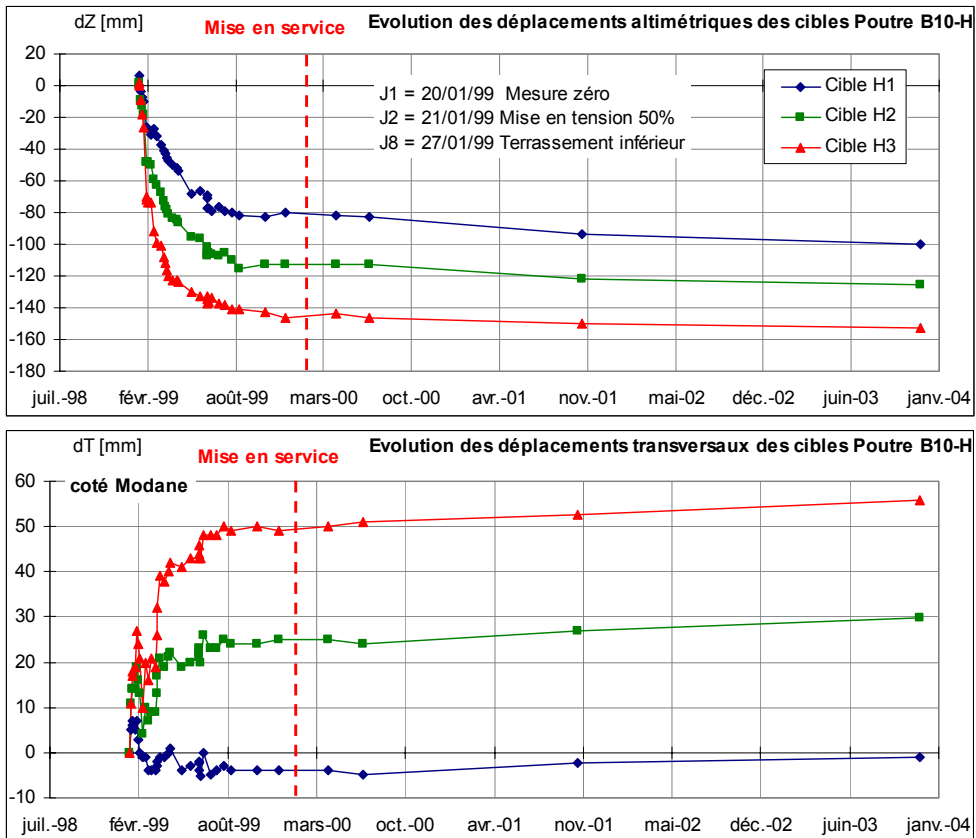
Figure 16 - Retaining wall MS 222-5 of Les Sorderettes – Topographical measurements of 3 points on elevation H, from completion of construction until 2003 monitoring.

The topographical measurements are given in *Figure Figure–16*. Since the original operation in January 1999, the beam has settled by -11 to -153 mm and has moved towards the River Arc by -9 to +67 mm. These high values correspond to the construction work phase. Since the motorway has been open to traffic, these movements have remained below the set thresholds: -8 to -12 mm settlement (with a threshold at -20 mm) and -1 to +5 mm crosswise movement (threshold at +20 mm). For all points, the mean deviations are within the range of precision of the measurements, i.e., ± 10 mm.

Considering the variations observed since the opening of the motorway, we must conclude that the structure is still subject to some movements. These movements go hand in hand with a slight local loss of tension in the tie rods. Following the new measurements planned for 2005, the detailed analysis of the results should enable us, if necessary, to define a maintenance programme aimed at re-tensioning certain tie rods, cleaning the drains and piezometers, and providing additional drainage.

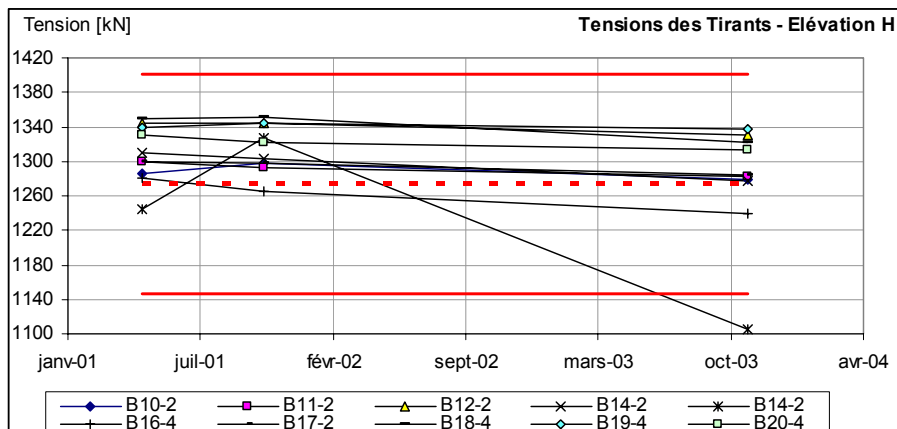
Figure 17- Retaining wall MS 222-5 in Les Sorderettes – Measurements of the tension of the tie rods in elevation H since the motorway opened to traffic.

The tie rods were installed with a theoretical tension of 1,274 kN. The measurements taken on the control tie rods are given in Figure Figure-17. They show that tensions vary within the required limits, with a slight tendency to decrease. Cell B14-2 is notable for its instability since the opening of the motorway, although the topographical measurements, including those in February 2004, do not show any apparent deformation on the facing of beam H. The next measurement will provide information on the development of this tie rod (identifying either a tension fault or damage to the dynamometric cell). At this stage, the tie rod's capacity is not questioned, but replacement of the cell must be envisaged.

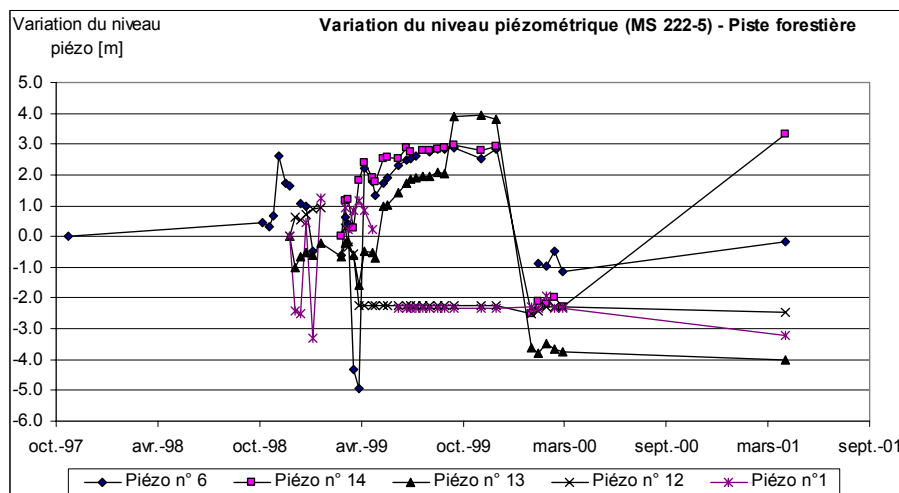
Figure 18- Retaining wall MS 222-5 in Les Sorderettes – Measurements of variations in piezometric level in elevation H.

The last measurements of drains were taken in March 2001 and are given in [Figure 18](#). It is difficult to interpret the piezometric levels and to compare them to previously-defined alarm thresholds, since the measurements are not always taken in the same season. Therefore it is difficult to correlate them, because November is a period of high water levels and February is normally a period of low water levels. The level of water at beam H remains below that measured during construction work from January 2000. Piezometer No. 14 shows a sharp increase in one single value in March 2001, while the other piezometers are stable. During topographical checks between 2001 and 2004, no abnormal movement in the structures was found. Therefore this equipment must be supervised, and cleaning of the piezometers has been recommended. For the other piezometric levels, the alarm thresholds were not reached.

Variation in the piezometric level (m) Variation in the piezometric level (MS 222-5) – Forest track
 Oct 01 Oct 98 April 99 Oct 99 Mar 00 Sept 00 Mar 01 Sept 01
