**XXIIIrd WORLD ROAD CONGRESS  
PARIS 2007**

**JAPAN - NATIONAL REPORT**

**RISK MANAGEMENT: A NEW APPROACH  
TO IMPROVING SAFETY**

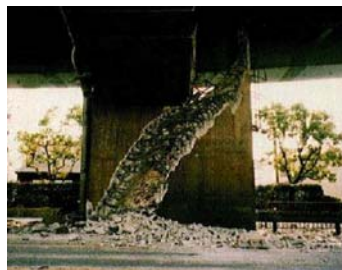
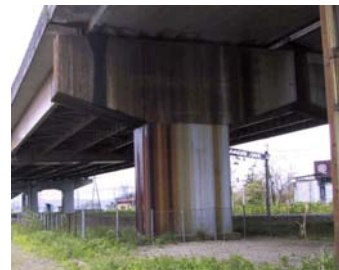
(a) Bridge pier damaged by the 1995 Hyogo-ken Nanbu Earthquake

(b) No damage with pier retrofit (2004 Niigata-ken Chuetsu Earthquake)

**Photo 1 - Effect of bridge pier retrofit (Both bridges were located in the areas recorded seismic intensity 7)**

Seismic retrofit of bridges has been pursued as part of the efforts to improve seismic resistance of road facilities. Photo 1 shows the effect of bridge pier retrofit as a typical retrofit method of road bridges. Recently, in view of the occurrence of the Niigata-ken Chuetsu Earthquake in 2004 and a fact that major earthquakes, such as the Tokai, Tonankai and Nankai Earthquakes, and strong inland earthquakes in the Metropolitan area may occur, MLIT laid out the 3-year Bridge Seismic Retrofit Program for Emergency Transport Roads (2005 to 2007) and the 3-year Bridge Seismic Retrofit Program for Road Bridges Over Shinkansen Tracks and Expressways (2005 to 2007), and have promoted seismic retrofit of those bridges. Those programs are intended to expedite seismic retrofit of the bridges in order to prevent serious damage such as collapse of bridges, ensure the function of emergency transport roads, and prevent secondary damage, for the strong ground motions such that generated by the 1995 Hyogo-ken Nanbu Earthquake.

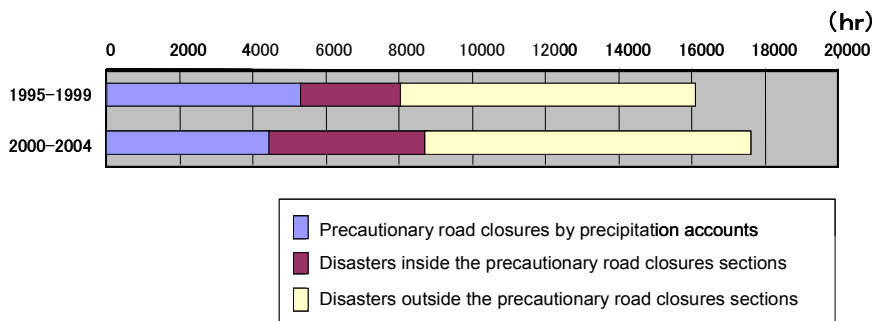
**Figure 3 - Precautionary road closures and breakdowns (National highways, 1995-2004)**

Figure 3 shows the details of the cumulative road closure time by road slope disasters and precautionary road closures in national highways in the past 10 years (1995 to 2004). Precautionary road closure by precipitation accounts for about 30%, disasters inside the precautionary road closure sections for about 20%, and disasters outside the precautionary road closure sections for about 50%. As indicated by this figure, it is necessary to take effective actions to prevent roads from being damaged or blocked by heavy rainfall in order to reduce road closure by heavy rainfall disasters or precautionary road closures from the viewpoint of maintaining safe road space for road users and ensuring road network continuity.

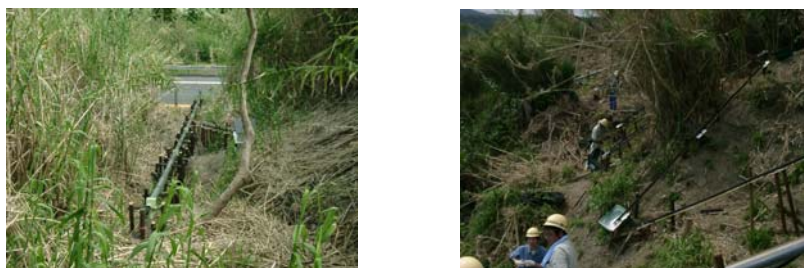
**Photo 2 - Installation example of sensor for slope failure measurement**

In addition to large-scale road inspections conducted once in a few years, such as the Comprehensive Road Disaster Prevention Inspection, or emergency inspections as triggered by the occurrences of large-scale disasters, periodic inspection, about once a year, or daily patrol is conducted with the help of the disaster prevention charts for early detection of problems. Whenever a problem is found, appropriate actions are taken, such as emergency repair. National highways are basically patrolled once a day. At part of road slopes where sight inspection or disaster measures are difficult, sensors are installed, as shown in Photo 2, to constantly monitor changes of the slope as part of the efforts to improve management of disaster-prone hazardous spots. New technologies such as optical fiber sensor are applied to monitoring. Vigorous efforts are being made to establish efficient precautionary road closure and evacuation guide by detecting and coping with a disaster in the early stage and predicting collapse.

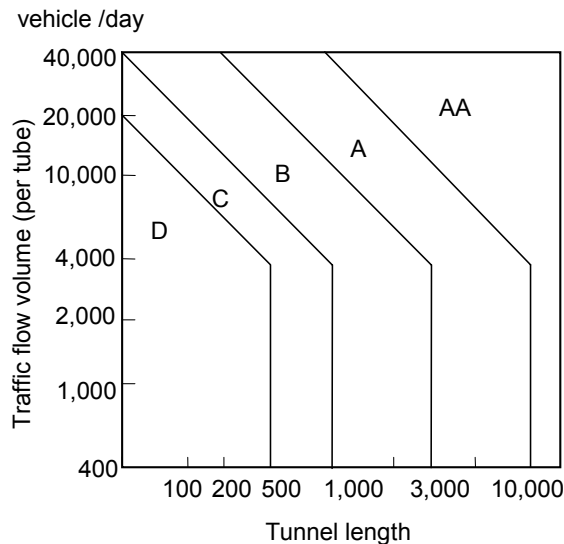
**Figure 5 - Tunnel classification**

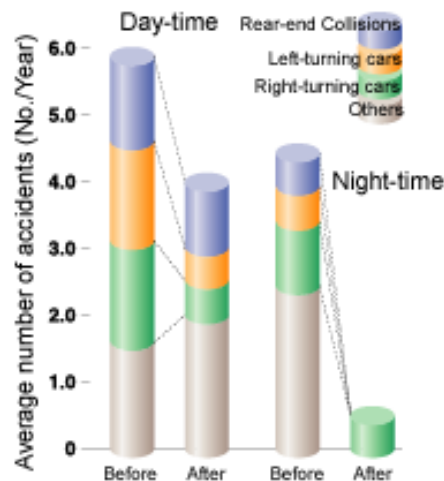
Figure 8-Effects of measures

Photo 3 shows intensive measures taken at a hazardous spot. The type of accidents that frequently occurred at this spot include exceedance of the speed limit in the intersection, accidents caused by cars turning left or right due to the inappropriate road alignment, and accidents in the night due to poor visibility. Solutions to those problems were installation of a traffic island, construction of a pedestrian bridge, down-sizing of the intersection by relocating stop lines, paving in colors, clarification of the nearside lane, and installation of additional road lights. Those measures successfully produced favorable results, a remarkable reduction in the number of accidents both in the daytime and night time, as shown in Figure 8.

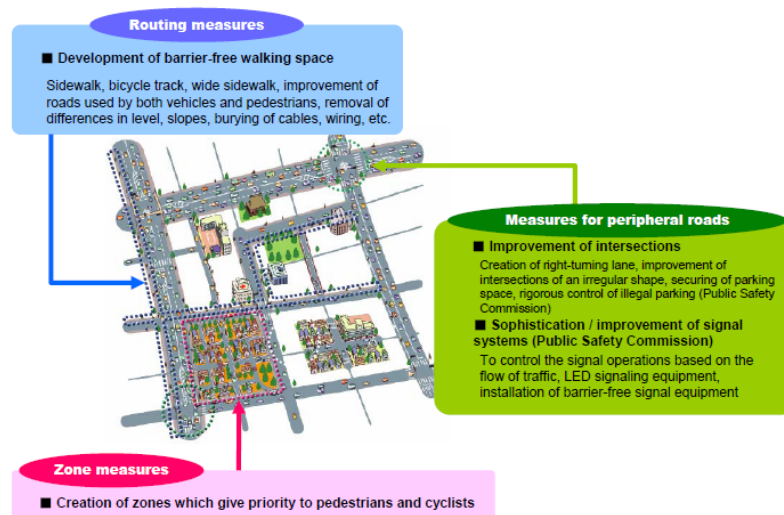
Figure 9 - Image of safe walking area

Many accidents still occur on residential roads in urban areas, whereas accident-prone roads are major ones in rural areas as earlier mentioned. Measures particularly focusing on safety of residential roads have been taken since 2002 as spot-specific and linear measures, while plane-specific measures have been taken since 2003. For the latter, model measures, such as "safe walking area" or "zonal road development for daily life," are being taken, while trying to build consensus of residents for those programs. So as shown in Figure 9, the effective measures, which combine physical measures such as widening sidewalks or installing humps to reduce traveling speed and non-physical measures such as prohibiting through traffic in specified zones, are tried. It is desired if the successful results may be obtained from traffic safety measures taken for residential roads, particularly those where such model measures were completed. It is also hoped that ideas for more effective measures may be gathered and handed down in the form of handbooks or case examples for future betterment of traffic safety.
