Virginia Department of Transportation Historic Bridge Management and Maintenance Plan

VDOT Historic Bridge Management and Maintenance Plan

Management Plan Recommendations

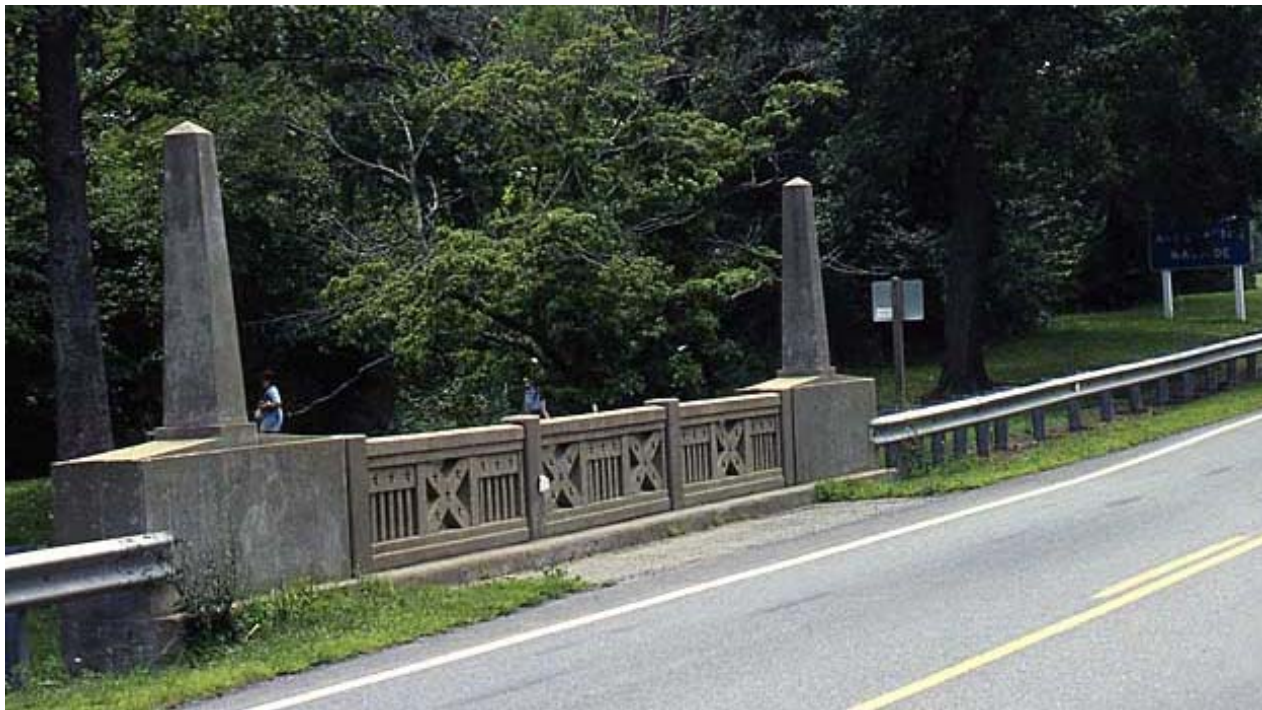
Appomattox Co. Structure 1002

Single-span reinforced concrete T-beam structure, built 1930, approximately 33 feet (10.06 m.) long.

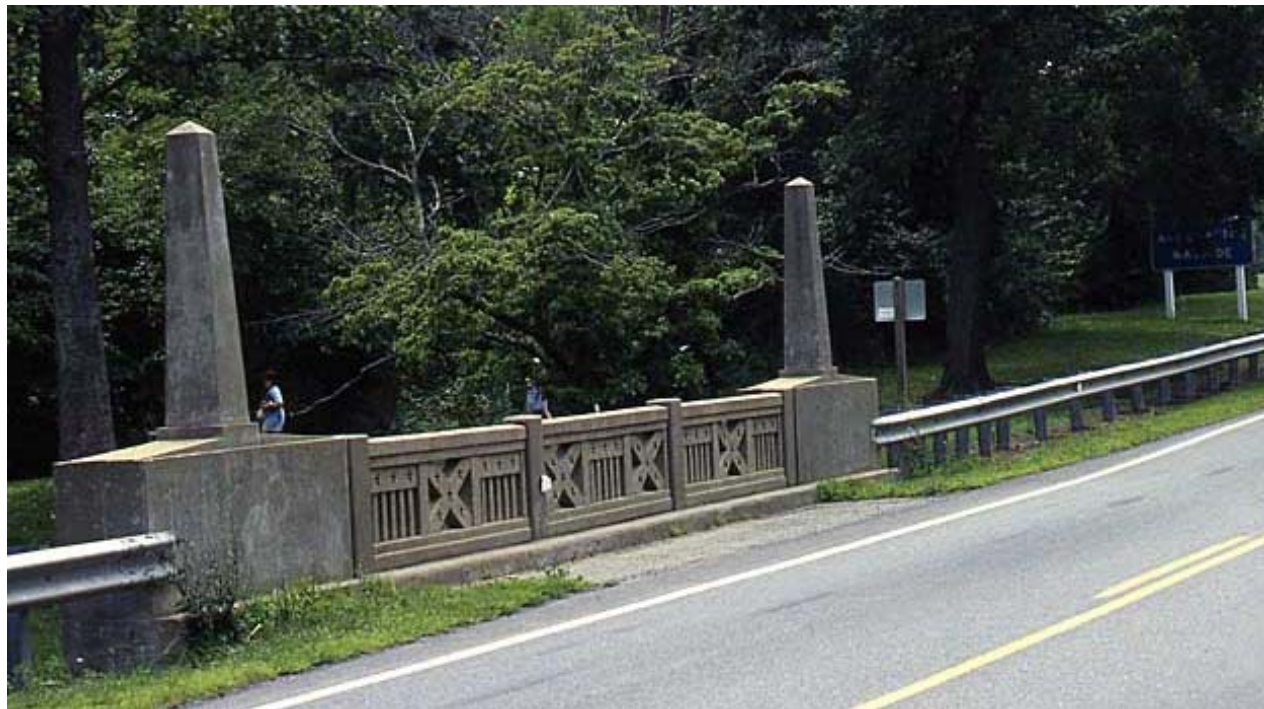
Appomattox Co. Structure 1002

A commemorative bridge near the Civil War surrender site at Appomattox Court House in Appomattox County.

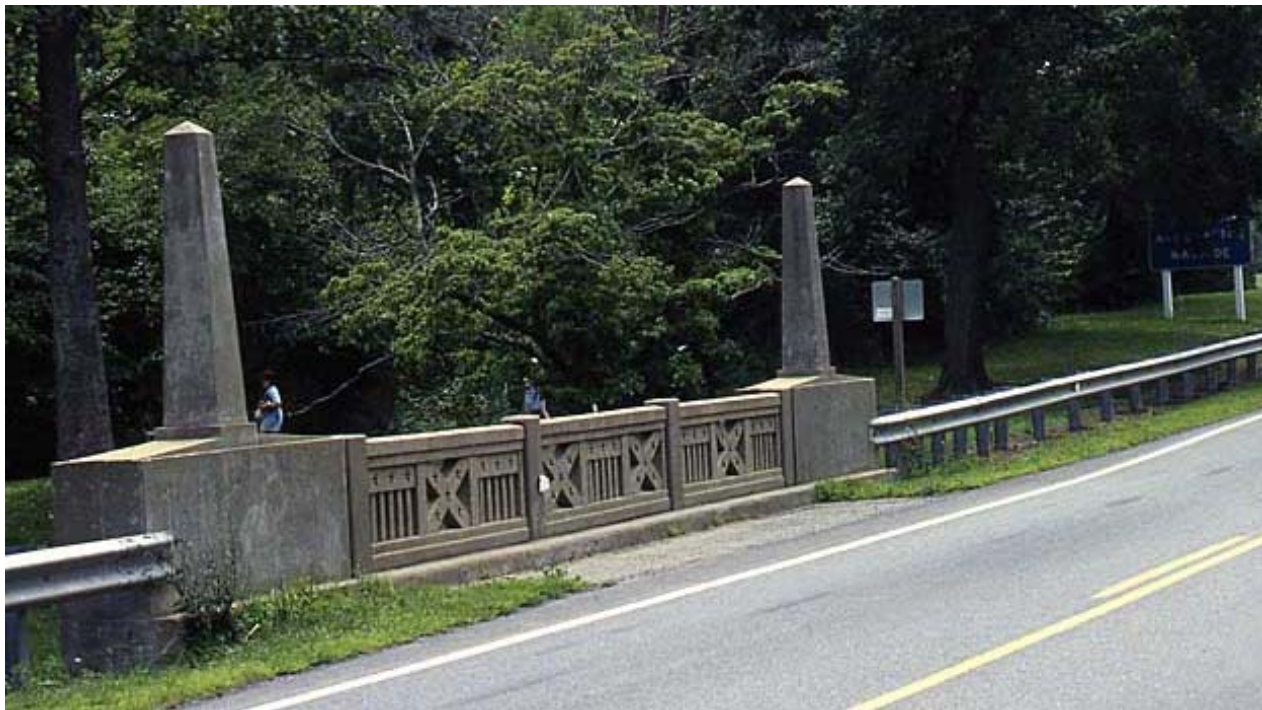
Appomattox Co. Structure 1002

Has unique concrete decorative elements (stylized Union and Confederate flag motifs, obelisks).

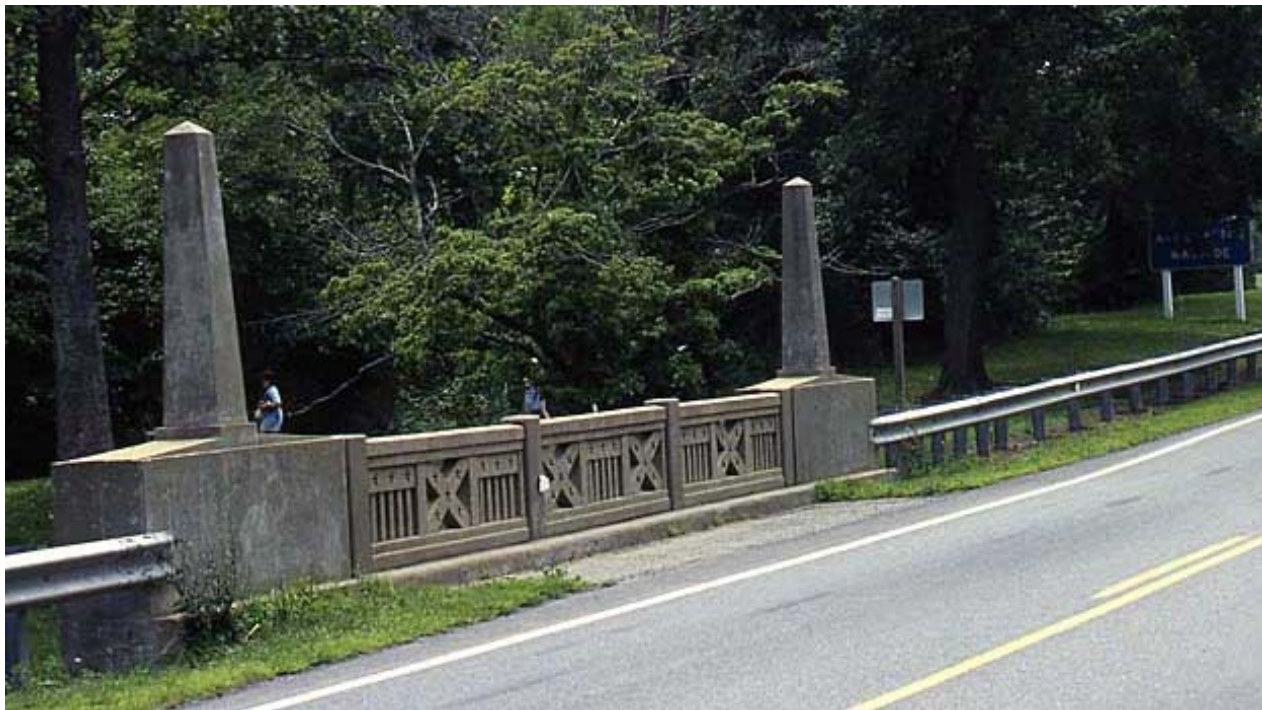
Appomattox Co. Structure 1002

Widened from 30 feet (9.14 m.) to 38 feet (11.58 m.) in 1971 (rails were moved and reused; the end posts/ obelisks were replicated).

Minor condition issues (some spalling and moisture seepage, minor cracking and delamination, scour); vegetation was encroaching on the bridge.

Repair and maintain for vehicular use, with preventive maintenance as needed.

Remove the asphalt overlay, evaluate/repair the deck, and install a new concrete overlay; clean drains, remove vegetation, repair spalled and delaminated areas, and address the scour problem.

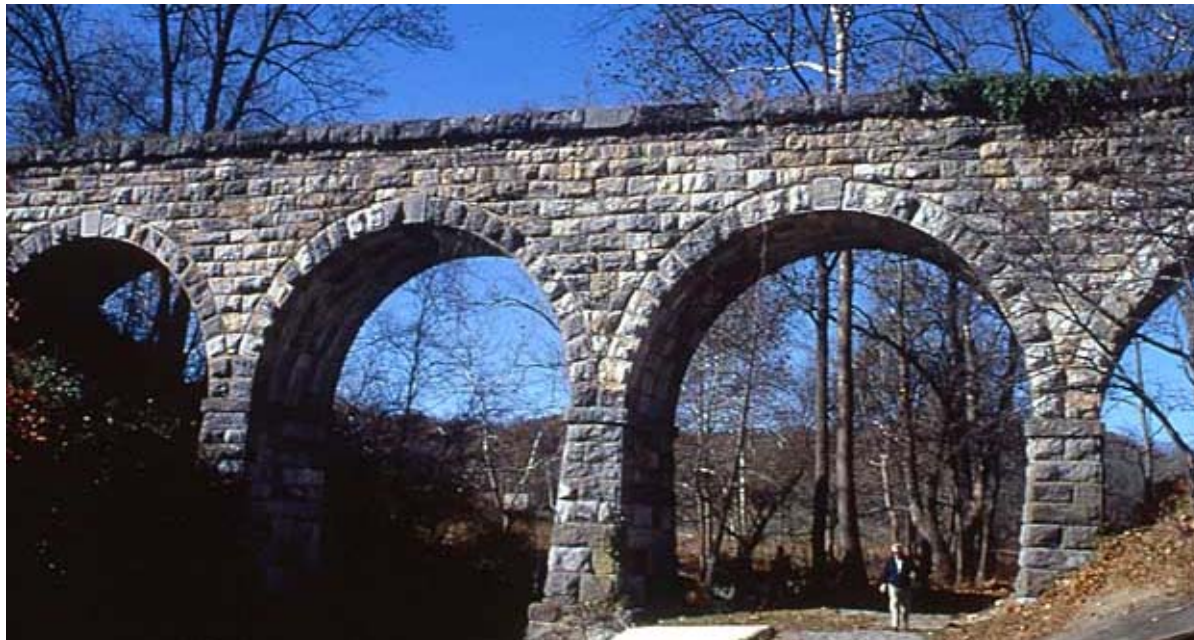
Valley Railroad Bridge

**Four-span masonry arch bridge,
former railroad bridge;
approximately 147 feet (44.81 m.)
long.**

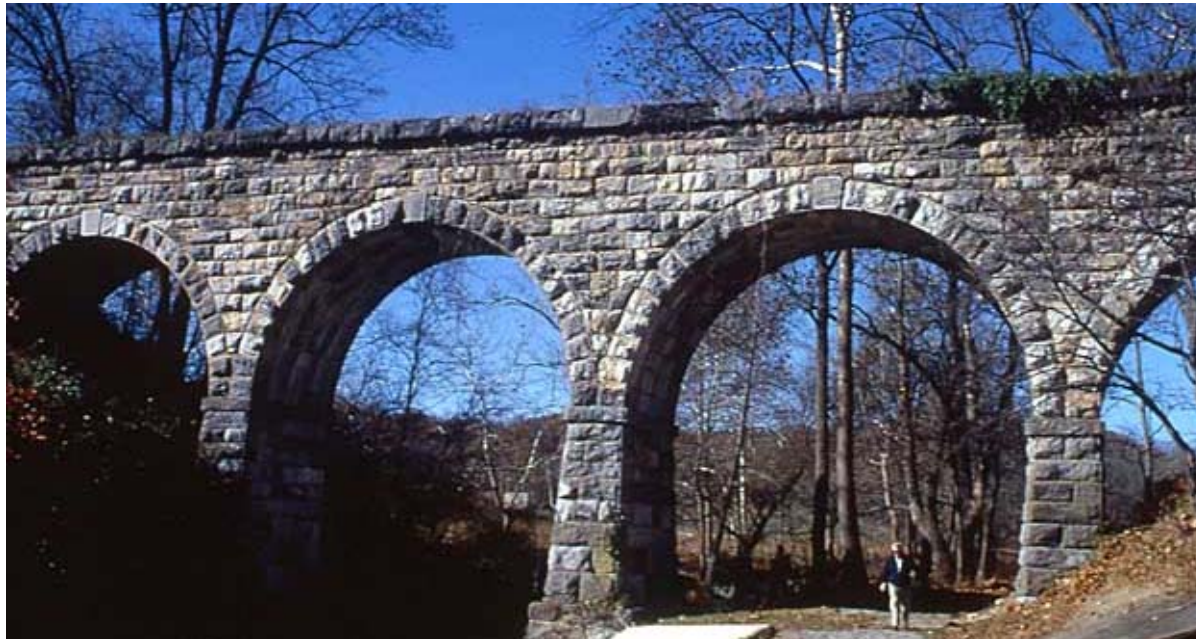
Valley Railroad Bridge

Built in 1874; one of Virginia's largest 19th century masonry railroad bridge structures (railroad line was discontinued in 1942).

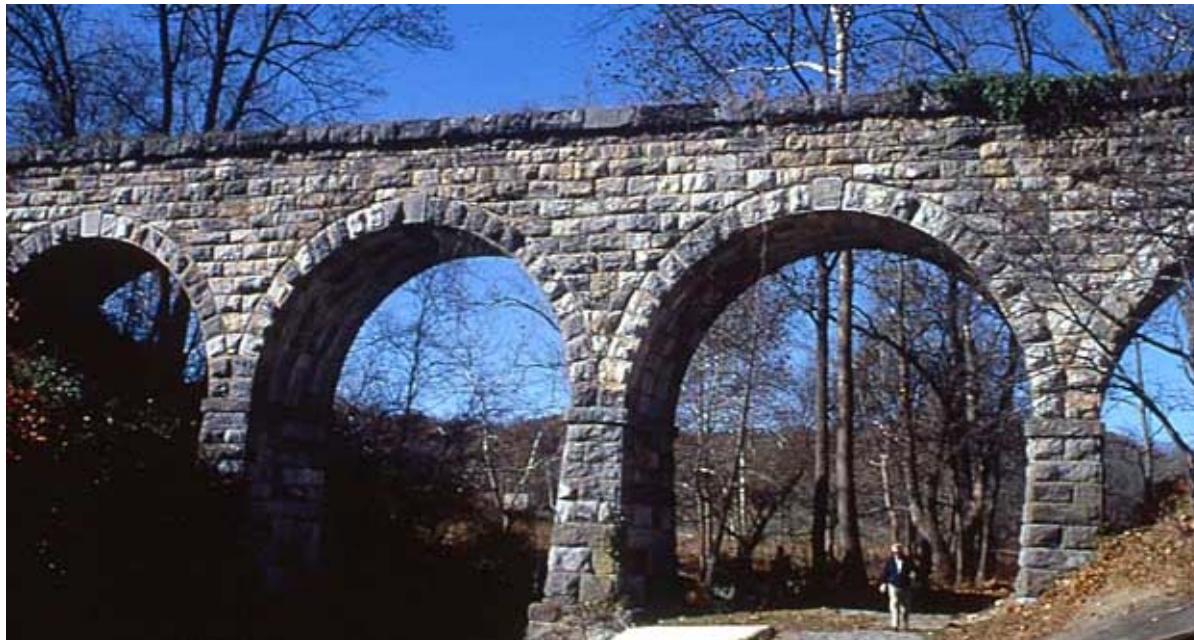
Valley Railroad Bridge

Preserved as a landscape element in the Interstate 81 right-of-way in Augusta County.

Condition issues included vegetation on the bridge, some areas of seepage through the arch, and corresponding loss of mortar.

Repair and maintain for adaptive use as a landscape feature, with subsequent preventive maintenance as needed.

Remove vegetation; repair or monitor cracks as necessary; monitor and maintain the streambed; minimize seepage through the structure.

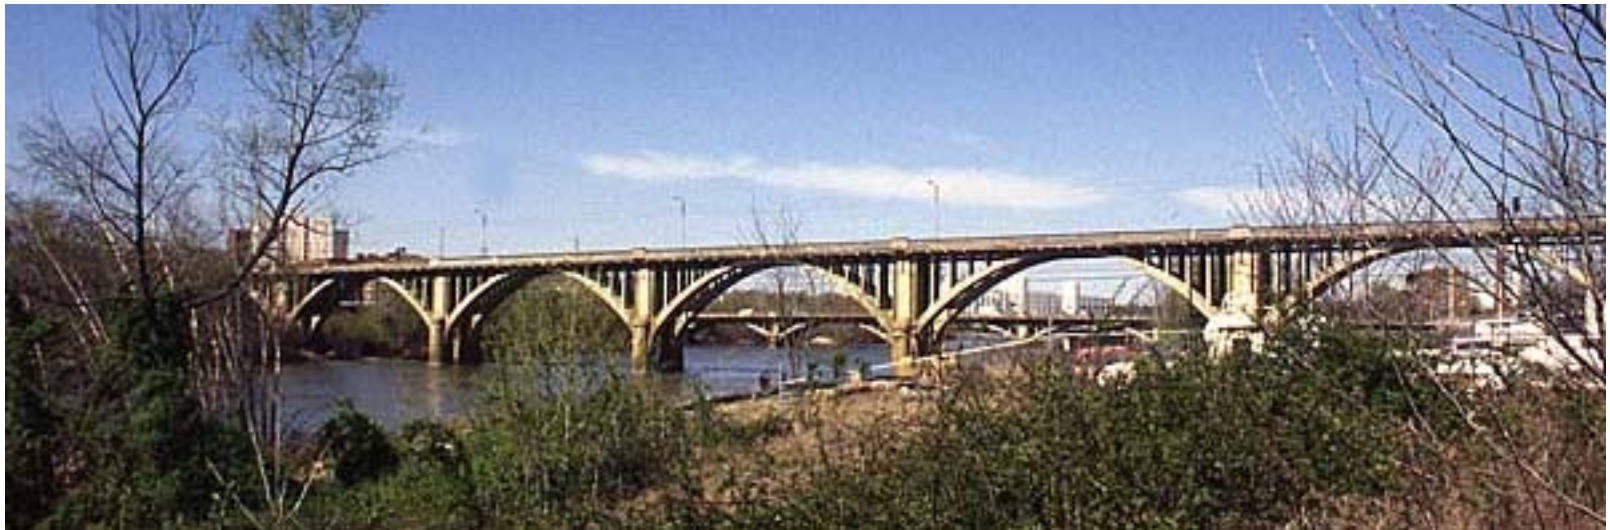
Worsham Street Bridge

Ten-span concrete arch bridge, designed by the noted bridge engineer Daniel B. Luten, built in 1928, carries Worsham Street over the Dan River in the City of Danville.

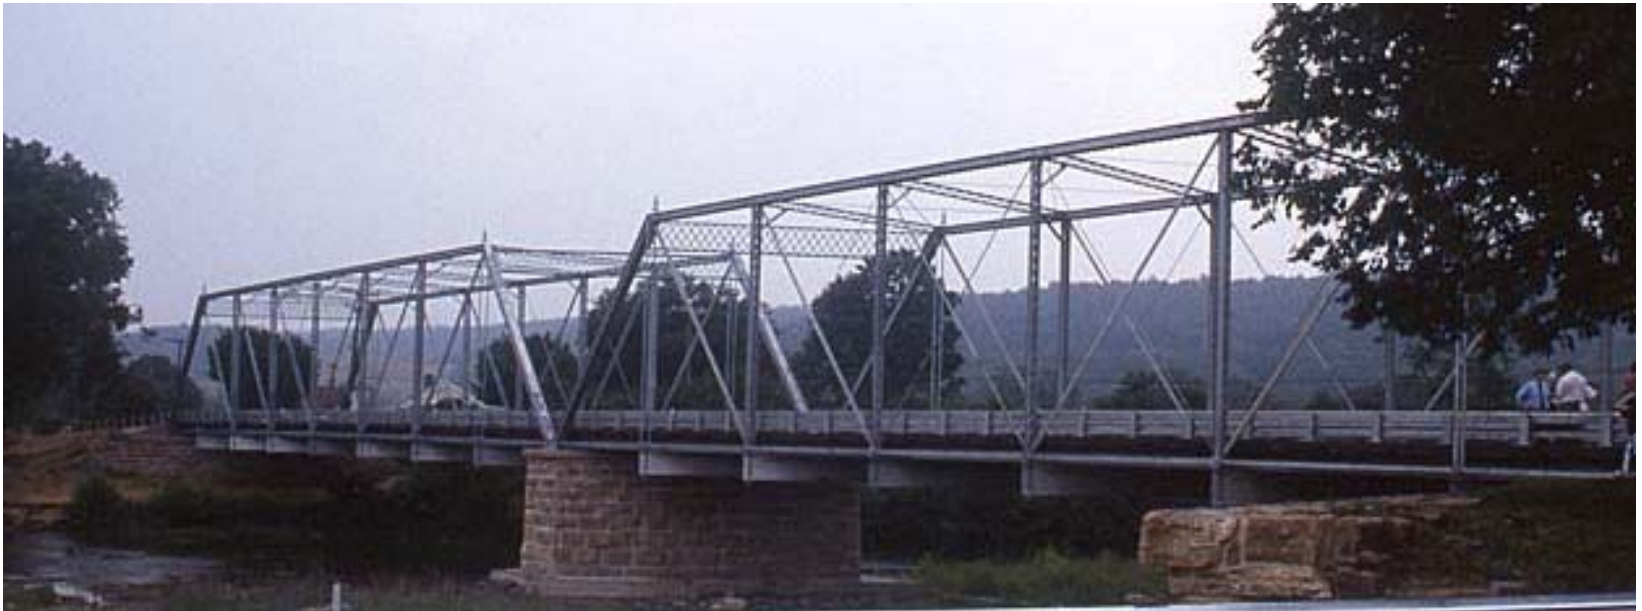
Goshen Bridge

Two-span steel Pratt through truss, built 1890, approximately 261 feet (79.55 m.) long overall

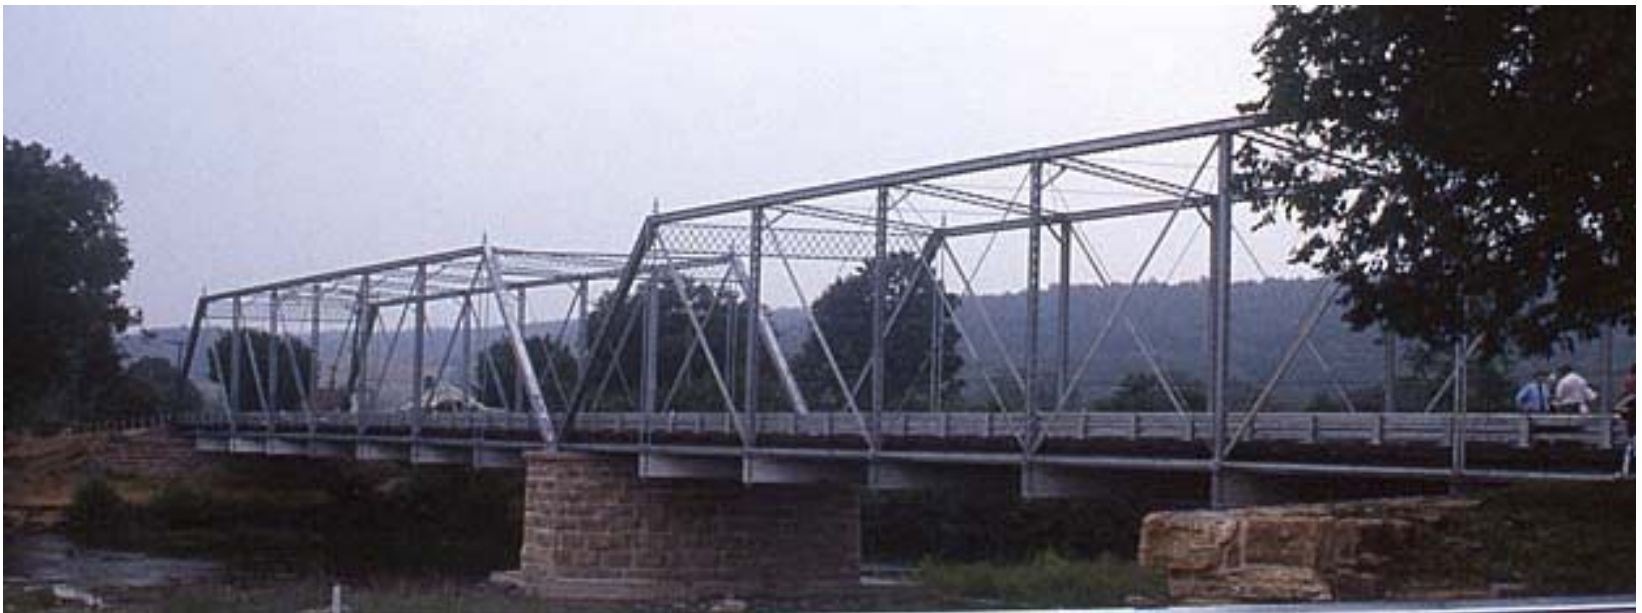
Goshen Bridge

Trusses are approximately 139 feet (42.37 m.) and 121 feet (36.88 m.) long

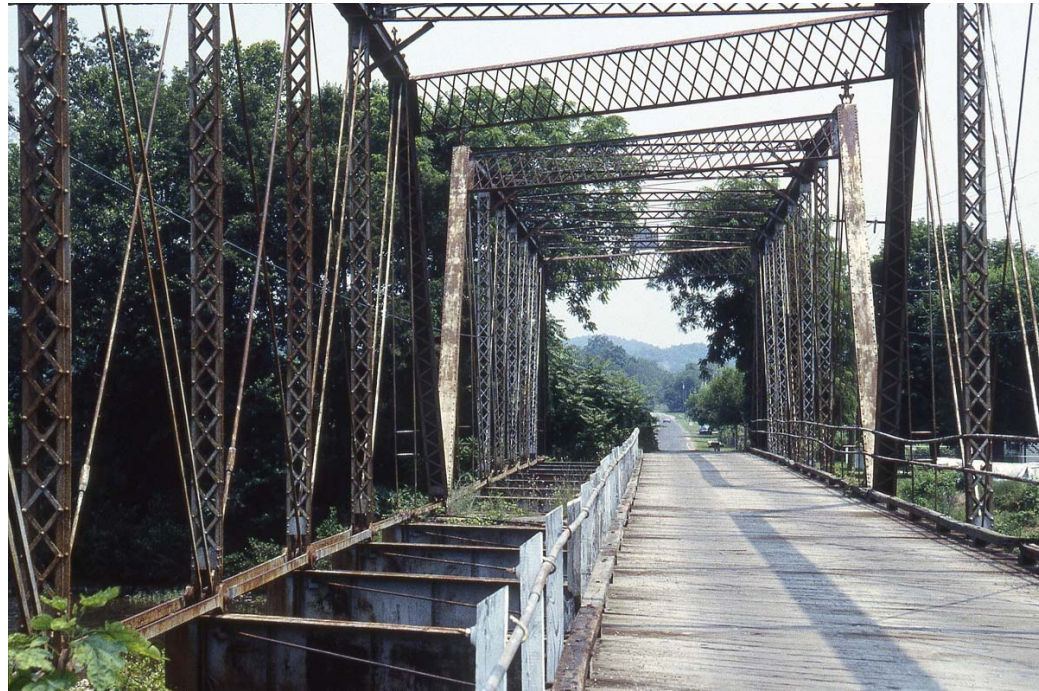
Goshen Bridge

There were numerous areas of corrosion and section loss to steel members. Piers were missing mortar and some substructure stones.

The stone piers were cleaned, repaired and repointed as needed, using a compatible mortar mix.

Due to section loss, severe active corrosion, and pack rust, all end posts, hip verticals, upper chord members, counters, and pins had to be replaced.

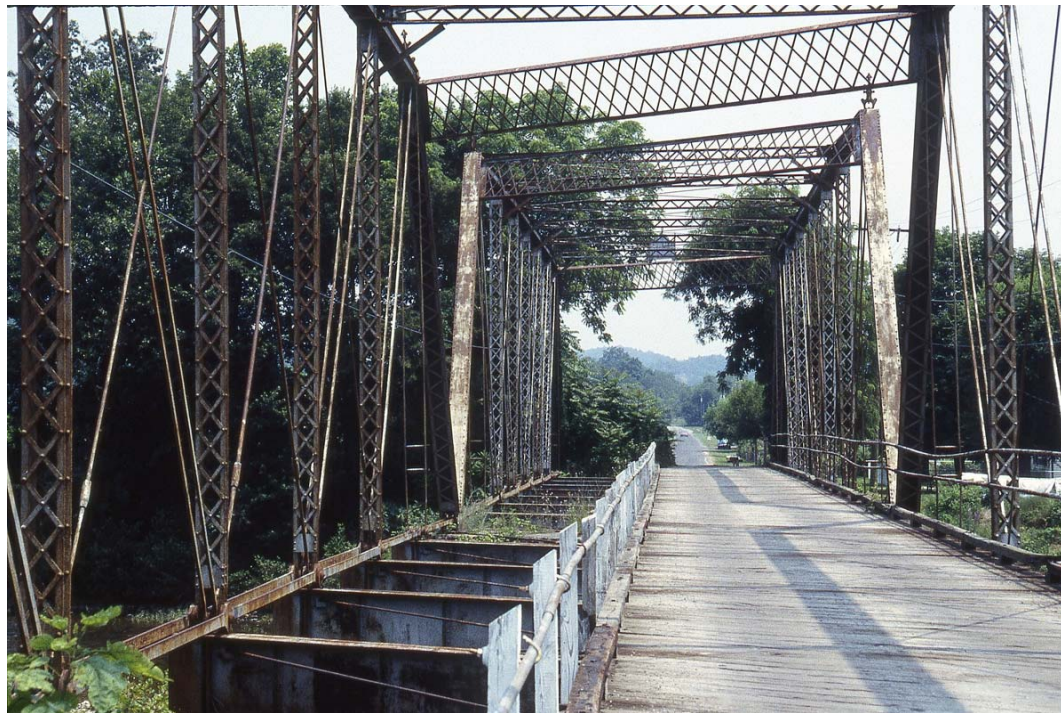
Goshen Bridge

Roller bearing devices were frozen and some were displaced. Debris was present on the bridge seats, connections and between stringers.

Due to corrosion concerns, laminated elastomeric pads were used in the expansion bearings.

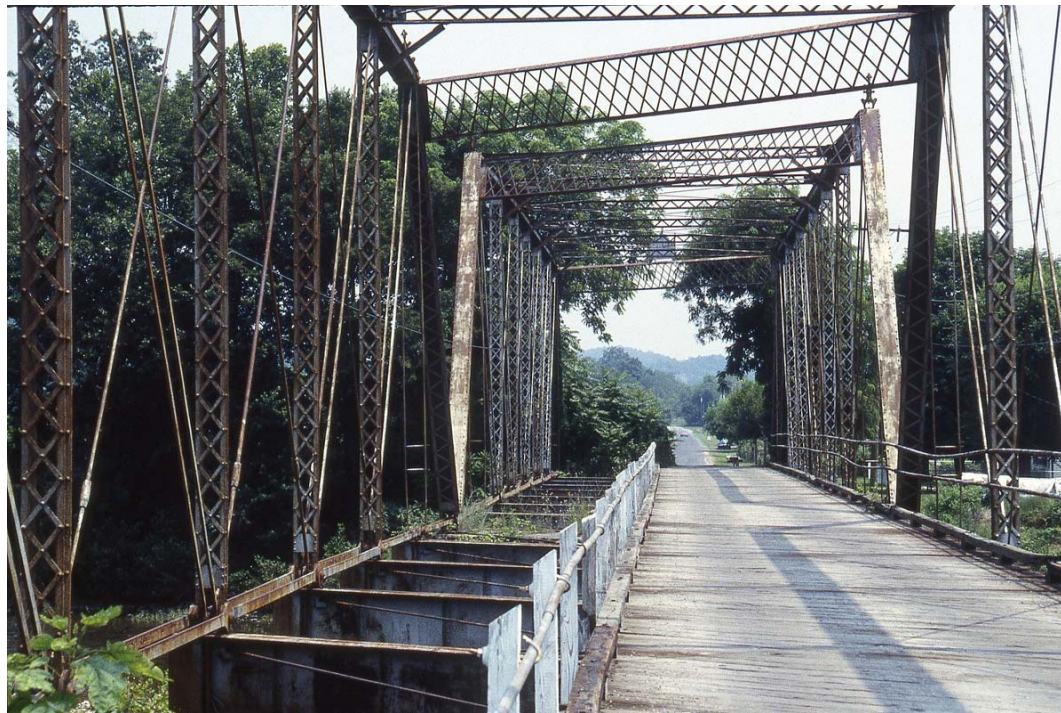
Goshen Bridge

Only one lane was open to vehicular traffic; the other lane (originally planned as a streetcar lane) had not had decking for at least 50 years.

Glued laminated timber deck panels replaced the original nail-laminated plank deck.

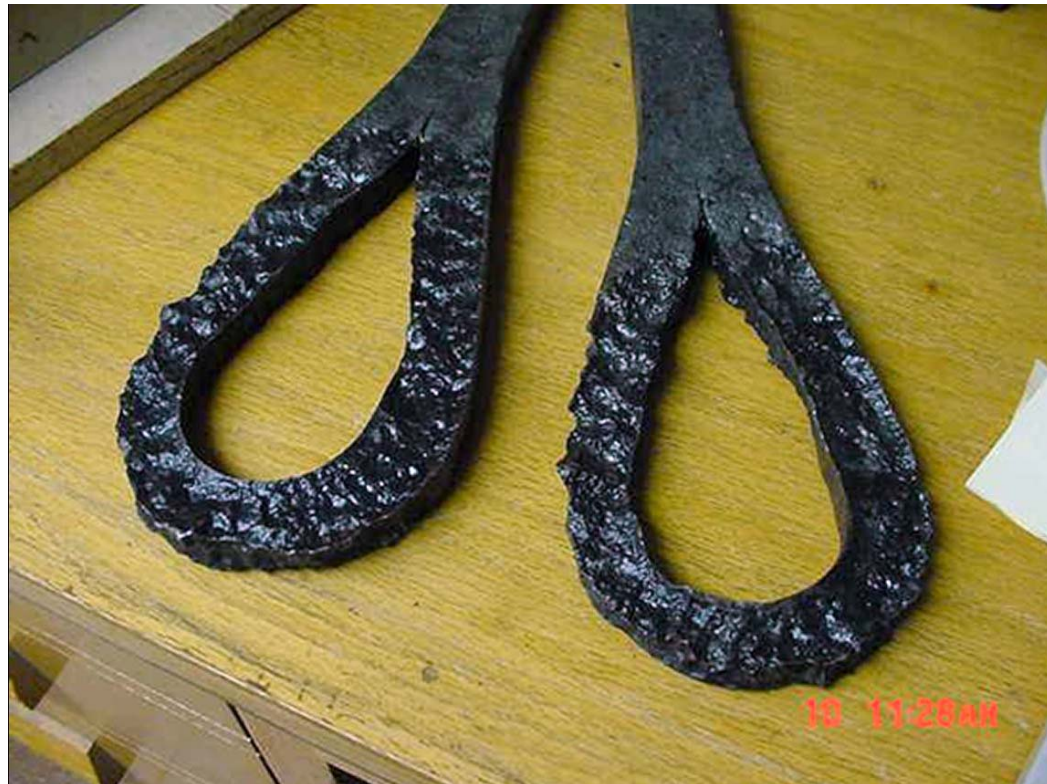
Goshen Bridge Rehabilitation

Loop-welded eye bars and counters, which are prone to failure and have been prohibited, were not replaced in-kind.

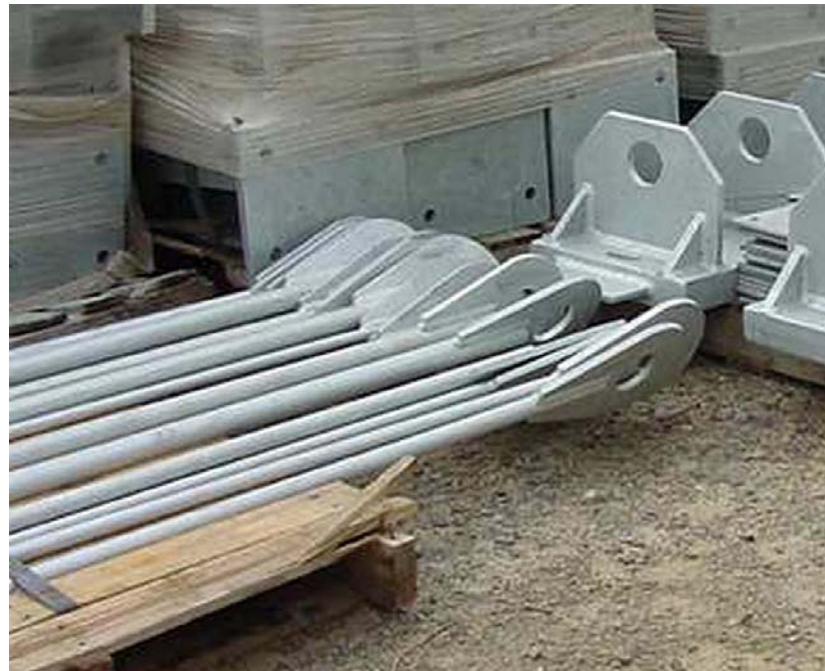
Goshen Bridge Rehabilitation

Changes in these elements were made to comply with current American Association of State Highway and Transportation Officials (AASHTO) standards.

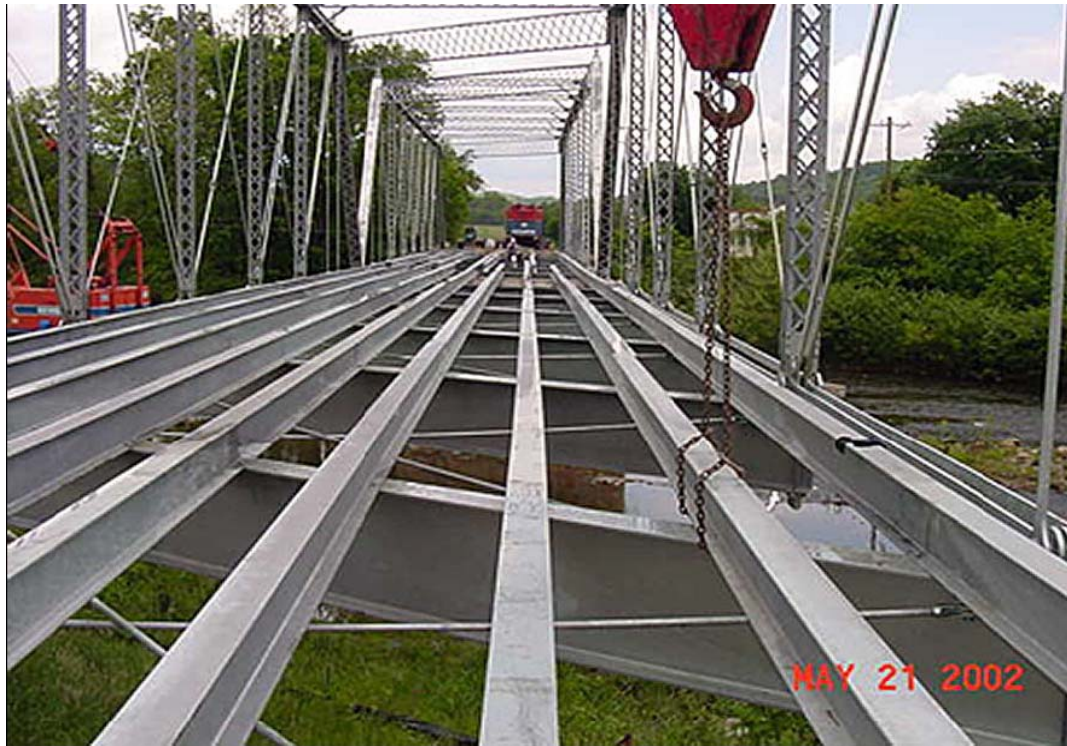
Goshen Bridge Rehabilitation

All of the structural steel, including the bolts and bearings, was galvanized.

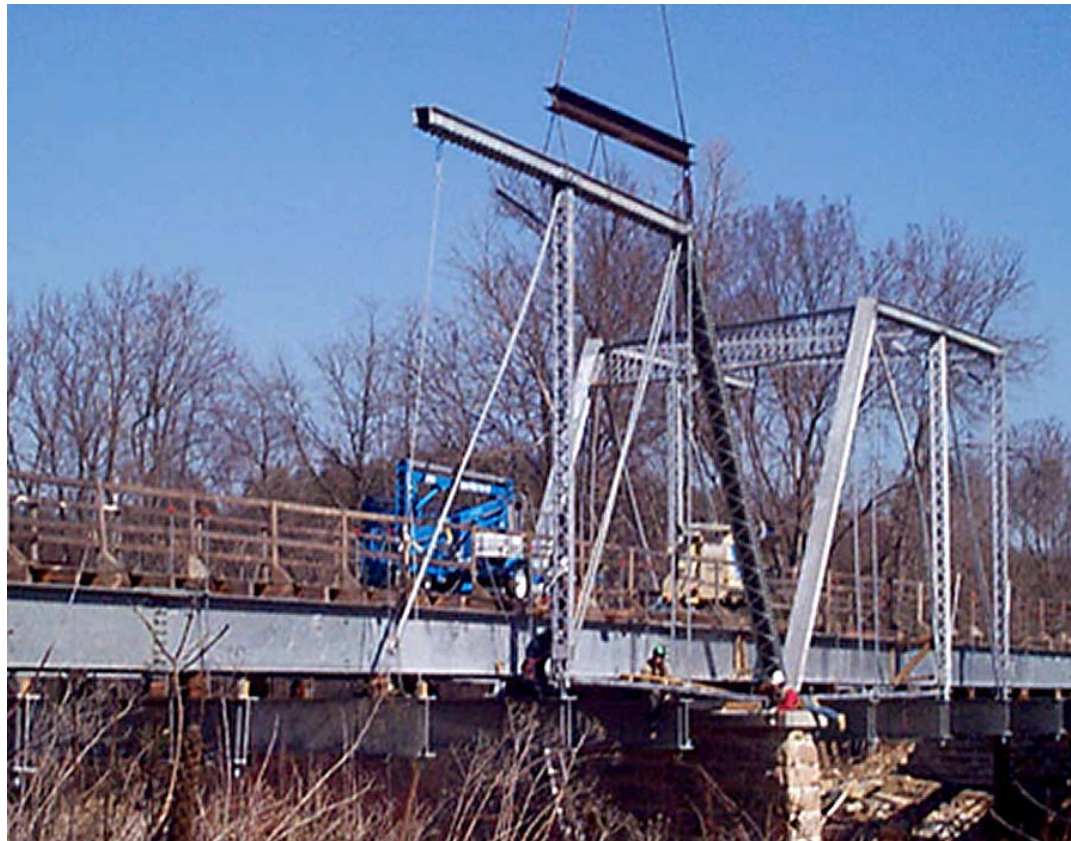
Goshen Bridge Rehabilitation

The truss elements were reassembled.

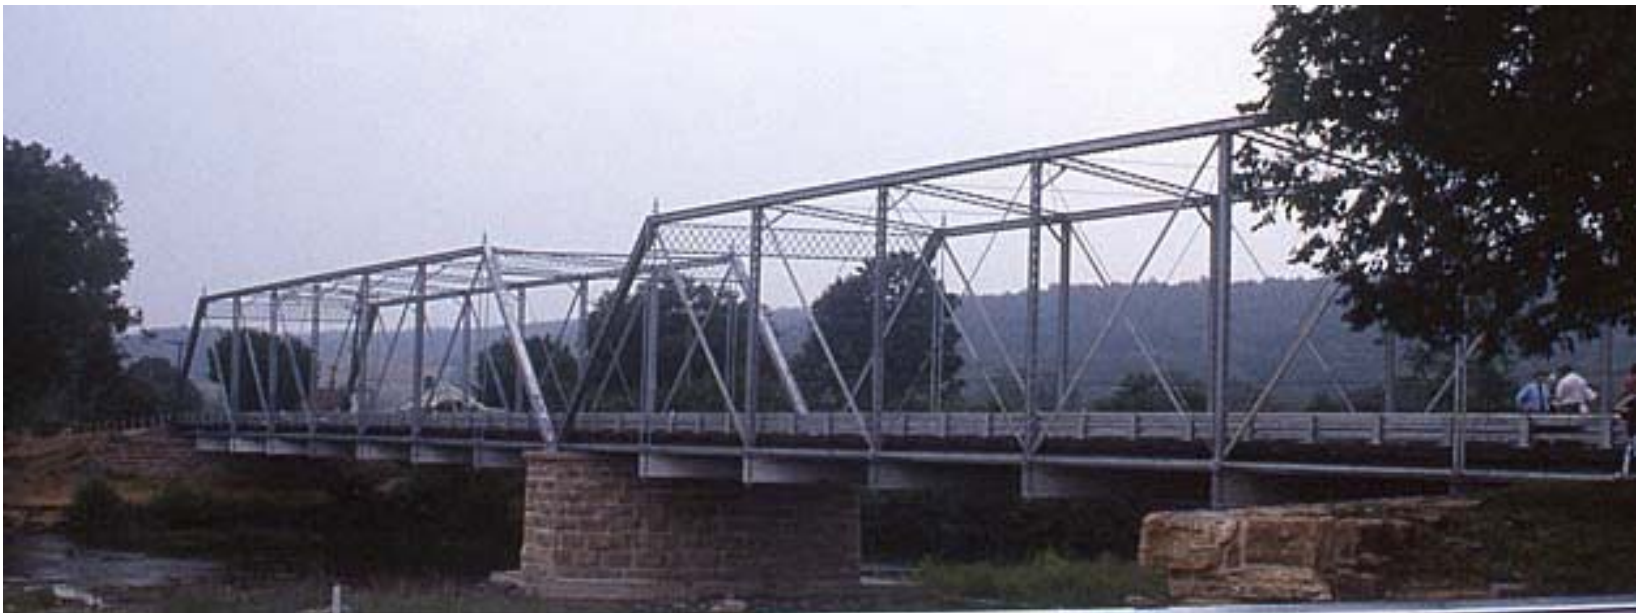
Goshen Bridge Rehabilitation

The bridge was restored for two lanes of vehicular traffic, and included the capacity to carry emergency vehicles. It was reopened in July, 2002.
